Some Case Histories with Lessons to Learn in Dam Engineering

Luiz Guilherme de Mello¹

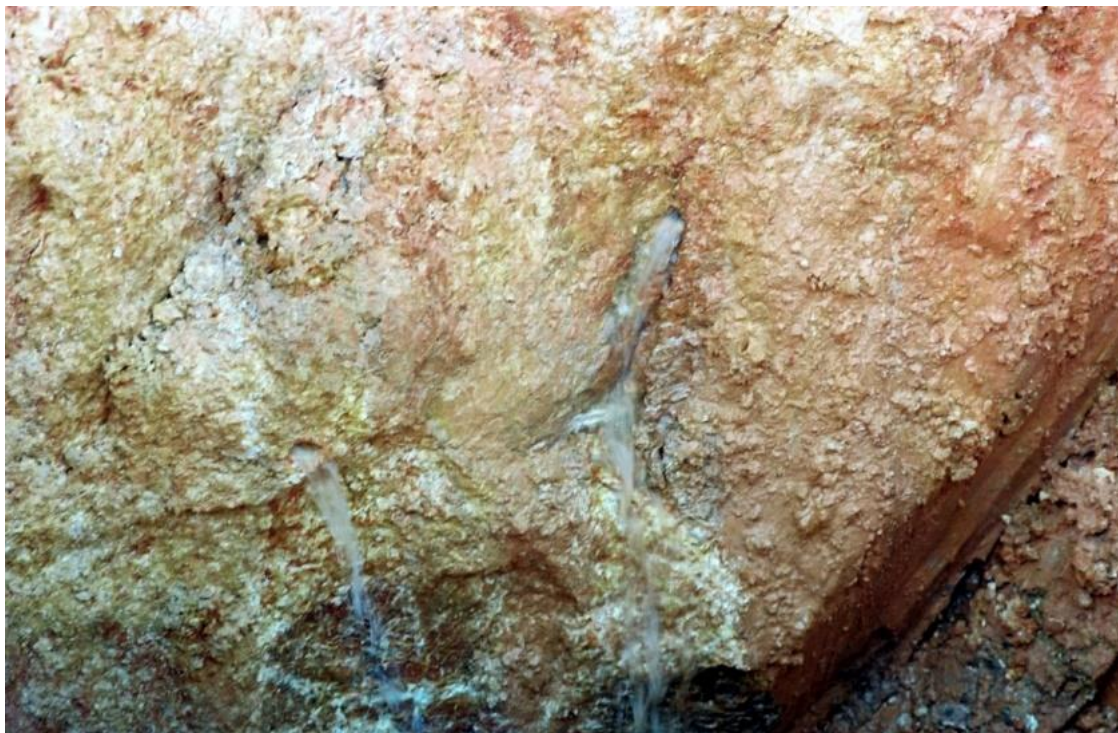
Different phases and sophisticated subsoil investigation associated the high permeabilities to the presence of tubular cavities, canaliculi, in the saprolitic soil profile, with diameters varying from millimetric to centimetric (2 to 3cm), intercommunicating and with an erratic geometric pattern. They were detected in most trenches, with a frequency, which would vary grossly between one or two per square meter for the largest diameters, and one per square decimeter (100 per m²) for the canaliculi of 2 mm diameter. This frequency varies along the foundation, and some trenches did not detect any canaliculi at all.

These canaliculi were interpreted as being generated by intense termite activity linked with the last glacial period and the associated lowering of water table linked to the ocean regression (de Mello, L.G. et al, 1987). The action of termites was proposed by the Portuguese biologist Machado A.B (1983), confirming the activity of these insects in all the samples, through traces, essentially composed of faecal and oral pellets, found inside the canaliculi. According to Machado the canaliculi developed probably in the last glacial quaternary era (12.000 to 18.000 years ago), when the region had relatively dry climatic conditions, decisive for the existence of vegetation formations designated as "credo" and "caatinga", propitious for the proliferation of termites. These insects became rare after the formation of the amazon forest and were not found inside the canaliculi studied. Machado also suggested that the canaliculi of higher diameters should correspond to ramifications of roots, which the termites had eaten, and that those with diameter smaller than 0.8 millimetres would have their origin associated with the disintegration of thin roots, still partially preserved in the regional soils. Photo 2.1, Photo 2.2 and Photo 2.3 illustrate said canaliculi in inspection trenches just excavated.

Photo 2.1 – Canaliculi at Balbina Hydroelectric Power Plant Dam foundations (1)

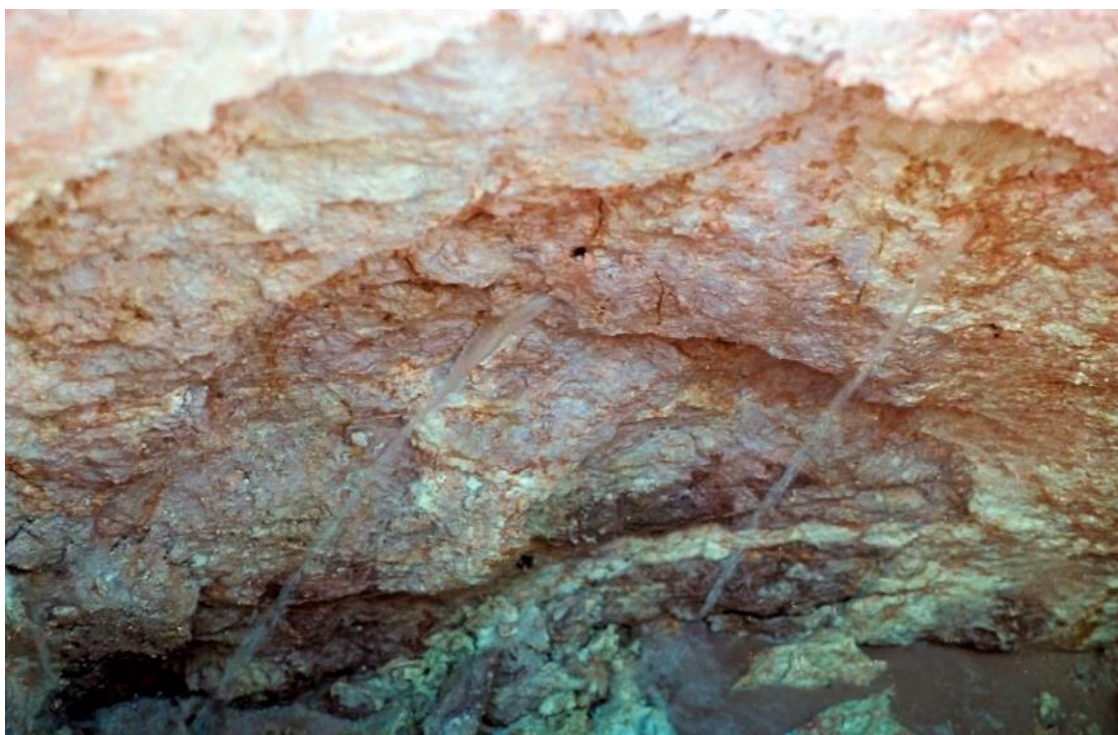
Photo 2.2 – Canaliculi at Balbina Hydroelectric Power Plant Dam foundations (2)

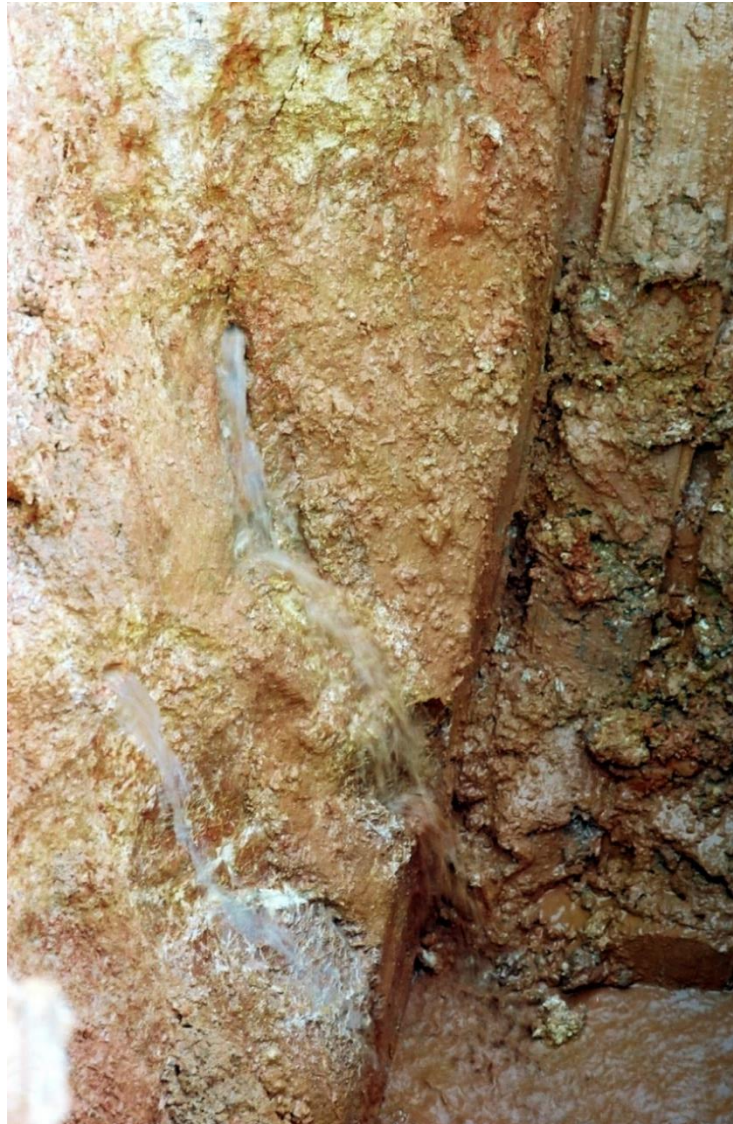
Photo 2.3 – Canaliculi at Balbina Hydroelectric Power Plant Dam foundations (3)

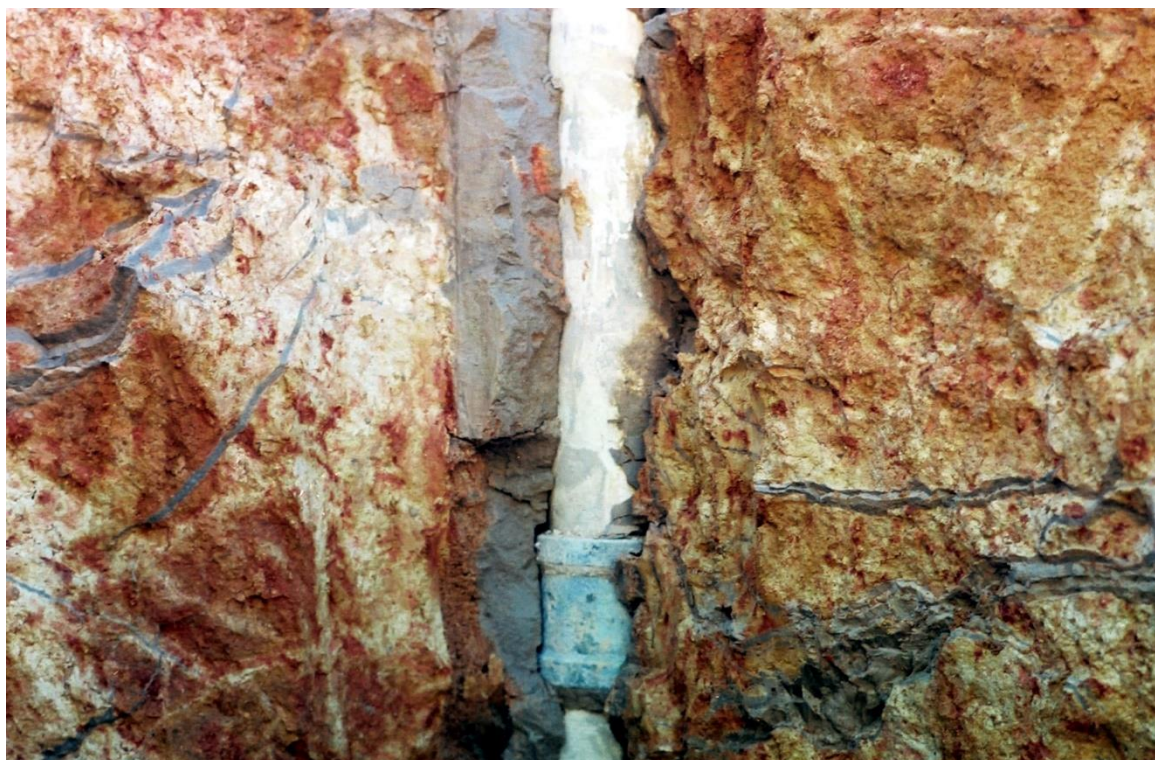
Photo 2.4 – Inspection trench - Tube a manchette in grouted borehole, with grout planes generated by hydraulic fracturing

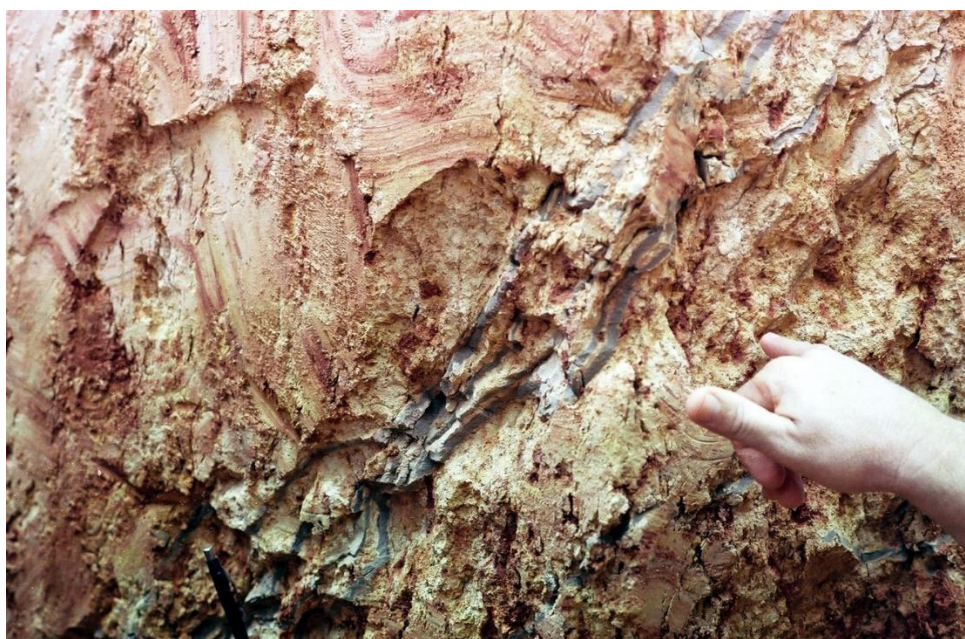
Photos 2.5 to 2.8 were taken at the inspection trenches, depicting the successful treatment of the canaliculi.

Photo 2.5 – Inspection trench – clacage planes intersecting and treating canaliculi (1)

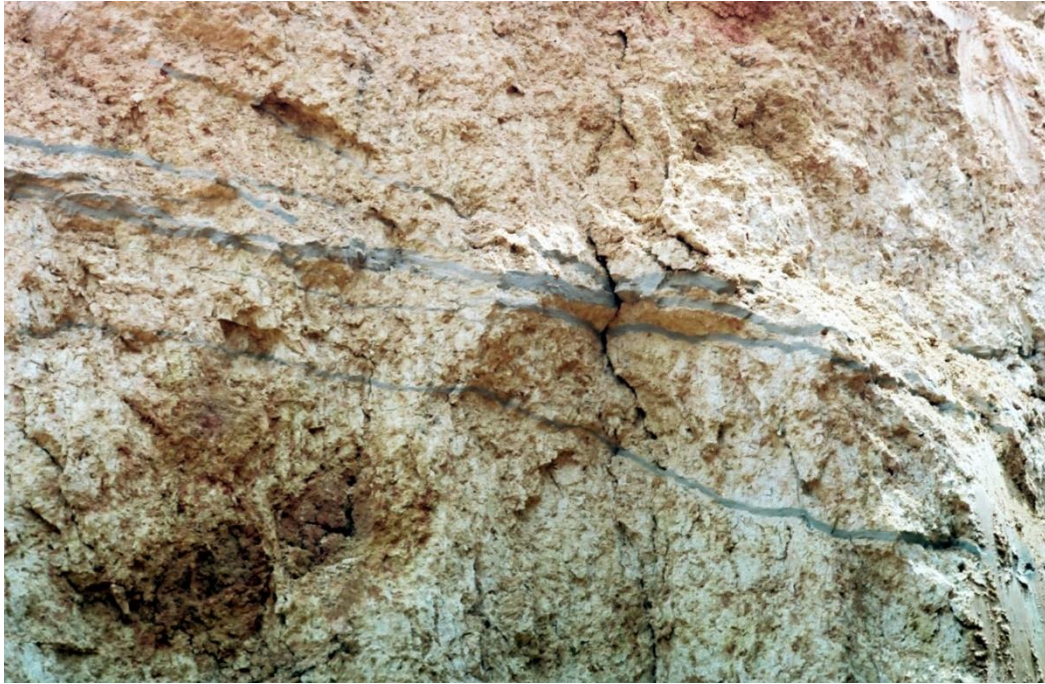
Photo 2.6 - Inspection trench – clacage planes intersecting and treating canaliculi (2)

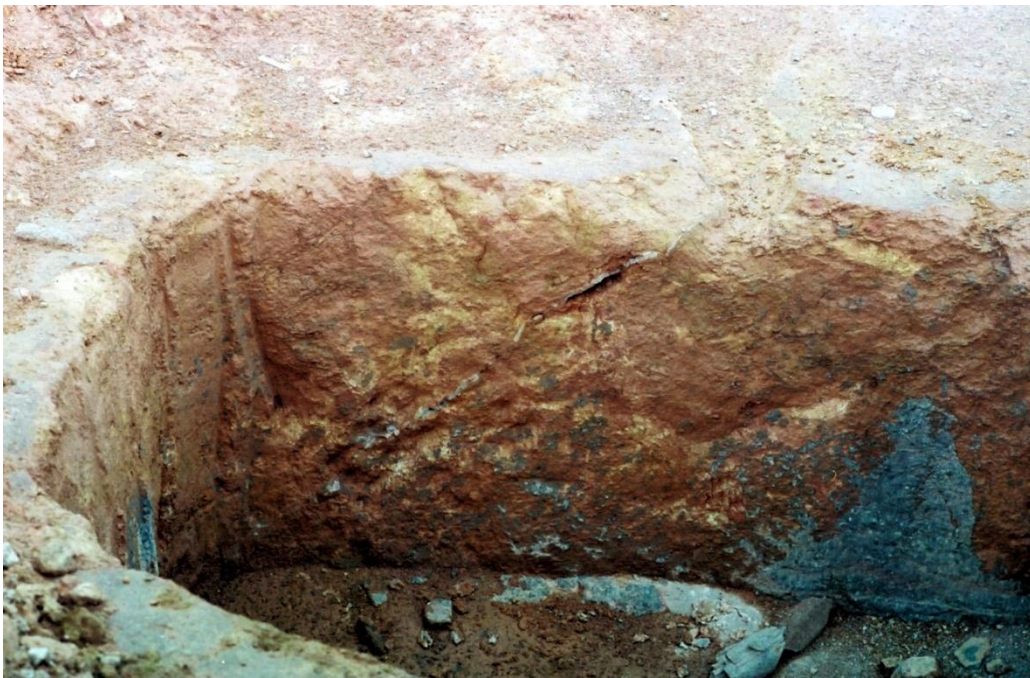
Photo 2.7 - Inspection trench – clacage planes intersecting and treating canaliculi (3)

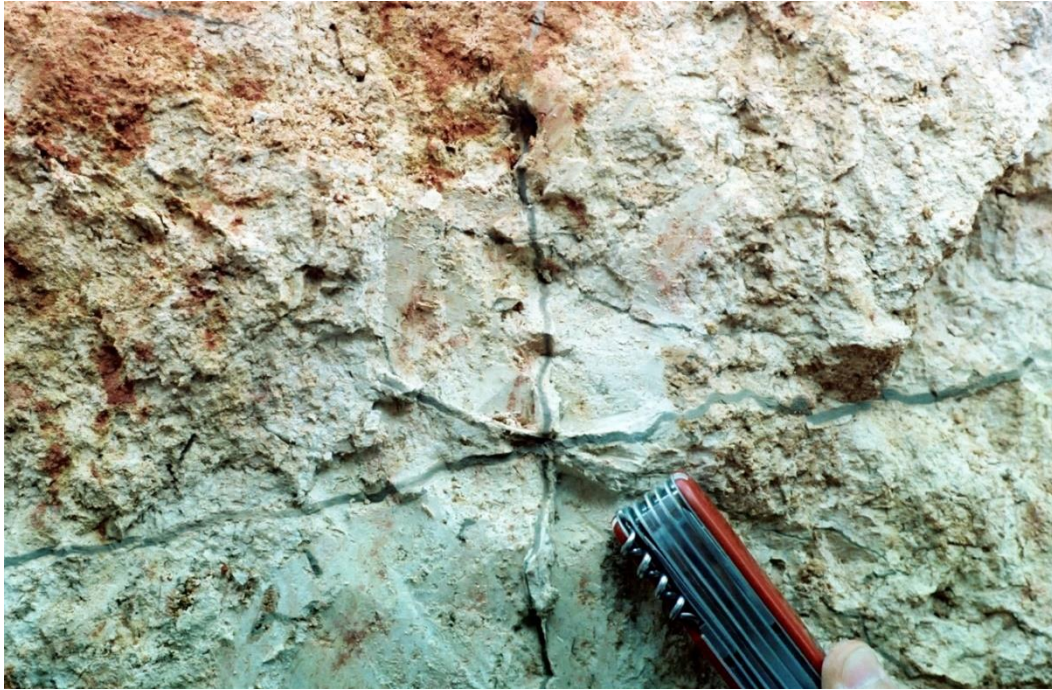
Photo 2.8 - Inspection trench – treated canaliculi (4)

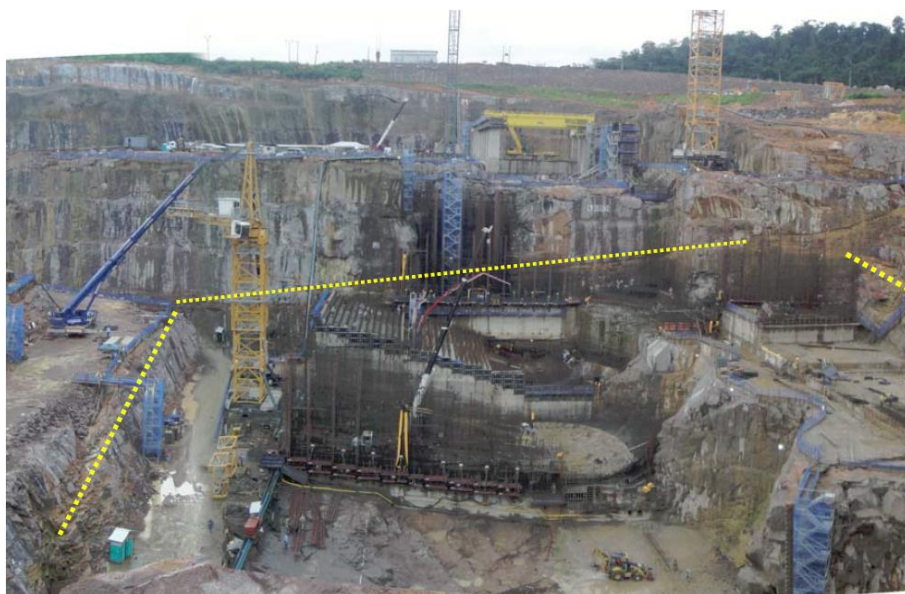
This shear zone, identified as master joint, has its trace clearly visible on all walls of the excavation (Photo 3.1), dipping downstream with local components towards the river as shown in Figure 3.8.

Photo 3.1 – Master joint trace emphasized in yellow, as visible at the excavation walls

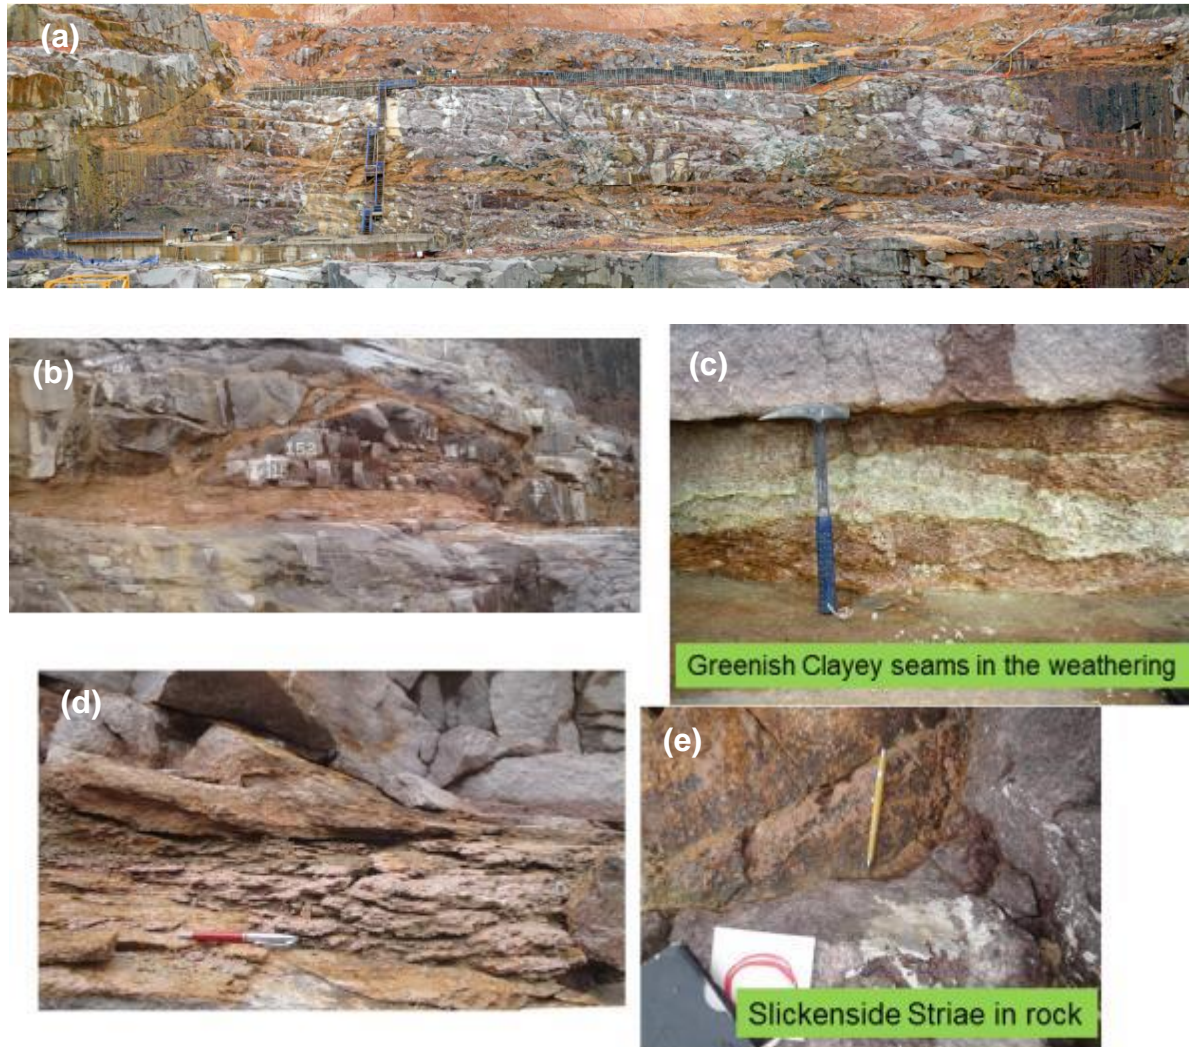
Photo 3.2 – Typical shear features in the master joint (1): (a) General view of excavation wall; (b) Isolated shear lens; (c) Clayey zone in a lens; (d) Lenticular lamination; (e) rock-rock displacement estriae.

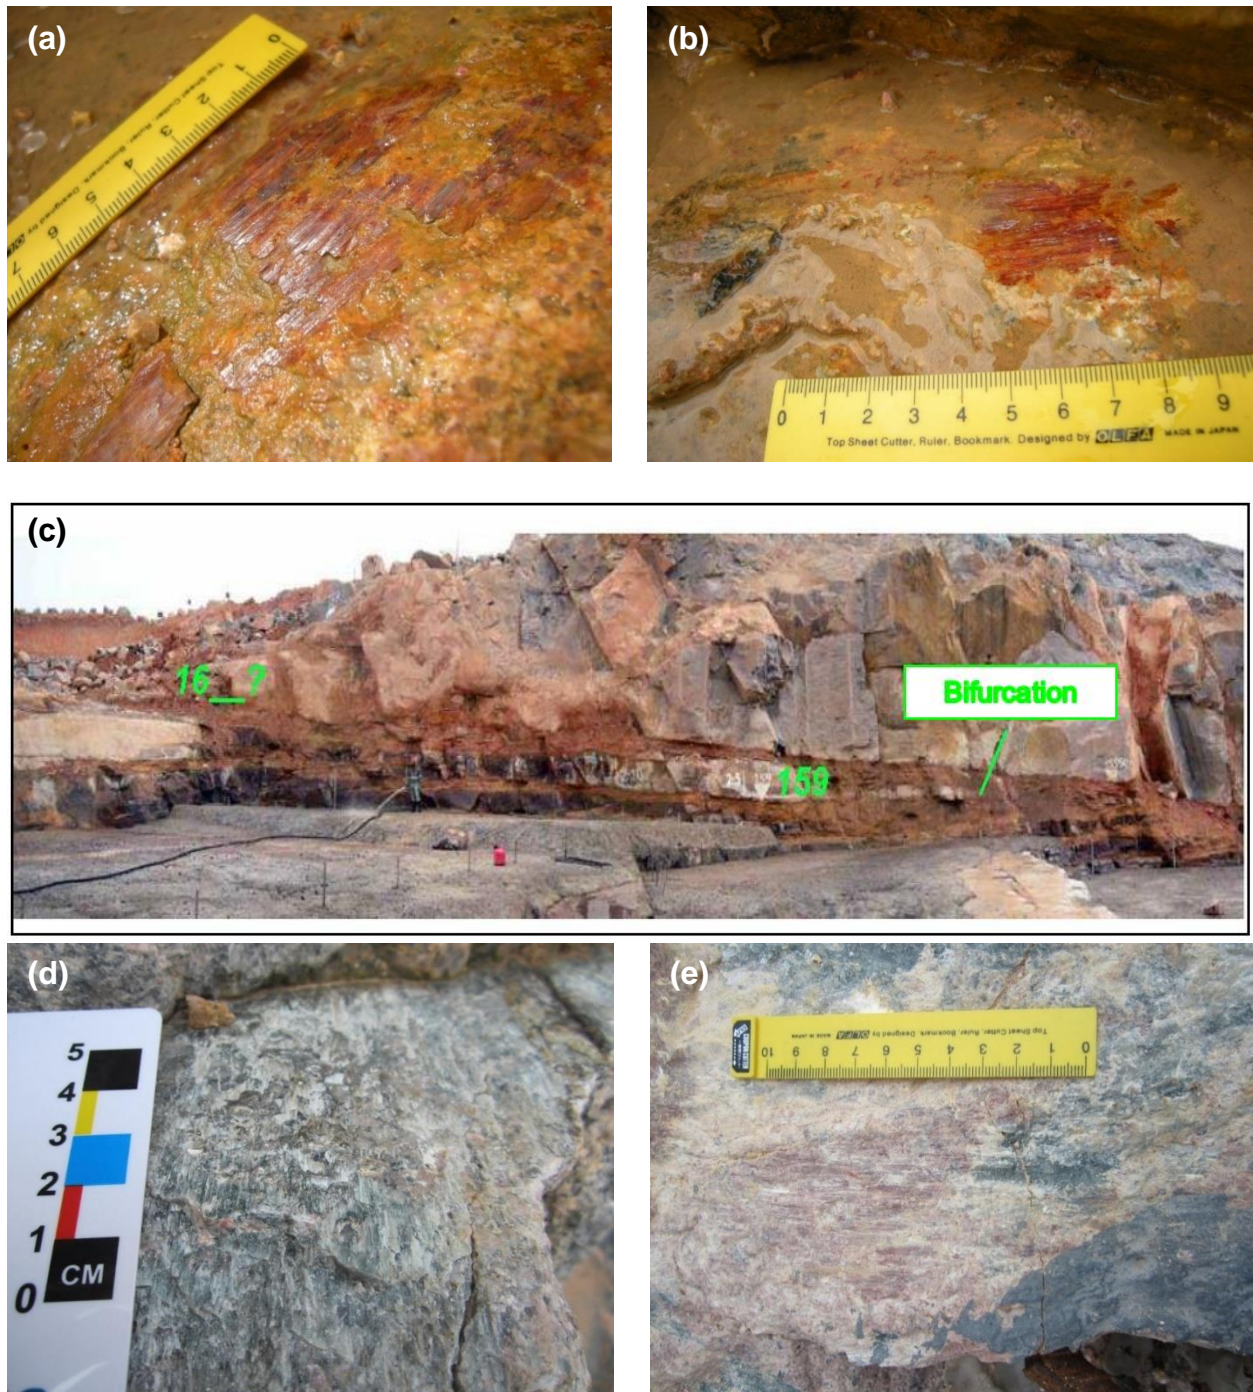
The indications of thrust tectonism along extensive sub-horizontal discontinuities confirm the presence of pre-shearing, including in the rock / rock surfaces as observed in different locations of the excavated face, as well as, later, in the stabilizing structures excavated in the area (Photo 3.3 (a) to (e)).

Photo 3.3 – Typical shear features in the master joint (2): (a) (b) Slickensides; (c) Bifurcation at master joint; (d) and (e) Estriae in non-weathered rock / rock interface

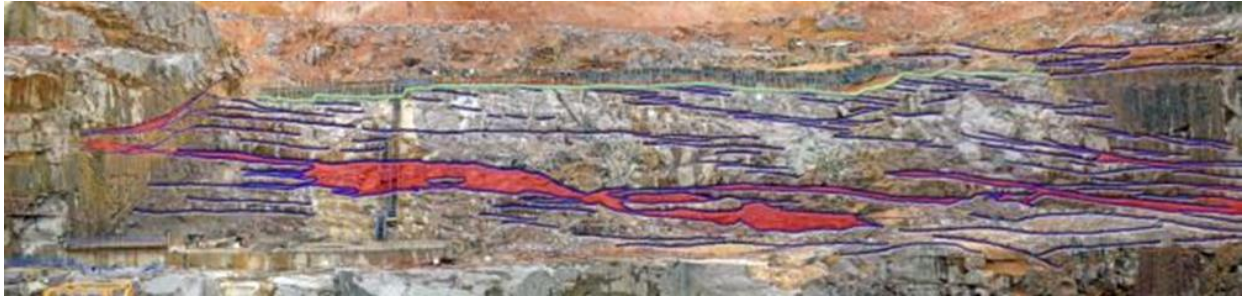
Photo 3.4 – Master joint and discontinuity pattern at water intake structure foundations

Based on this revised geological model the stability of the intake structure with relation to its sliding became intrinsically conditioned by the master joint, requiring special attention. Photo 3.4 presents the discontinuity pattern mapped at the water intake structure foundation's as seen in the penstocks excavation face, and Figure 3.9 displays a cross section for the water intake structure, presenting the identified discontinuity pattern as used in the geomechanical model proposed.

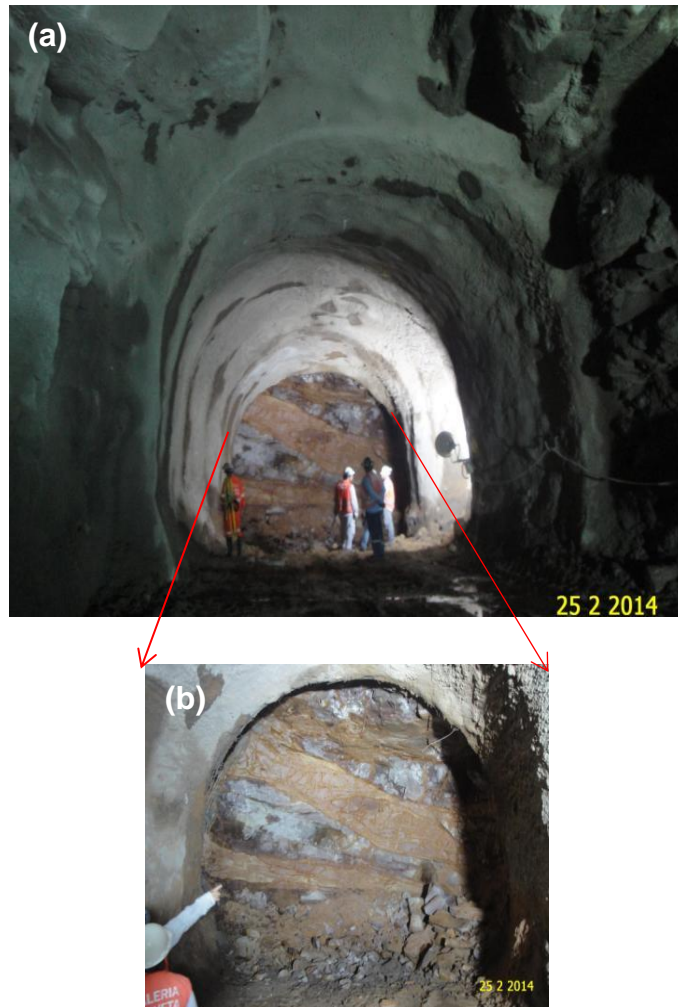
Photo 3.5 - Front view of the downstream shear key. Note the gallery overbreak above the steel ribs (a), and the detail of the downstream dipping of the weathered master joint (b).

Stabilizing shear keys were designed to guarantee safety of the structure from sliding as conditioned by the master joint (Figures 3.15, 3.16, Photos 3.5 (a), (b) and 3.6), associated to a drainage gallery previously conceived, also at the foundation of the intake structure, at elevation 140m, and relieving the water pressure as drained by a battery of vertical drains (Figures 3.14, 3.15, 3.18 and 3.17).

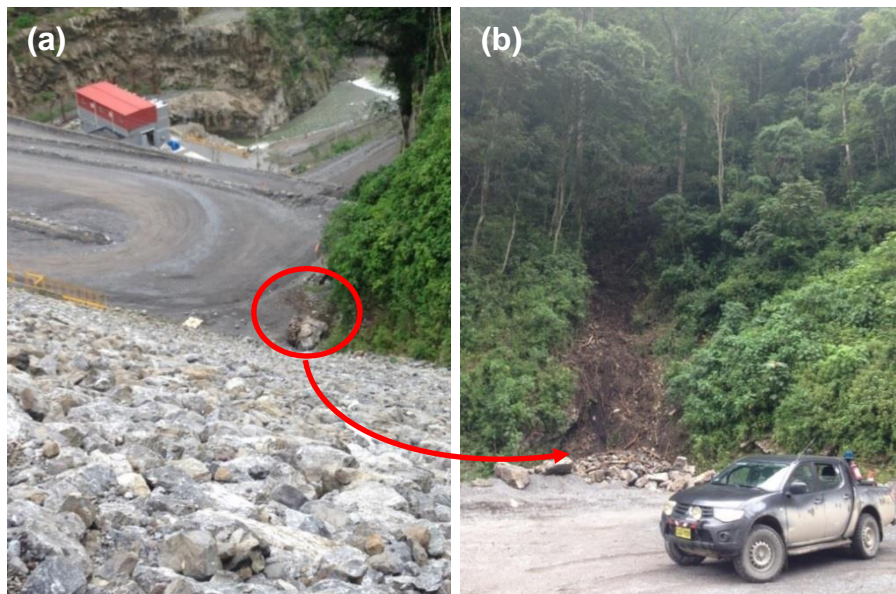
Photo 4.5 - Right bank – landslide downstream of the dam

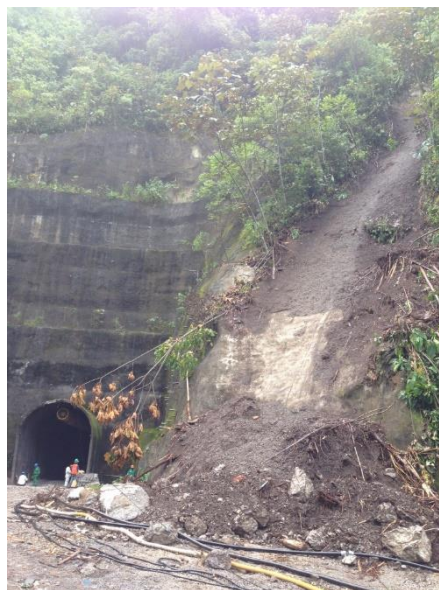
Photo 4.6 - Adit 2 – landslide near the entrance portal

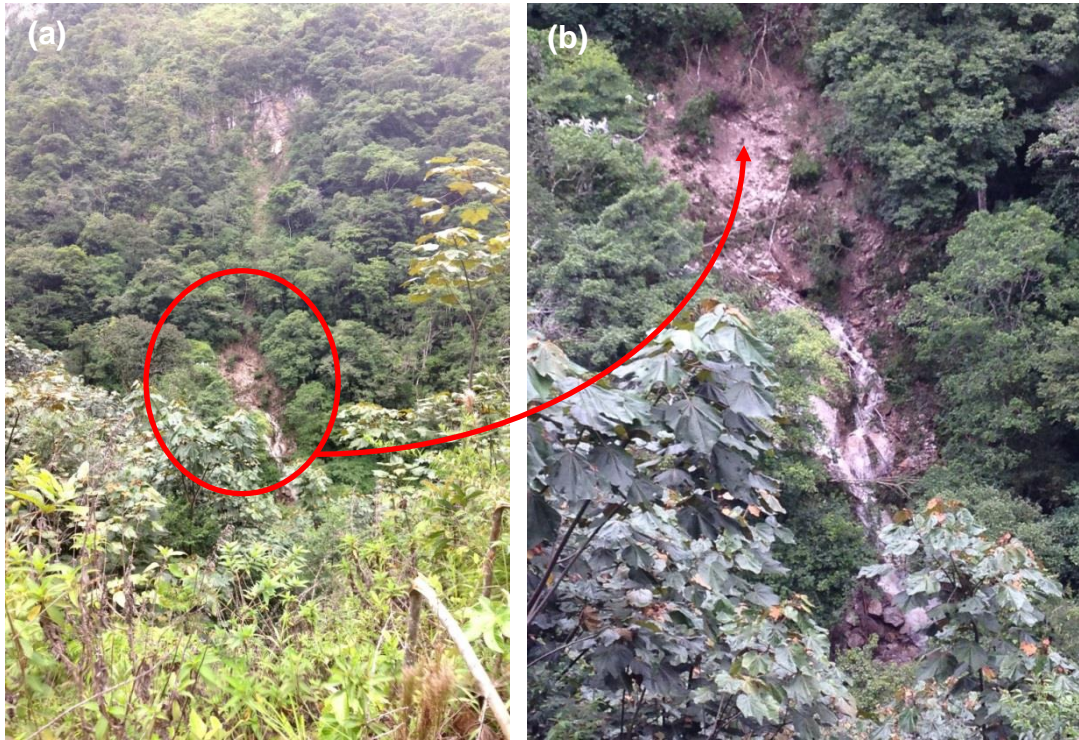
Photo 4.7 - Chimao creek – left bank – landslide around 100m upstream of the access bridge for adit 3

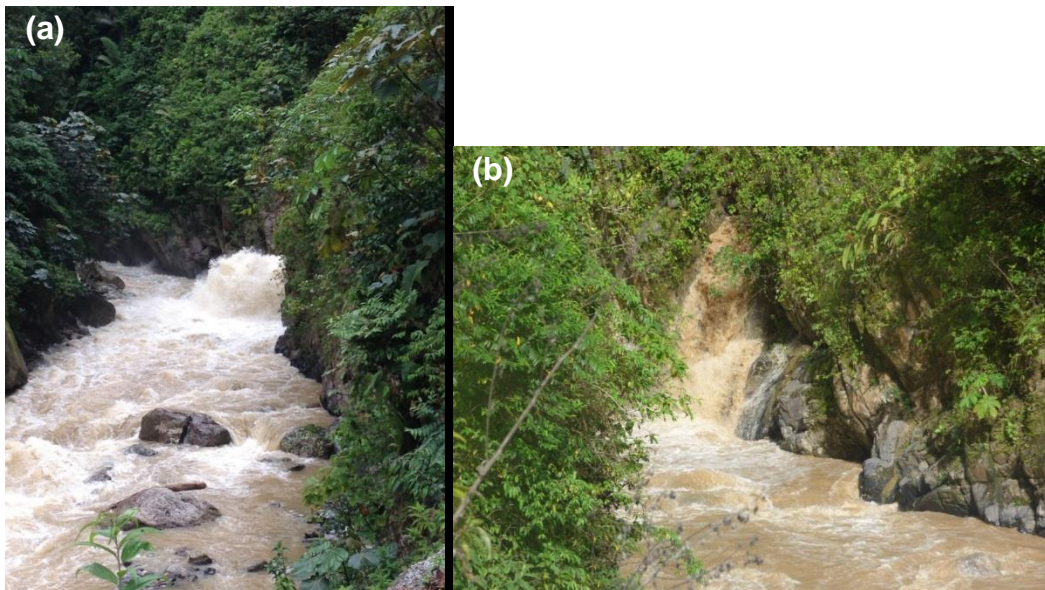
Photo 4.8 - Chimao creek – left bank – high-volume flow of dirty water was observed (later known as coming from the headrace tunnel) about 100m upstream of the access bridge for adit 3 the day after the earthquake. Water can be seen with important amount of solids in suspension.

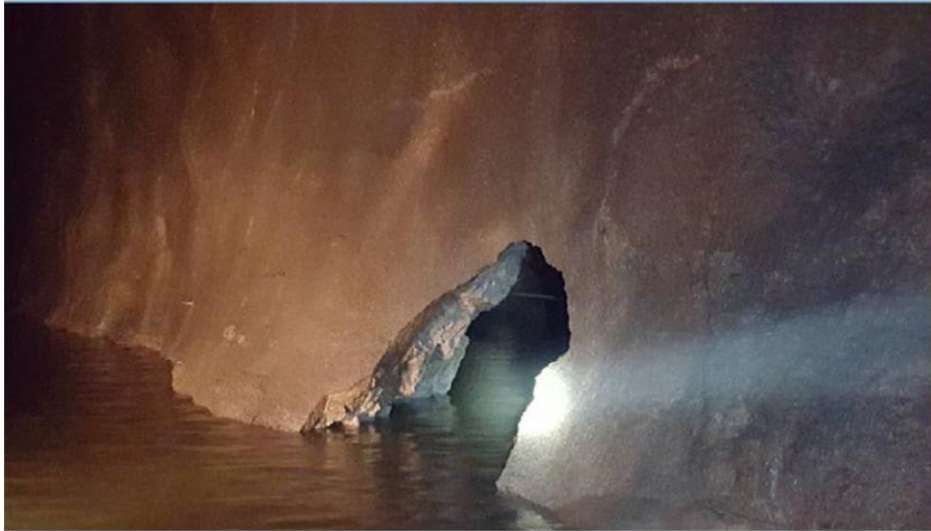
Photo 4.9 - View of the entrance to the cavity on the hydraulic left sidewall of the headrace tunnel at chainage 12+740

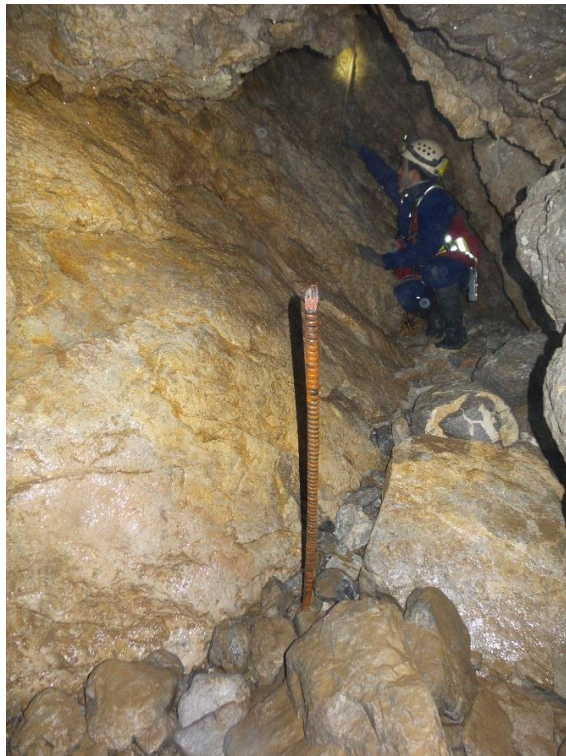
Photo 4.10 - View of a headrace tunnel rock bolt. The fact that the bolt is vertical suggests that the area being inspected is above the roof of the Tunnel

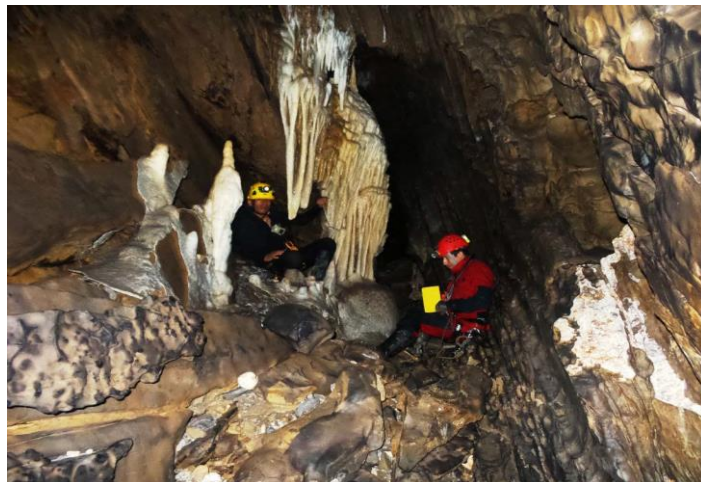
Photo 4.11 - View of El Suspiro de Frescia cavity with stalactites and stalagmites
