A case history of a major construction period dam failure

BY VICTOR F.B. DE MELLO

Consulting Engineer, São Paulo, Brasil

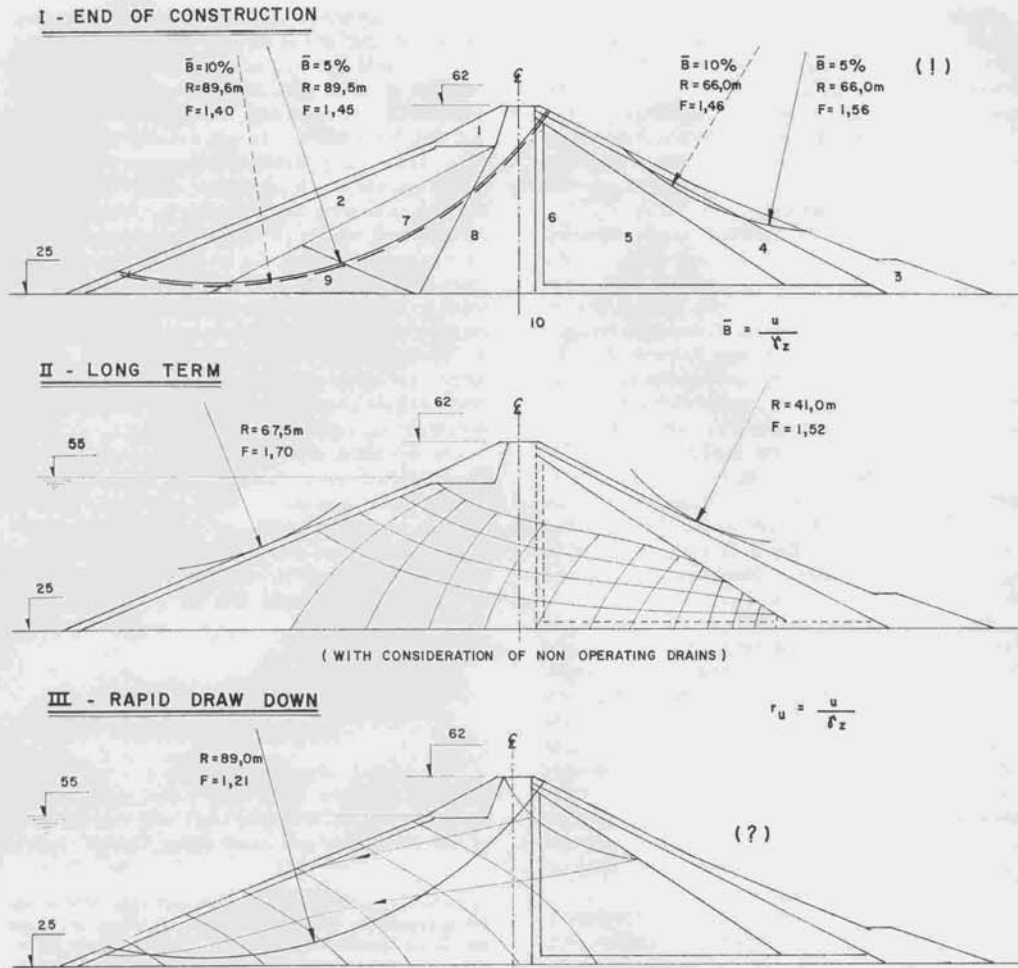
FIG. 2.

The bid documents included some recognizedly questionable (fig. 2) geotechnical analyses, but, to an experienced earth dam engineer, visual appreciation of the cross section and analyses should suffice to indicate overall acceptability of the plans, and easy design-as-you-go adjustment. Construction period analyses were stated to have used \bar{B} coefficients (a questionable "constant" in itself) of 5% and 10% (presumably a weighted average for both upstream materials, so very distinct, an undesirably crude assumption and extremely low values for the black clay). Rapid draw-down RDD (upstream) and full reservoir (RES) (downstream) slope stabilities employed flownets and presumed effective stress parameters. The RES flownet seems far too pessimistically hypothesized: in part it is recalled that the assumption of impervious boundary at the top of alluvial riverbed is indeed applicable at two transverse planes, at the bottom of the abutments where the dam rests on sound impervious bedrock; but the further assumption of an ideal-

ly clogged chimney filter-drain, so that the flownet would exit in the narrow downstream gravelly shell could hardly find justification. The RDD flownet is quite unexplainable. Figure 2 summarizes the flownets and nominal stability analyses, run by computer. It was decided that for the submerged slices it would be more practical to adopt $r_u = u/\gamma z = 0$, together with using submerged unit weights: possibly the tabulated use of zero unit weight of water was associated with such practice. Finally, for so-called *long term analyses* a frequently quoted obligation (however absurd) to adopt $c' = 0$ was used; consequently, the routine computer analyses inevitably singled out as least stable the critical circles tangent to the slopes, for slide volumes $dV \rightarrow 0$. The hypothesis and analysis constitute an extreme lower bound, obtainable at sight by $FS = \tan\phi'/\tan i$.

On the unconservative side one must note the incorporation of a most current misconception, spread under routine teaching and texts. That is, the use of effective stress (c' , ϕ') coupled exclusively with flownet porepressures, as if under incremental stress-strain conditions that could lead to sliding there would not be a Δu associated with compressibility.

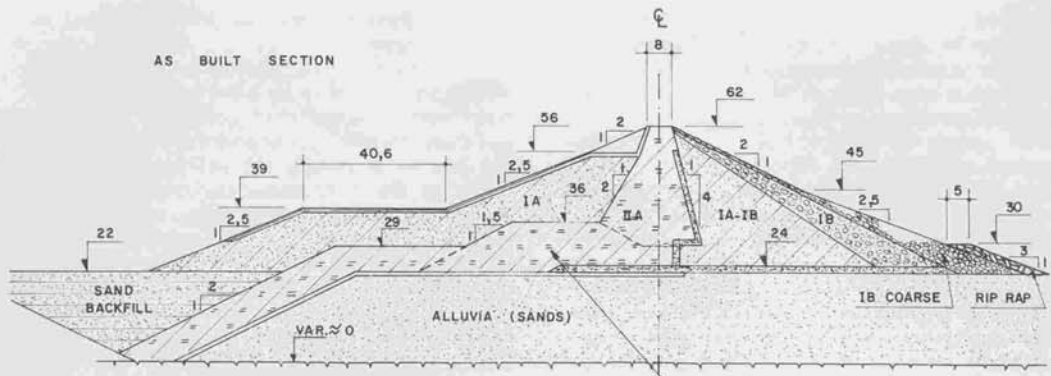
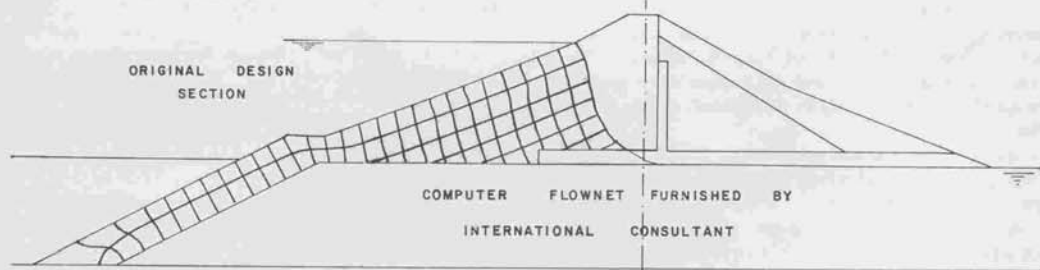
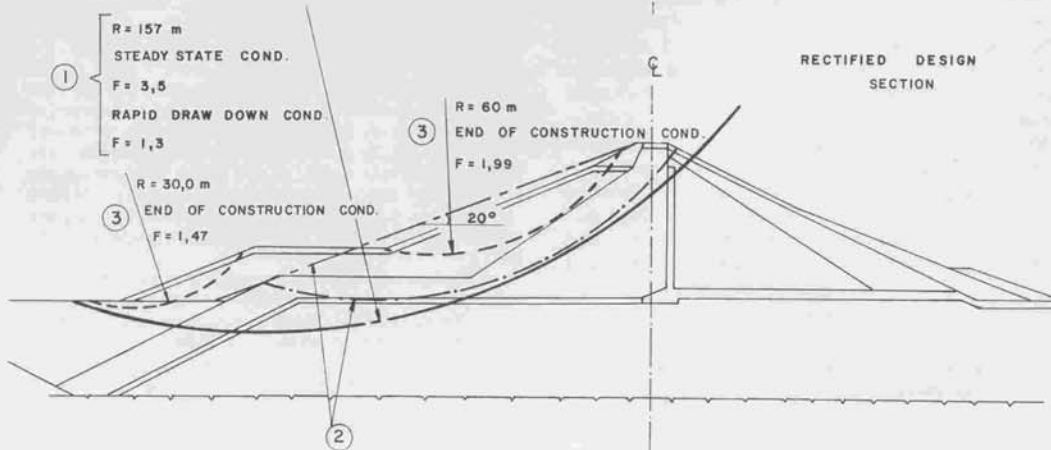
FIG. 3.

PART OF SECTION RAISED IN ADVANCE AS "COFFERDAM" US. SLOPE SUFFERED 1st FAILURE

- 1 - COMPUTER STABILITY ANALYSES FURNISHED BY INTERNATIONAL CONSULTANT.
- 2 - VISUAL INDICATION OF CRITICAL CIRCLE ENTIRELY IN BLACK CLAY OF $\phi \approx 20^\circ$ EXPECTED TO SUPPORT SLOPE OF $1 \approx 20^\circ$.
- 3 - CONSTRUCTION PERIOD COMPUTER ANALYSES FURNISHED BY INSPECTORS AFTER 1st FAILURE OF "COFFERDAM"

The computer analyses submitted included a finite element flownet of steady state seepage of the original design section, presumably to justify the concern regarding the alleged high seepage gradients (fig. 3). It included a curious and ob-

Further, the only other computer analyses submitted included the upstream slope stability cases (fig. 3) confidently considered applicable and sufficient. Regrettably the manner in which such results are furnished do not facilitate independent appraisal. However, some significant criticisms transpire immediately, such as: the cohesion parameter adopted, and the manner in which any possible soil testing was set aside; the oblivion of a construction period analysis, even in comparison with a full reservoir upstream analysis on which the absurdly high FS = 3.5 should serve as a minimum hint; the fact that failure "circles" did not establish themselves with a maximized stretch in the black clay, recognized as the weaker material and the only one definitely non-draining (moreover, the fact that the "critical circle" was given as coinciding for both the conditions).

⁽¹⁰⁾ It may be instructive to observe (fig. 3c) that the external slope corresponds roughly to 20°, the ϕ' value attributed to the black clay by all involved. A hypothetical "circle" could develop entirely within this clay. Therefore, were it not for the cohesion parameter, even without any pore pressure along the circle the 20° obliquity would be entirely absorbed. Should not visual examination indicate the need to reflect very carefully on c' and u values?

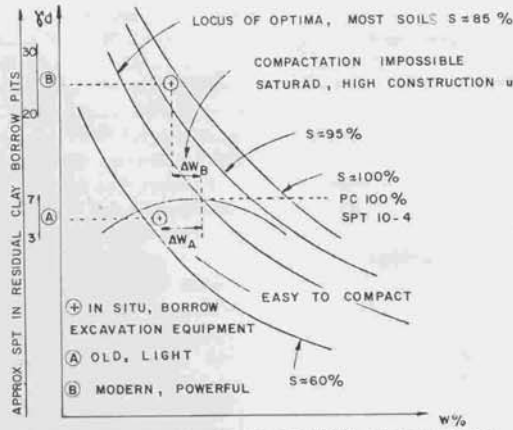
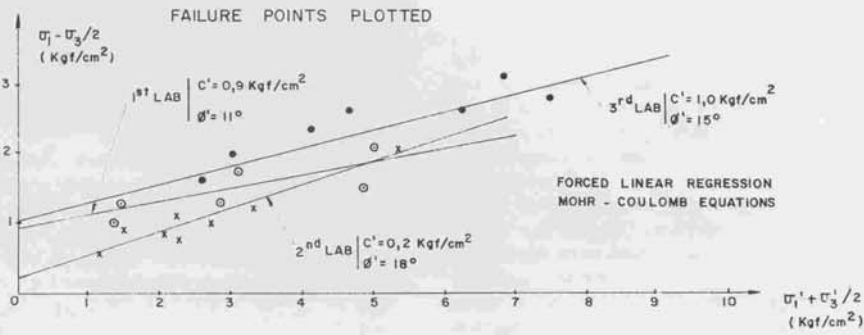
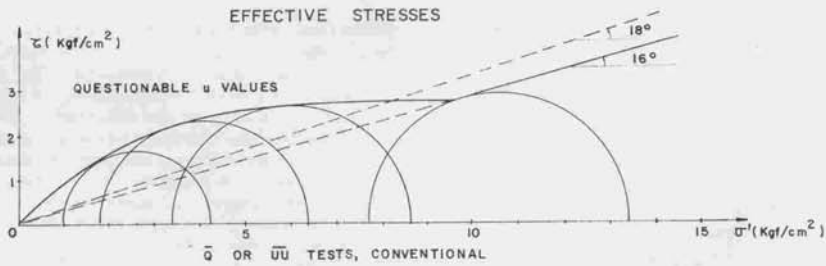
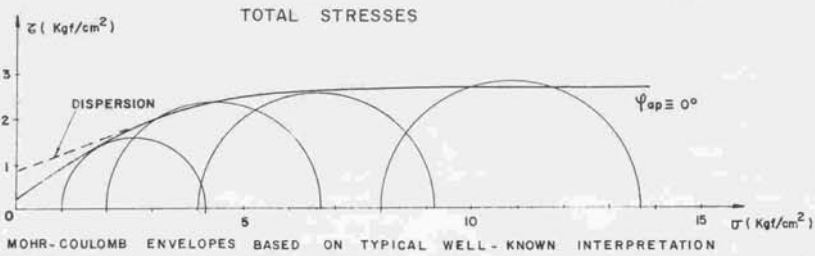
FIG. 4.

SCHEMATIC EXPLANATION OF WHY THE $\Delta W\%$ TEST OF BORROW PITS IS INSUFFICIENT FOR INDICATING COMPACTABILITY OF CLAYS

Questionable points on conventional index and triaxial tests, and interpretations

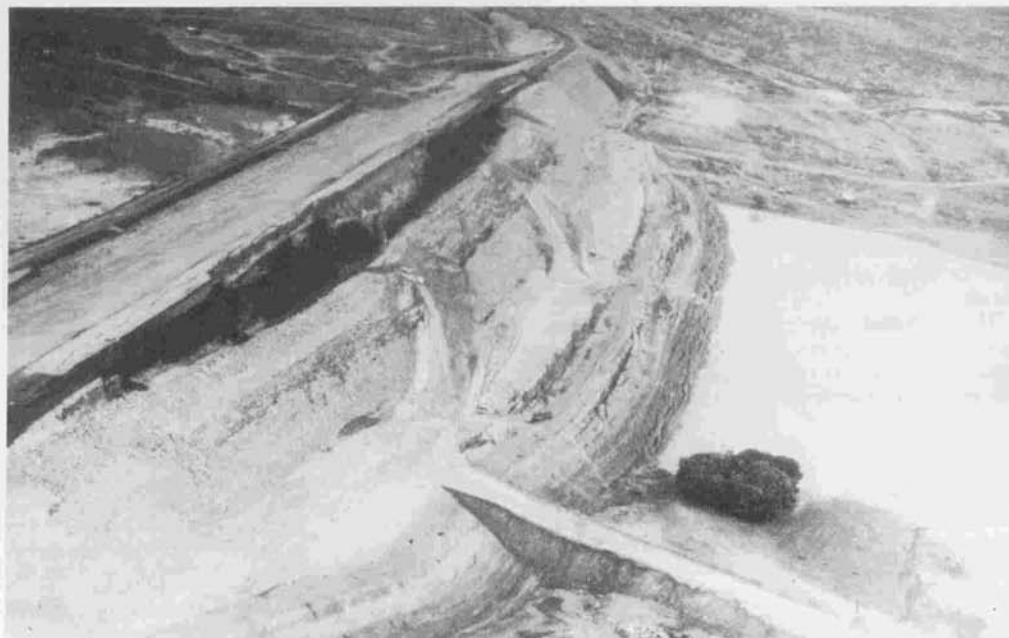
PHOTO 1.

Almost exactly one year after the above construction-period sliding, the entire dam developed a major slide as the fill reached 5 meters below the final crest. Eye witness descriptions of the failure, which developed in about 30 minutes,

vividly depict the sequence, starting with tension cracking at the top (more brittle behaviour), and followed by a rotational slip in the higher reach and a massive pushing outwards of the flatter lower section and berm along a distance of about 25 m. The photos 1 through 5 are self-explanatory: they were taken 6 days after the sliding, and so the shiny wet slickensided surfaces exposed to the wind and hot sun had mostly dried.

General view of the major construction period slide

Although the earthmoving volume involved is of the order of a million cubic meters, corrective reconstruction was rapidly initiated and is expected not to retard planned impoundment.

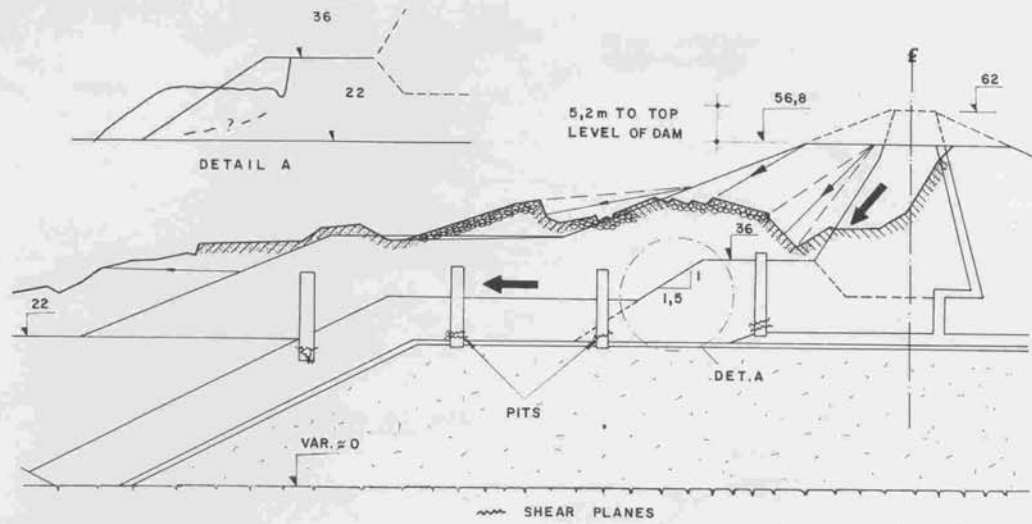
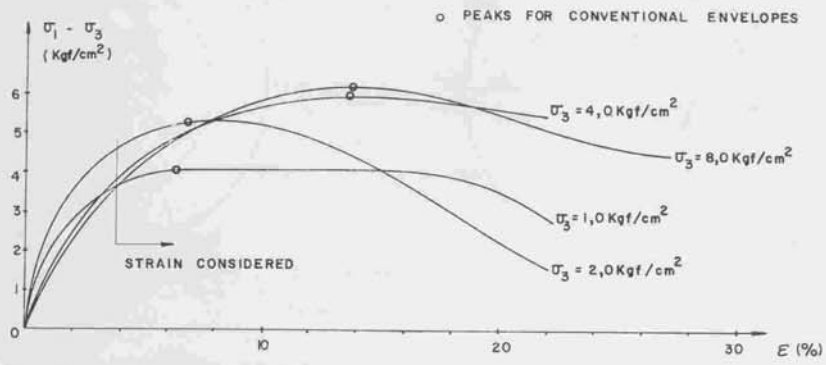
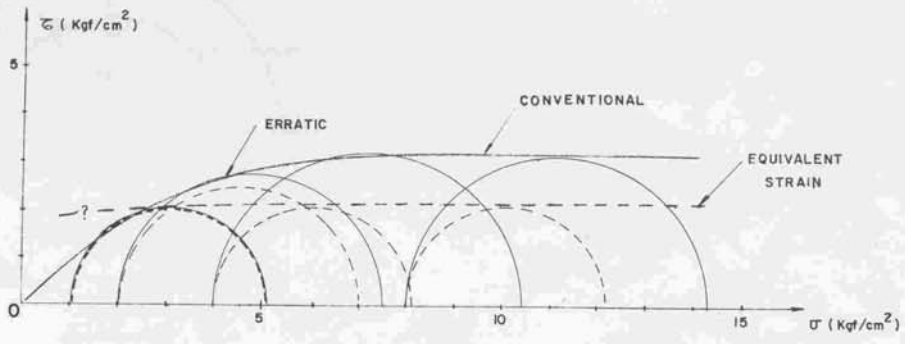
Failure surface and section. Triaxial tests and interpretation
FIG. 5.

The conditions of the failure were duly identified both by the surface evidence of the kinematics (fig. 5), and by the careful identifications of orientations of planes (shear planes and lift layering) in inspection pits, duly plotted in stereograms (fig. 6). Surprisingly, despite the early warning on construction period sliding of the black clay, no piezometers had been installed to accompany pore pressure development; a first piezometer had been installed but a few days before the major failure, but no readings had been taken.

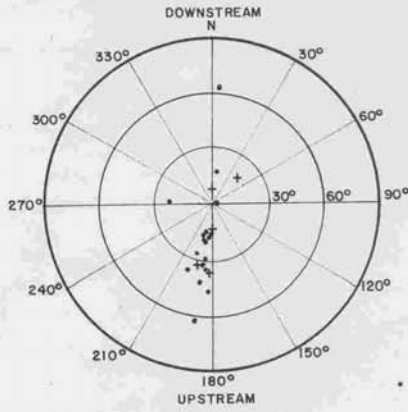
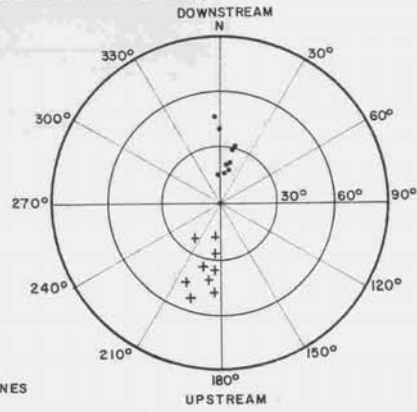
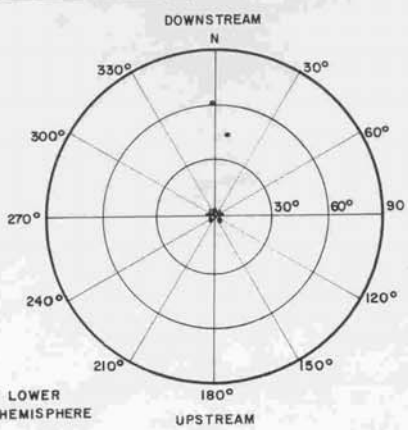
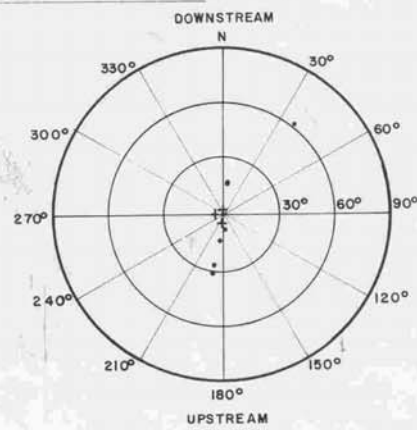
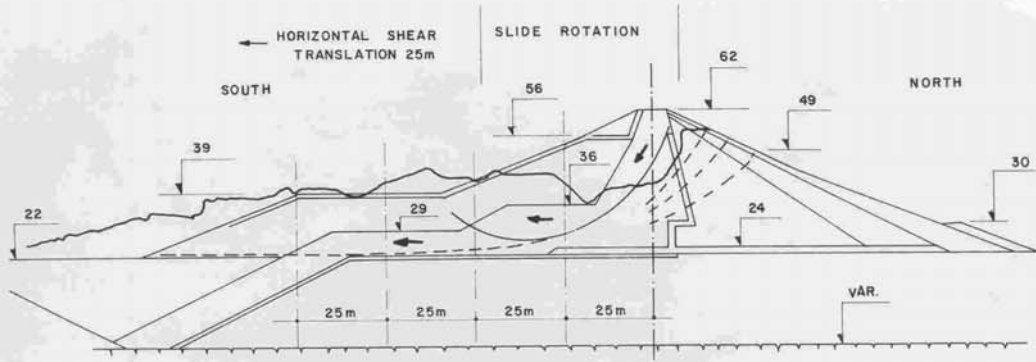
FIG. 6.

During the excavation of the inspection pits, many of the layers were detected to be intensely laminated by overcompaction. Further, in the

Stereo plots of planar patterns observed in inspection pits and interpreted kinematics of failure

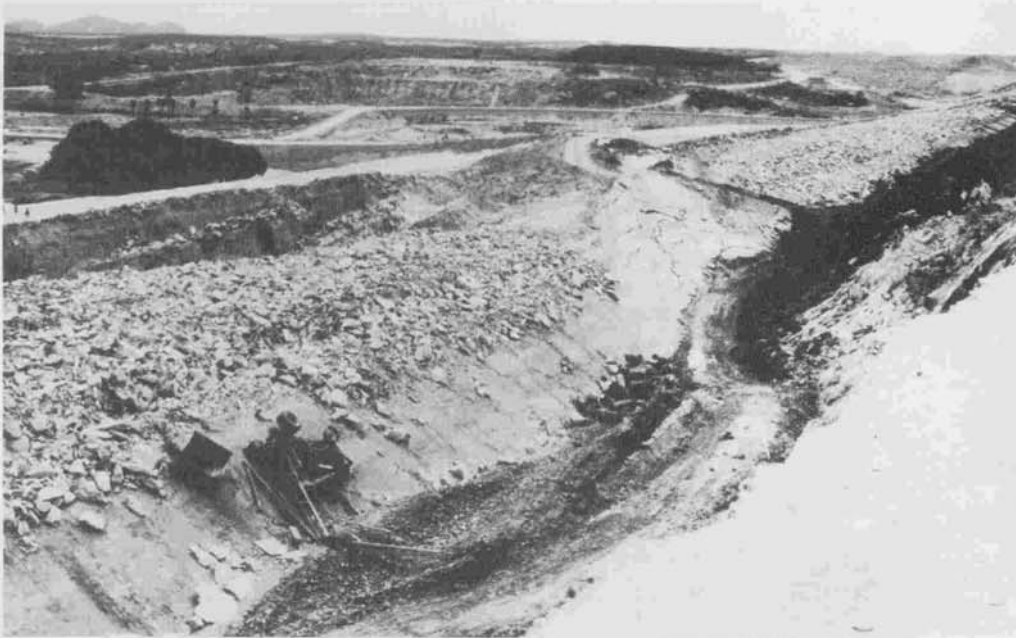
PHOTO 2.

Looking upstream from the remainder of crest, down on rotated mass

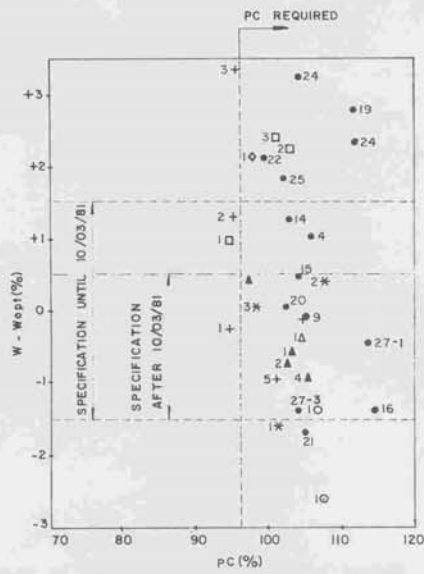
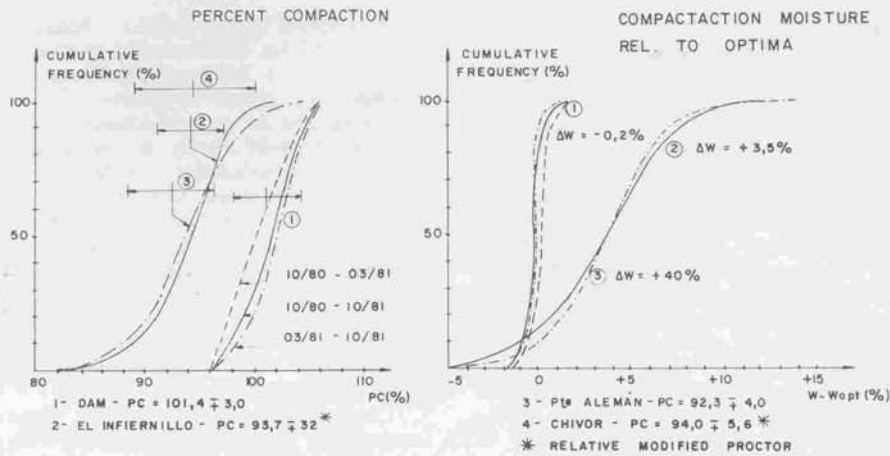
FIG. 7.

There had been much attrition regarding apparent heterogeneities in the inspection testing. Many a geotechnician loses perspective of true problems because of the diminutive scales of routine laboratory tests. At the scale of tens of centimeters, indeed the black clay is very difficult to work in the field to the appearance of a homogeneous mass. However, all three slides were so perfectly homogeneous, didactic, and bidimensional, that absolutely no question can persist of unsatisfactory homogenization. There can hardly be so well defined a failure except when a theoretical (design) aspect is intrinsically wrong. At any rate, for the purpose of record some index test data determined on small specimens in the inspection pits are summarized graphically in figure 7. In the same figure the frequency distributions of the inspection tests are also drawn. It can be seen that the statistical dispersions are

indeed very small, noticeably so in comparison with some very important dams published (e.g. El Infiernillo, Presidente Aleman, Esmeralda-Chivor) picked at random.

Compaction control index test data compared with specifications and dispersions compared with important dams

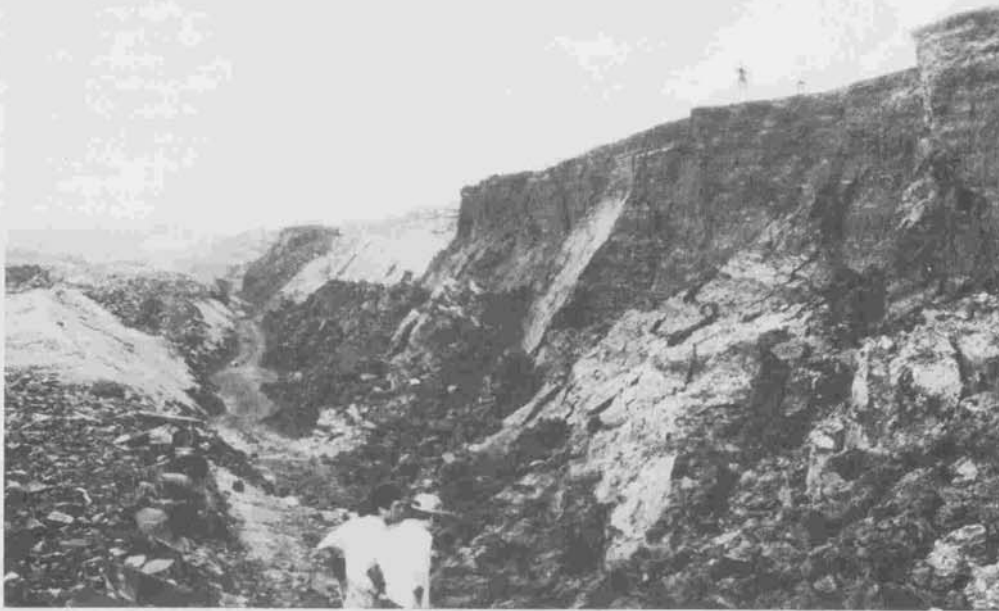
PHOTO 3.

Views of slide scarp with stretches broken off in tension and areas slickensided in shear

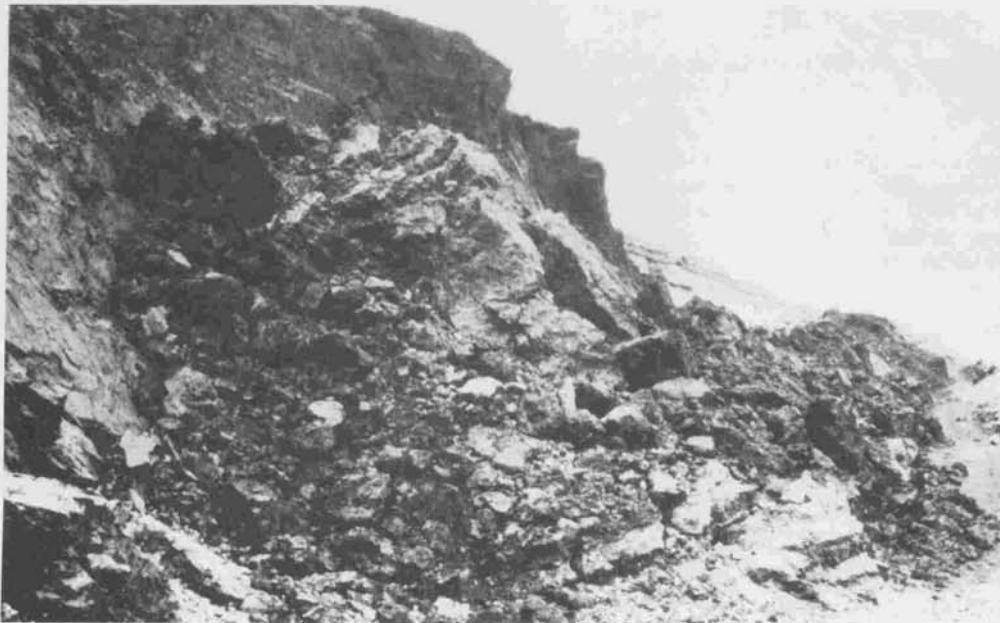
PHOTO 4.

Close-up of black clay partly slickensided in shear, partly broken off in "granular chunks"

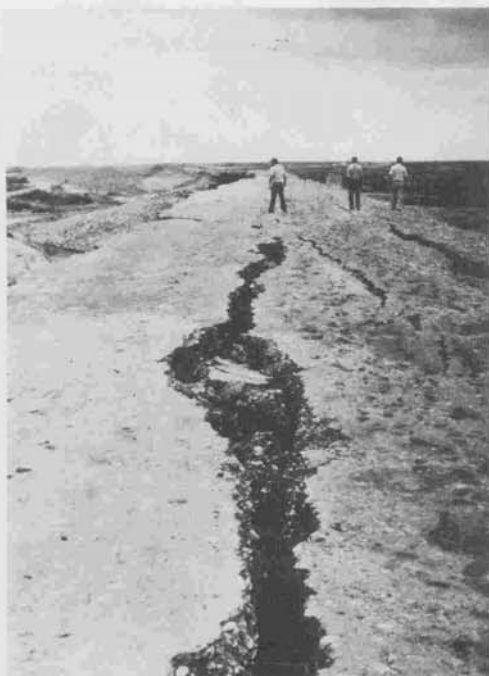
PHOTO 5.

pits in the upper part of the slide mass considerable tension cracking was evident. Analyses are yet being performed to assess the degree of interference of such tension cracks, and so also of some proportion of the horizontal plane reduced to ϕ' values closer to the residual value.

Tension cracks retrogressing behind slide scarp on remainder of crest and into upper part of downstream slope
