LESSONS FROM THE LIVES OF TWO DAMS

The Fourth Victor De Mello Lecture

September 10, 2014

James K. Mitchell, ScD, P.E. Distinguished Professor, Emeritus Virginia Tech, Blacksburg, VA, U.S.A.

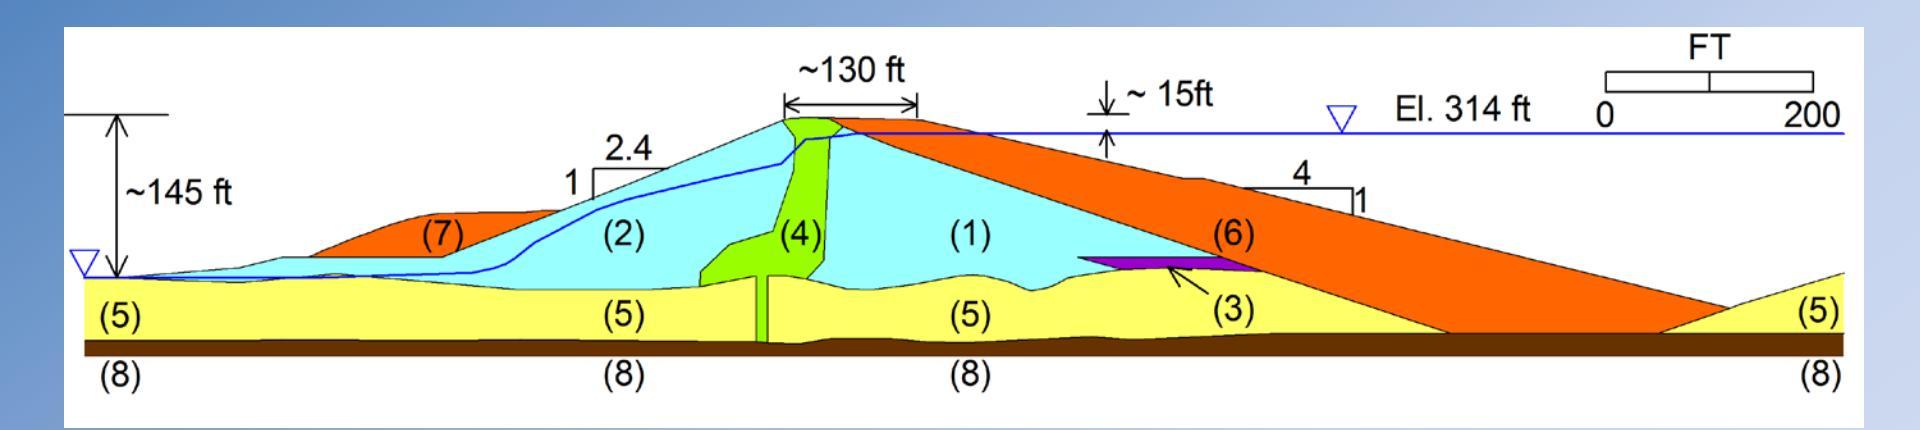
Composite maximum section of the dam after buttress additions. Note a very wide crest of about 130 feet (39.6m) for the dam. The various zones of the embankment and foundation: (1) upstream shell (hydraulic); (2) downstream shell (hydraulic); (3) ponded clay/silt; (4) core and key trench (hydraulic); (5) foundation soils; (6) upstream buttress (well-compacted) (1979); (7) downstream buttress (less-compacted) (1967); and (8) bedrock.

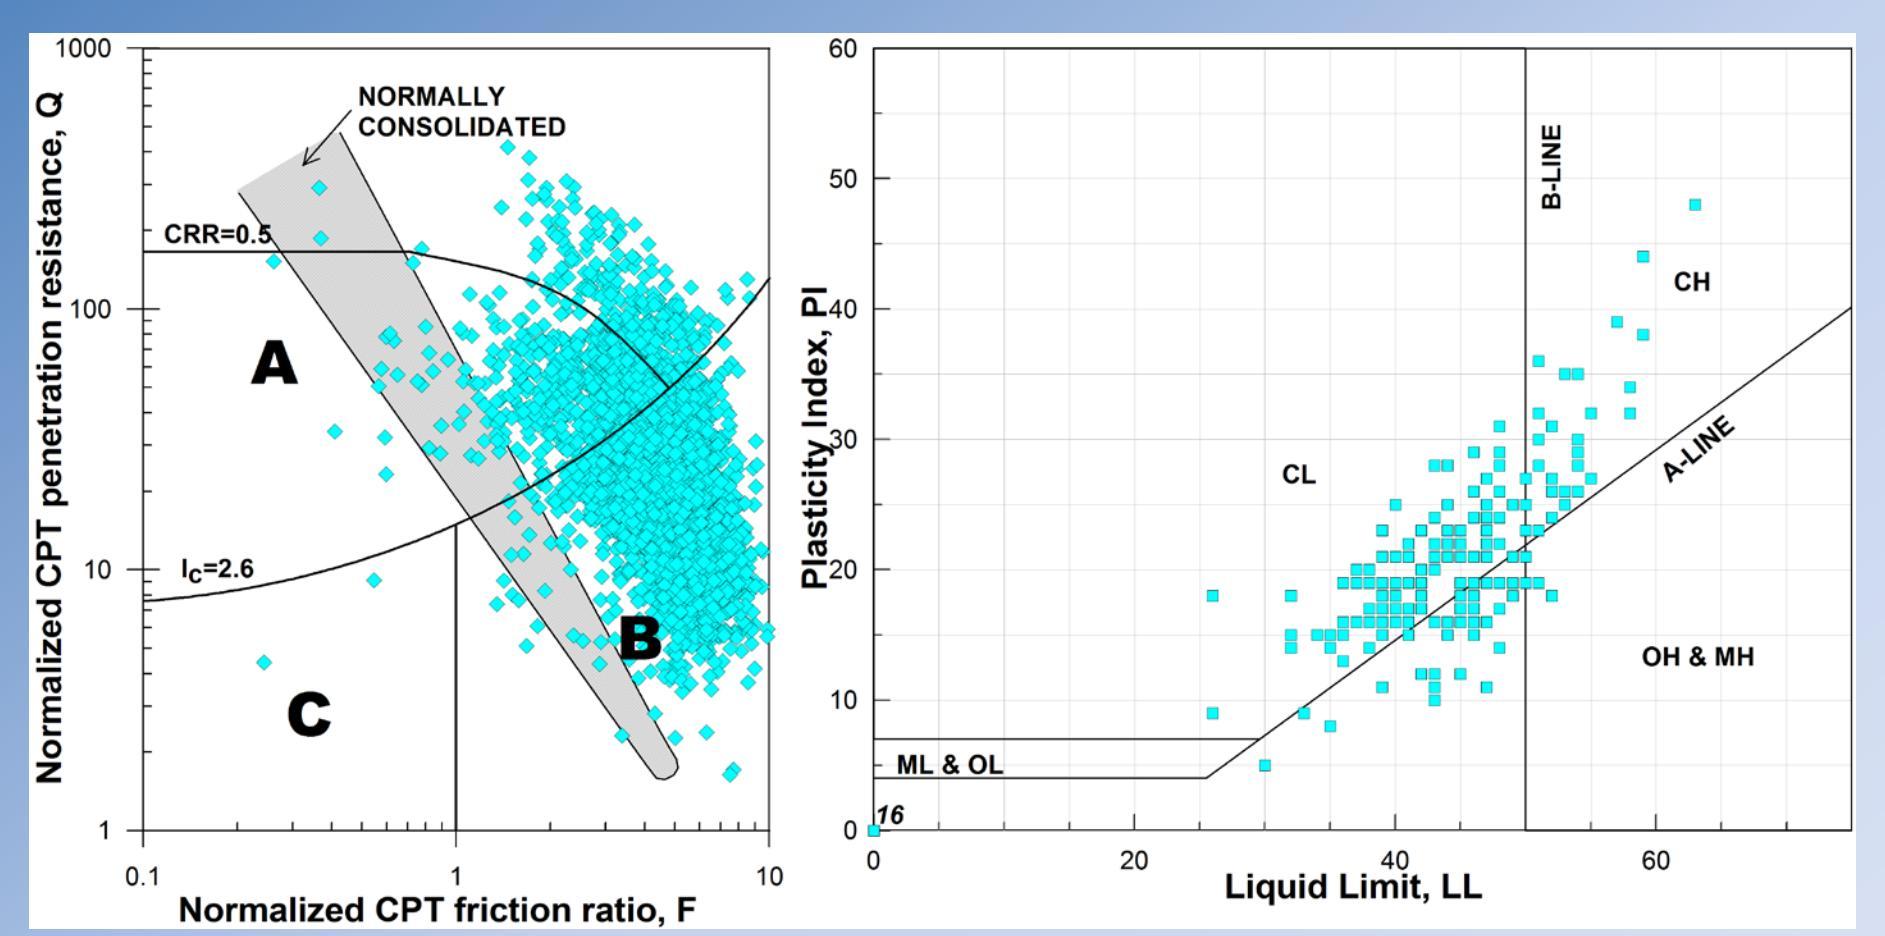
CPT and Plasticity Data for Shell Materials (from Moriwaki et al, 2008)

Zone A: Cyclic liquefaction possible; Zone B: Cyclic liquefaction unlikely; Zone C: Flow/Cyclic liquefaction possible.

SHELL MATERIAL IS NON-LIQUEFIABLE

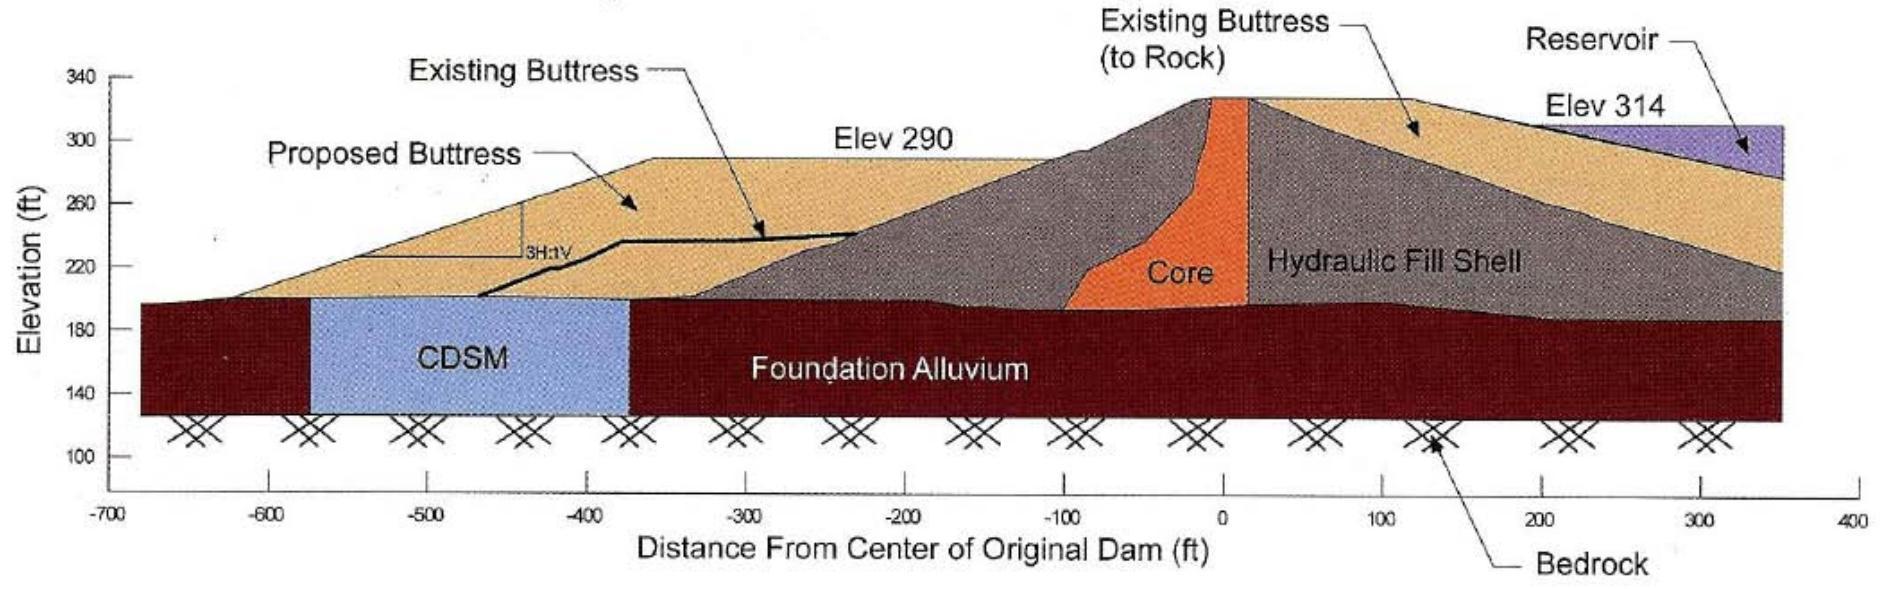
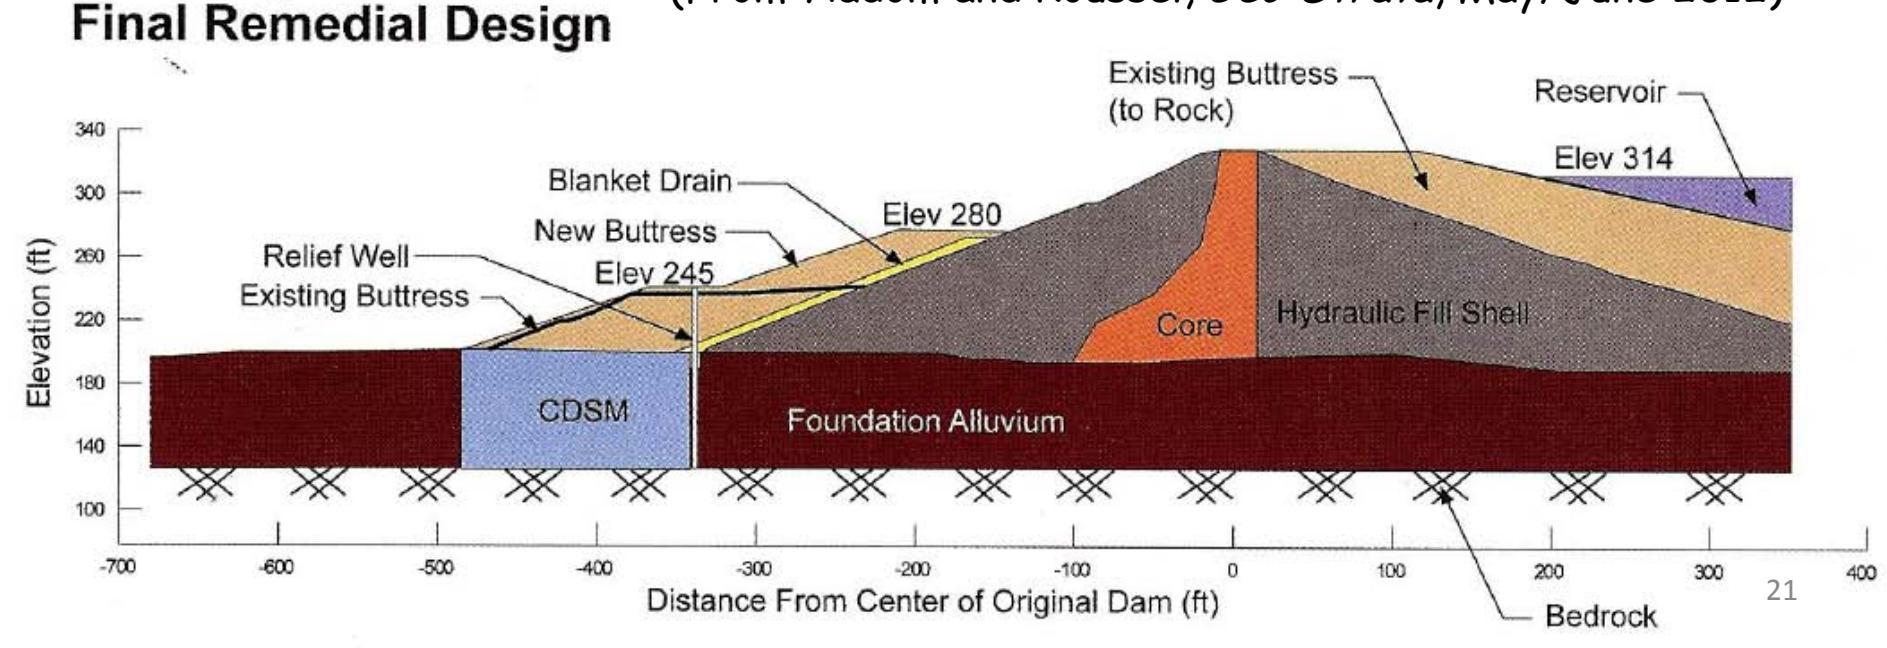
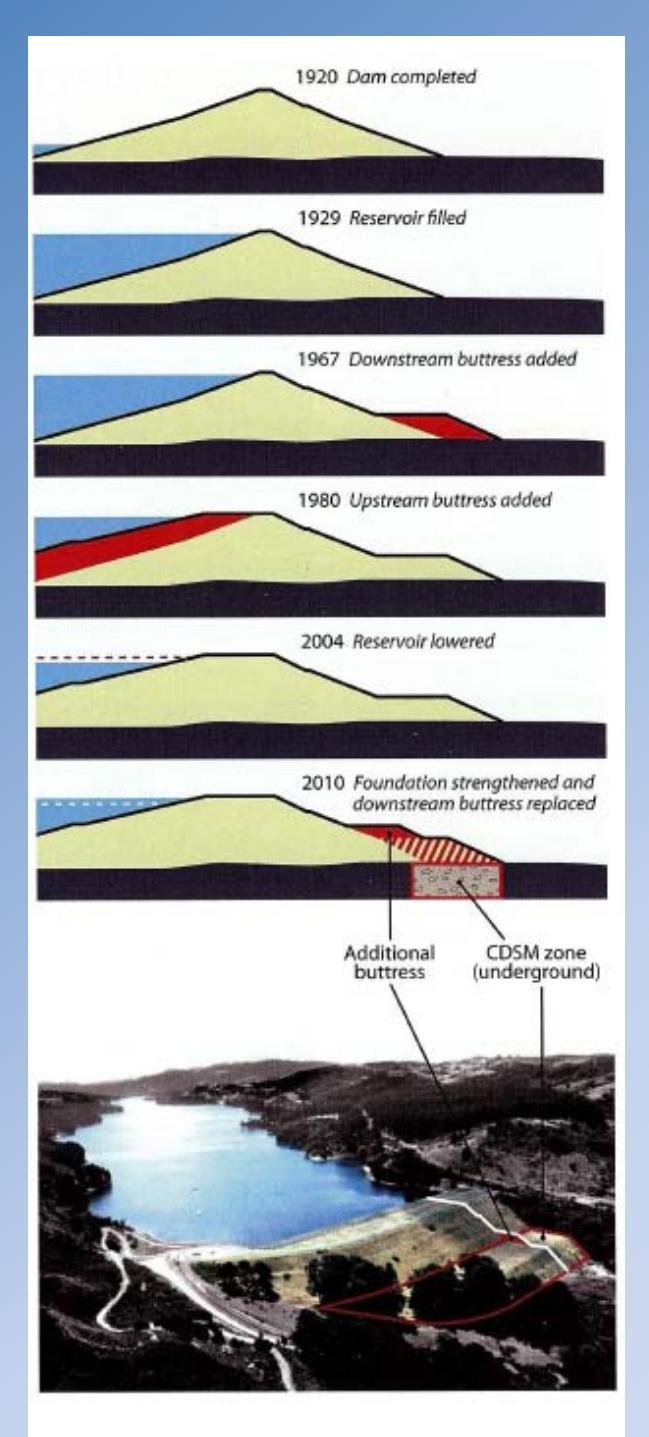
Stages in the seismic remediation of San Pablo Dam

Re-characterization of the hydraulic fill embankment material from liquefiable to nonliquefiable, fine-grained soil enabled significant reduction in the required sizes of the 2010 buttress and CDSM block, with a cost saving of ~U.S.\$40 million.

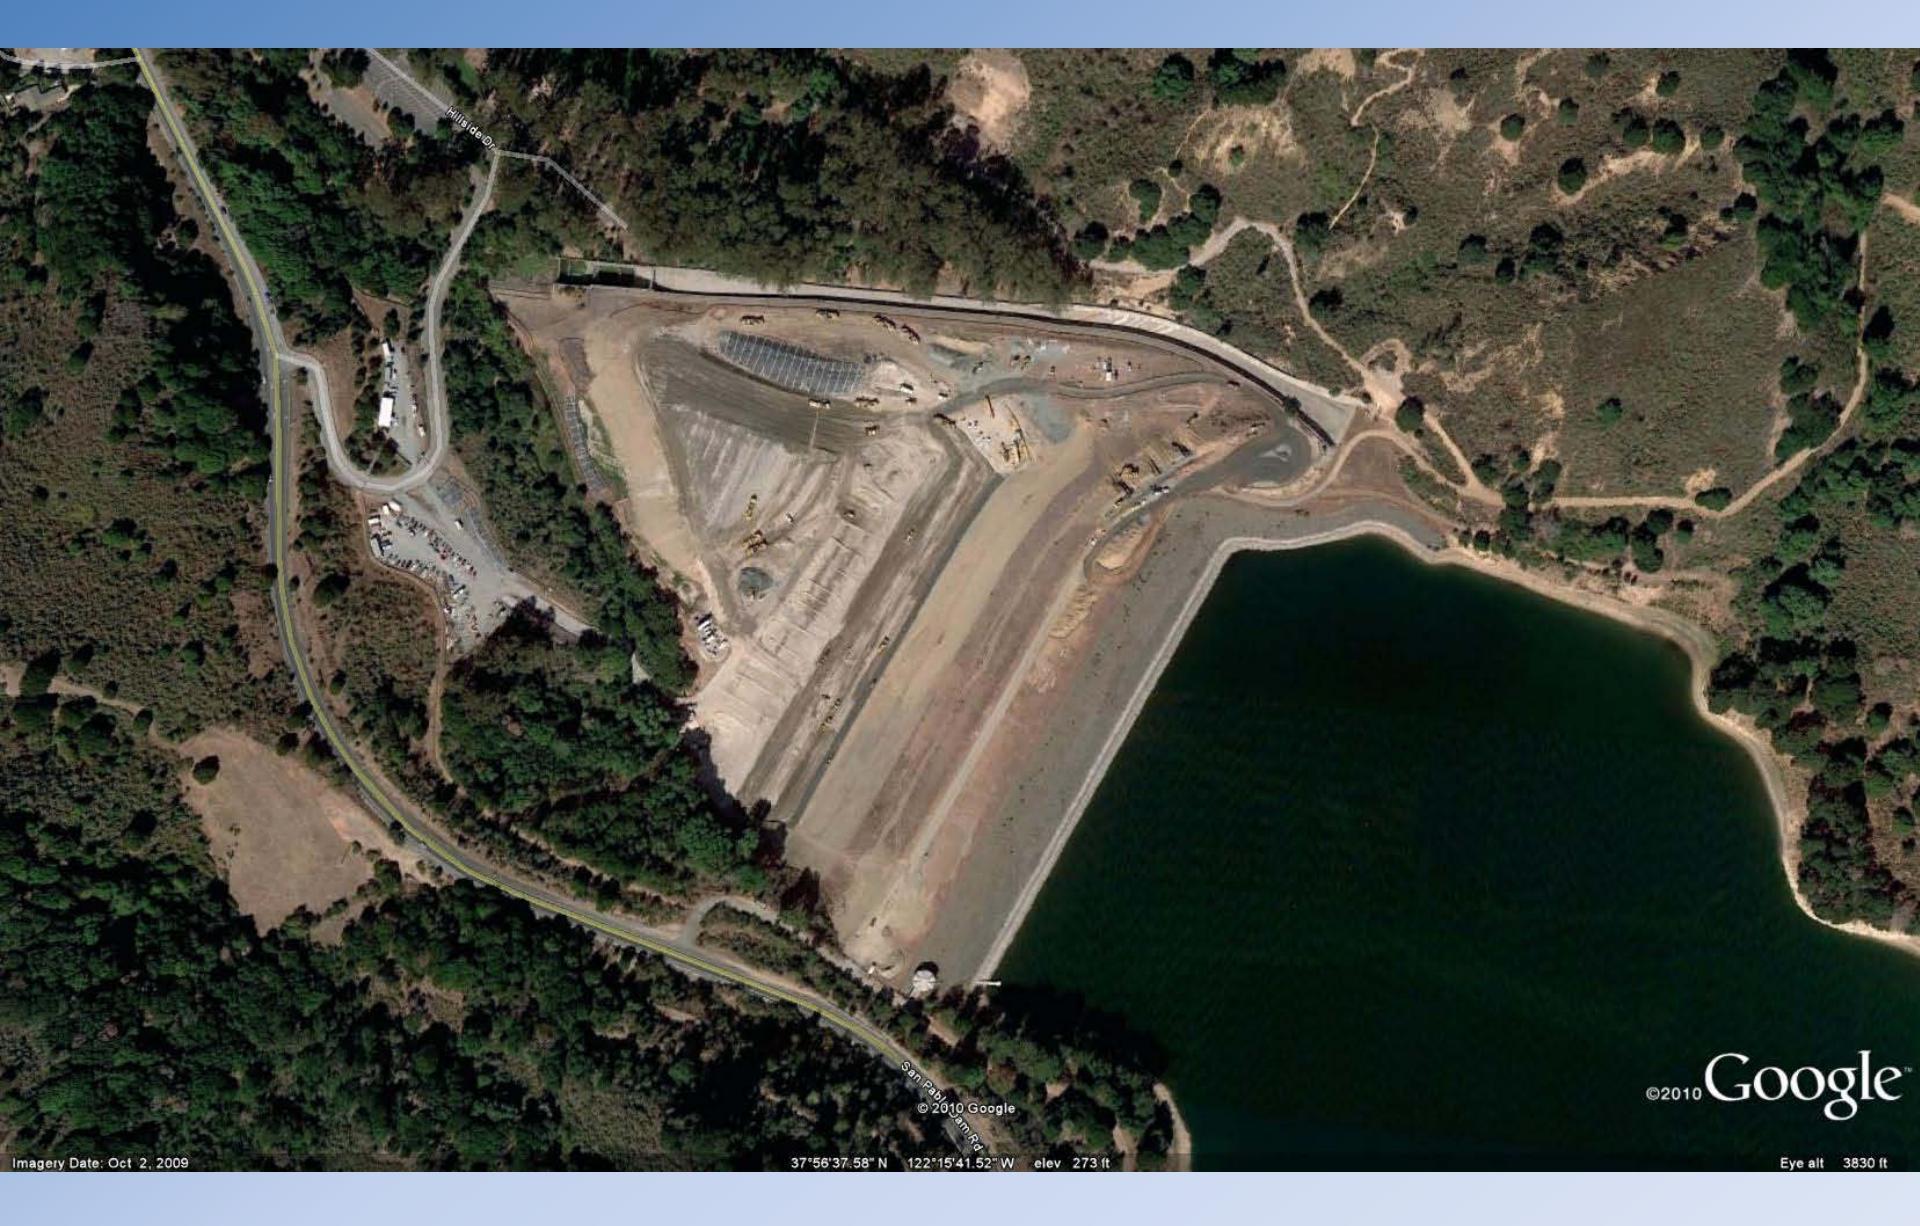
SAN PABLO DAM: Remediated (2010) using Cement Deep Soil Mix Block and Downstream Berm

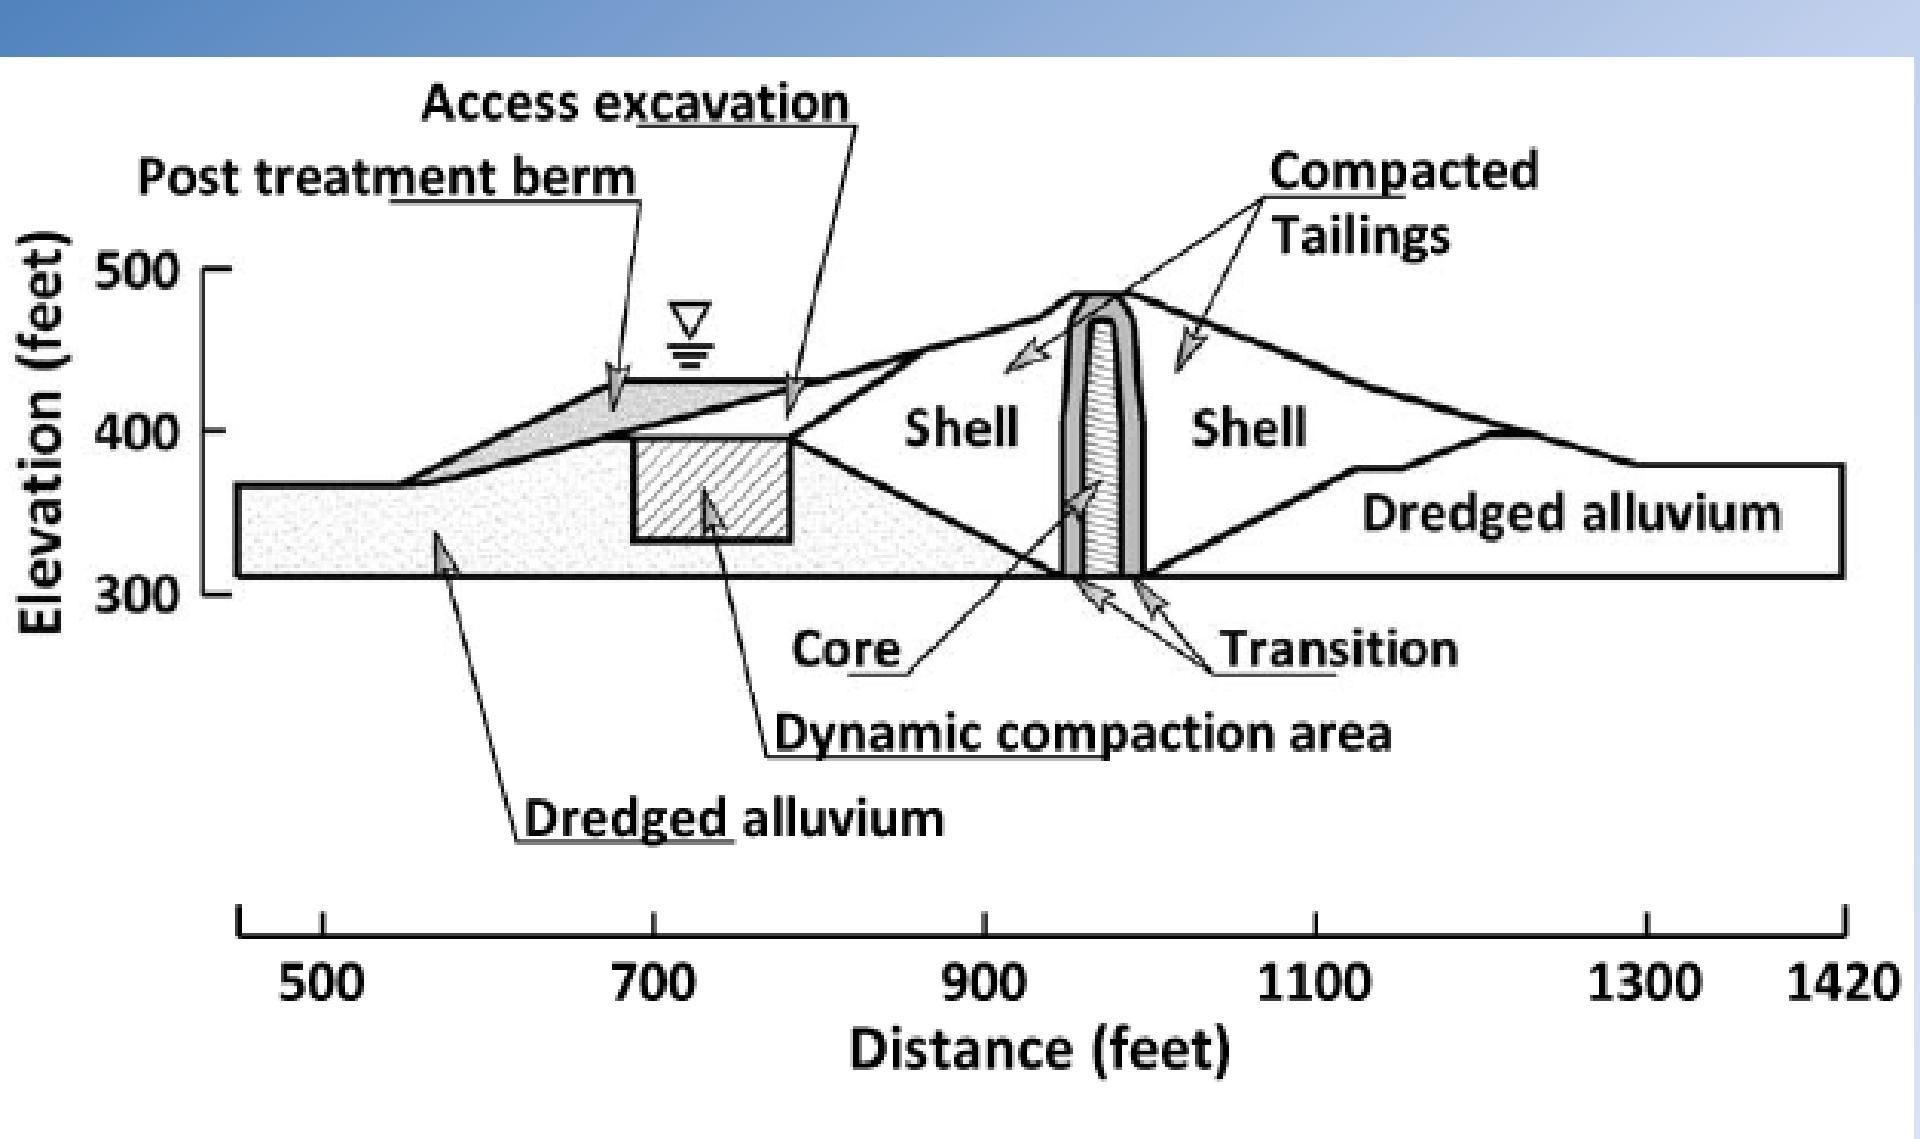
Fig. 6. Ground improvement design for stabilization of the upstream embankment of Mormon Island Auxiliary Dam done in 1990.

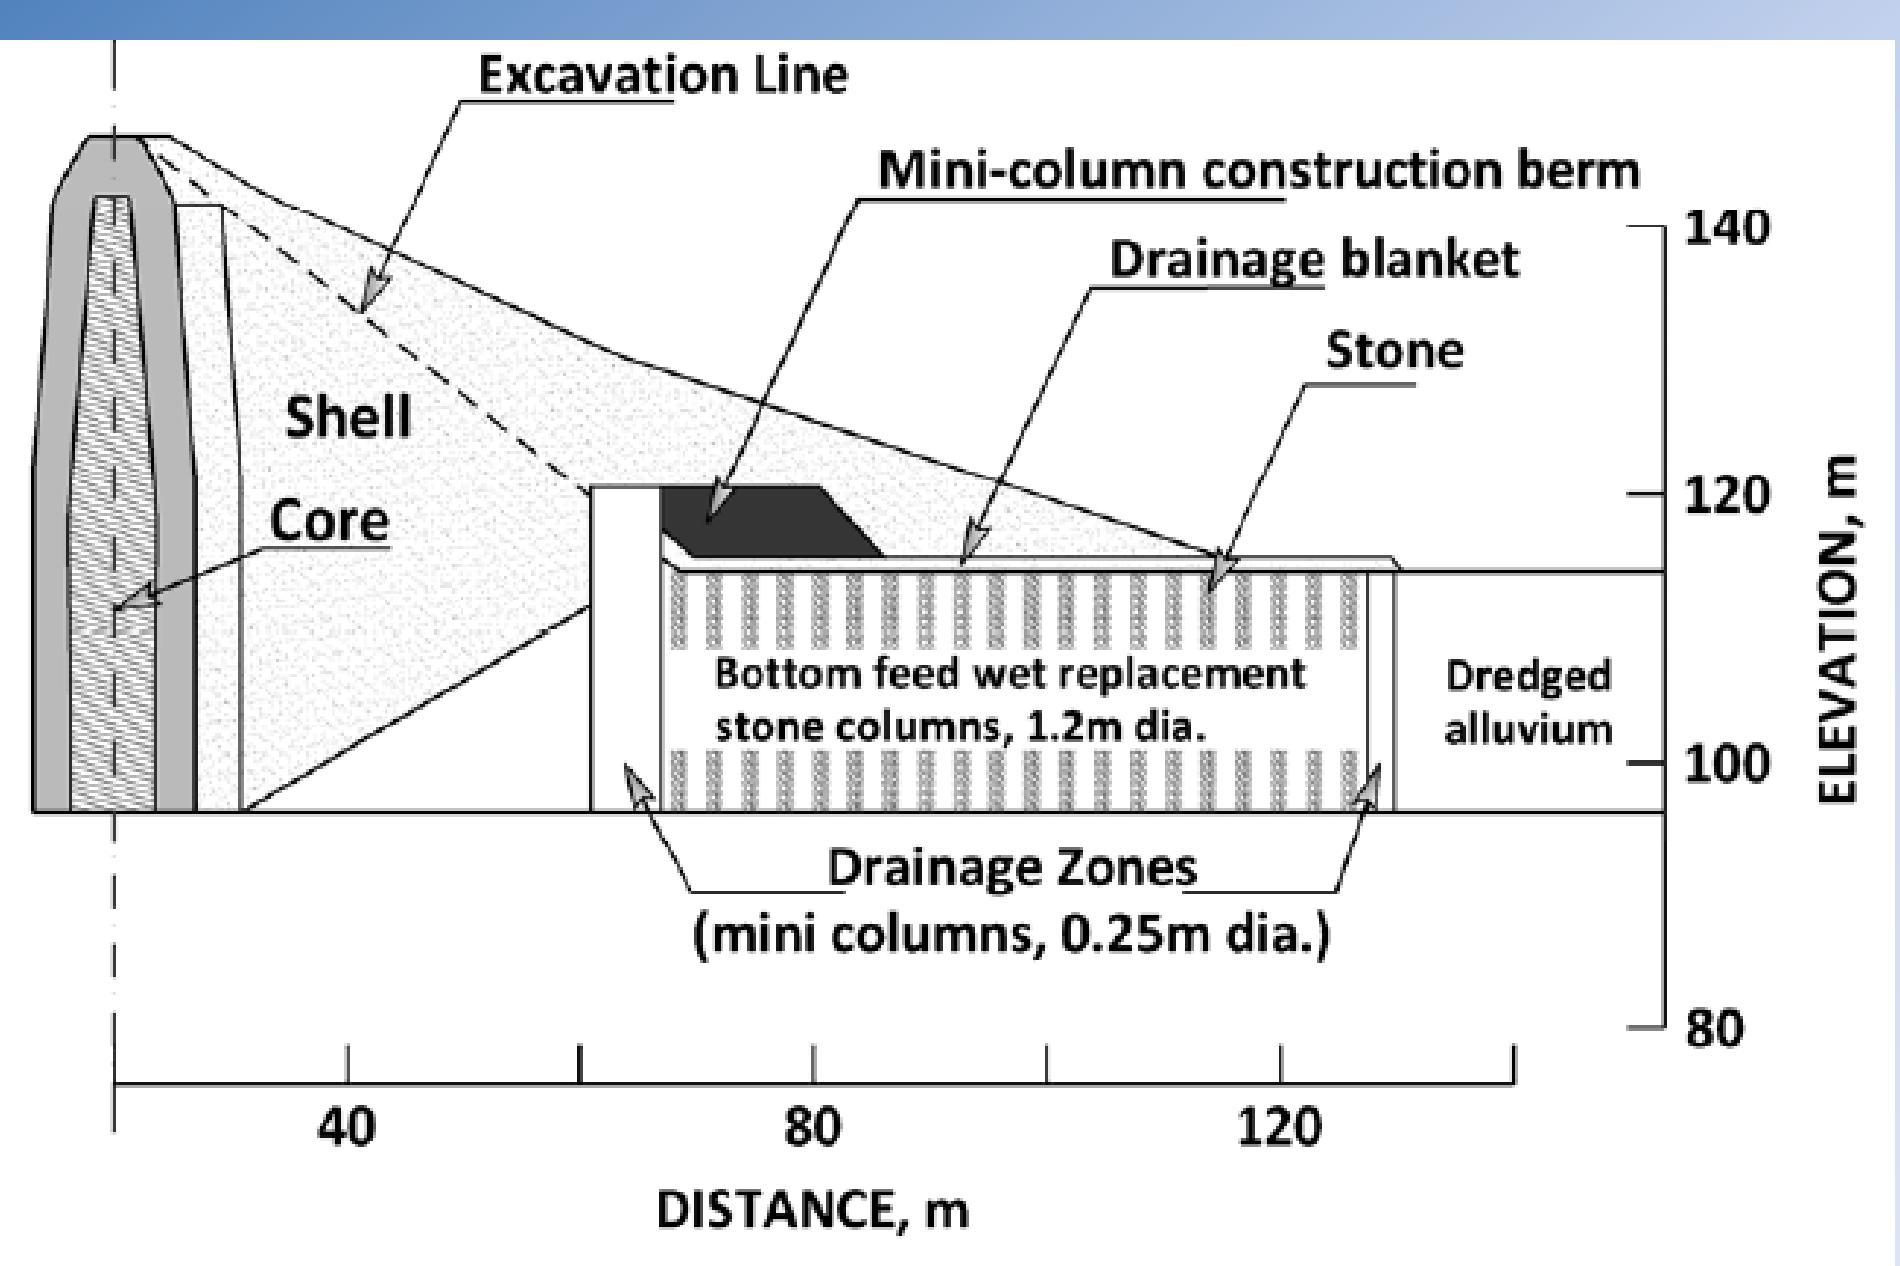
Fig. 7. Ground improvement design for stabilization of the downstream embankment of Mormon Island Auxiliary Dam done in 1993-94.

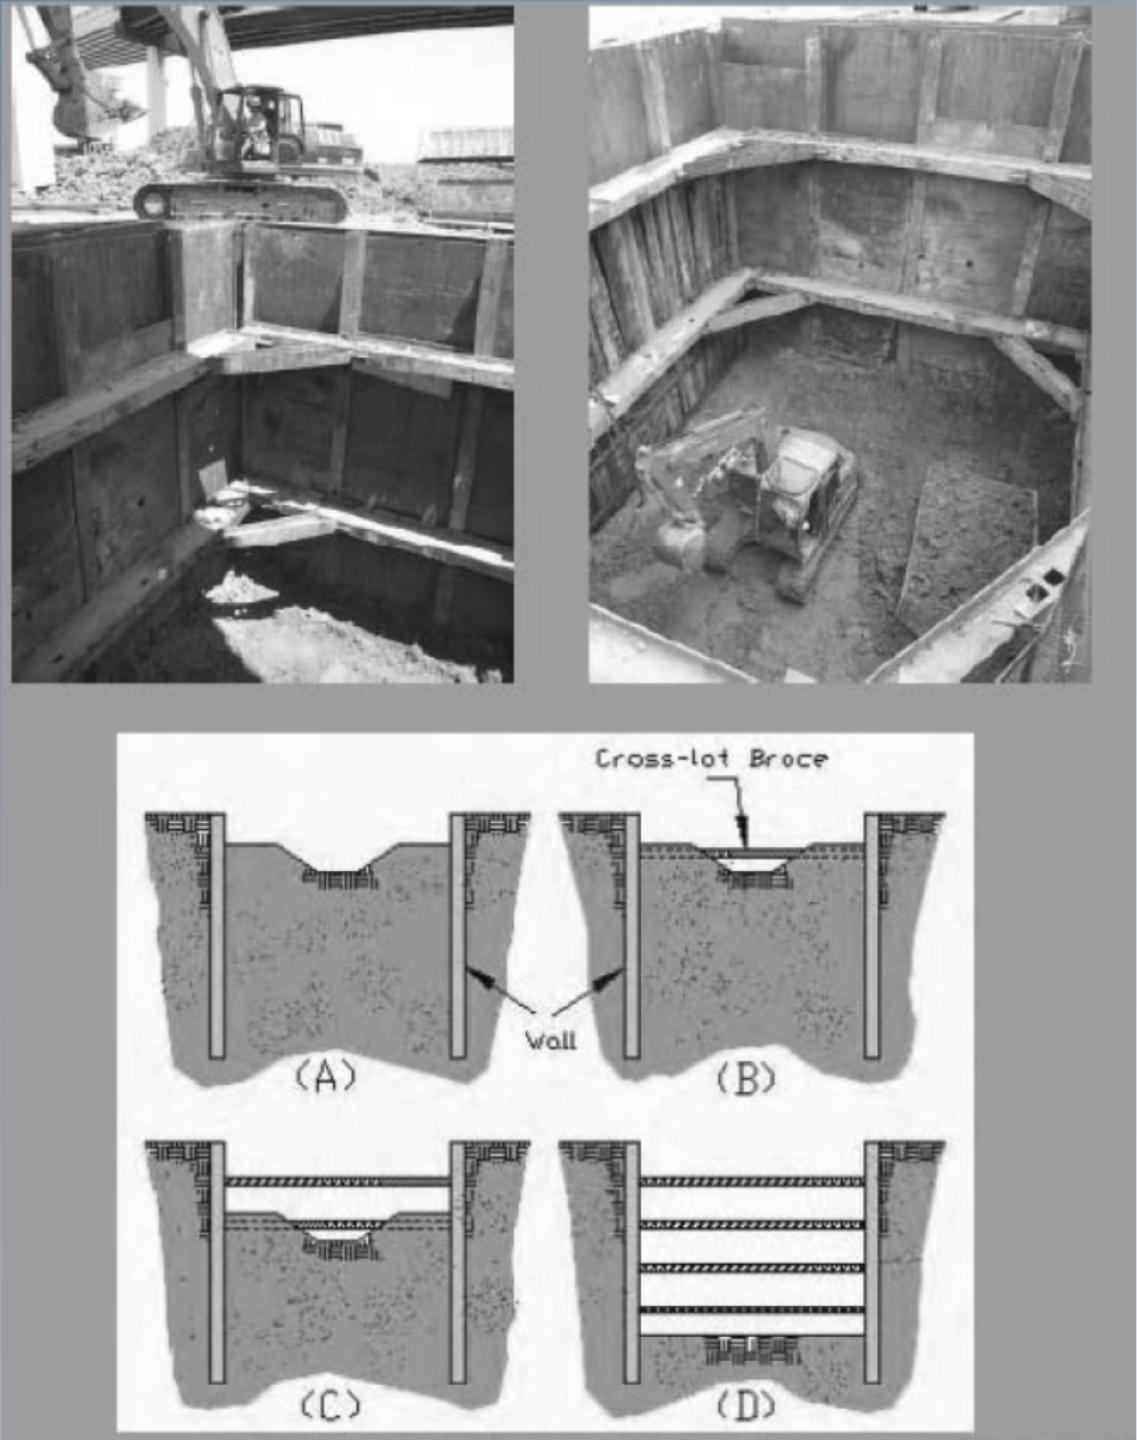
Schematic diagram and photos of the excavation and bracing system for construction of the concrete key block in the downstream toe area of Mormon Island Auxiliary Dam

•Decided on a cellular excavation with replacement by a concrete shear block along the downstream toe and a blanket stability berm over the downstream embankment slope.

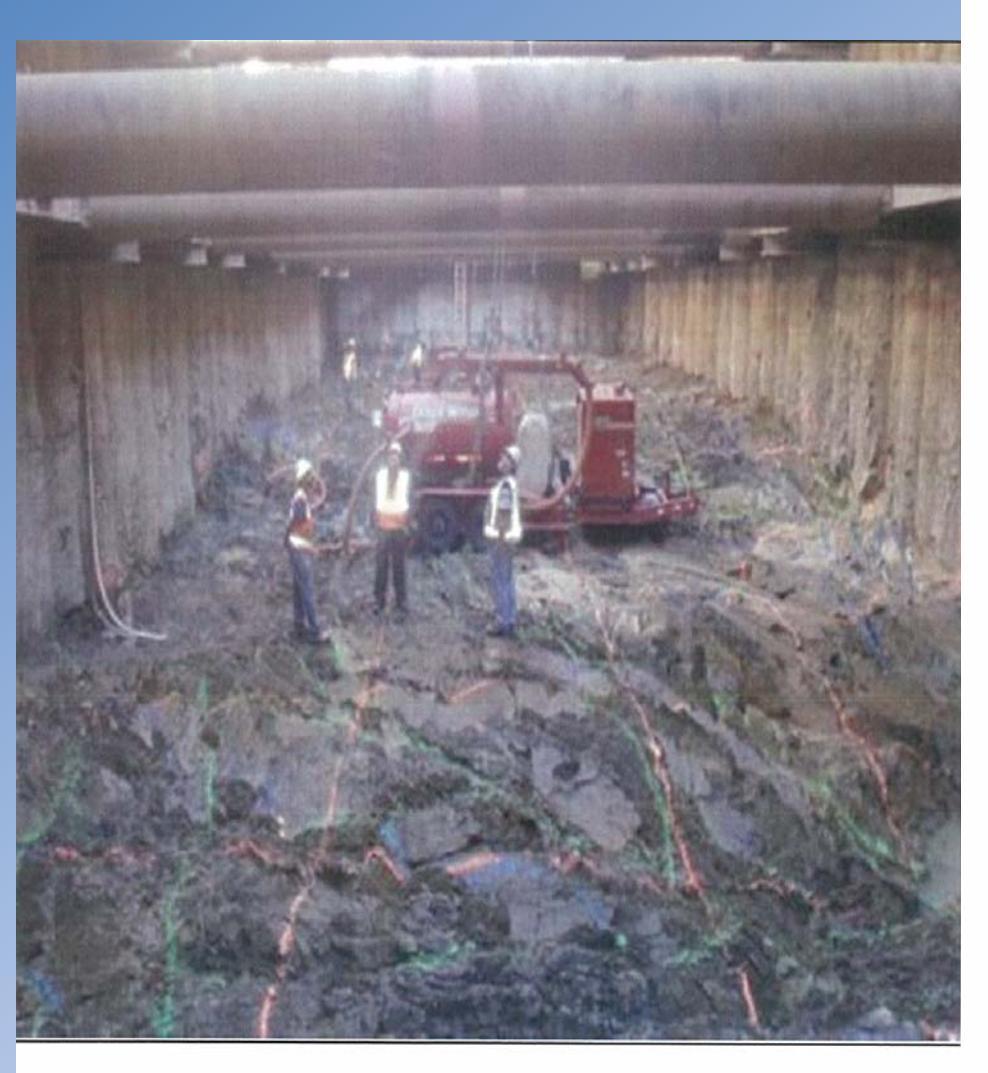
Photo 4. Rock surface at the bottom of Cell C.

Sliding resistance along the block rock interface is a major consideration.
