### 17° Congresso Nacional de Geotecnia

10° Congresso Luso-Brasileiro de Geotecnia 11° Encontro de Jovens Geotécnicos

### **VII VICTOR DE MELLO LECTURE**

### LESSON LEARNED FROM DAM CONSTRUCTION IN PATAGONIA ARGENTINA

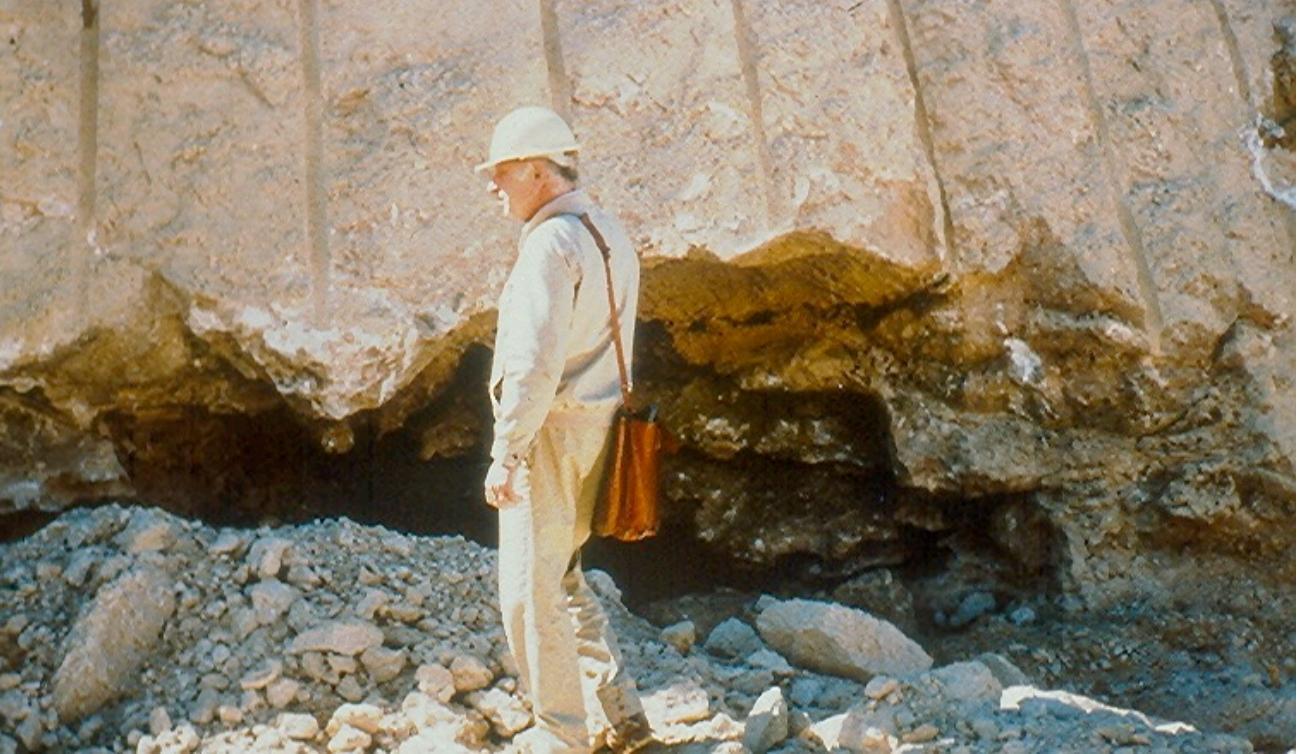
## **GYPSUM CAVERNS**

Unfavorable geological features were detected during work dam foundations: caverns and dissolution channels through massive gypsum below a zone of the left bank, with a length of 800 m, between stations 700-1500 m.

The investigation of the problem was initiated as a result of a fortuitous event: The presence of a saline paleo layer prevented the setting of the concrete cast to build the cut-off in that sector. The presence of the cavities was brought up by the noticeable presence of gypsum, the loss of injection water in the boreholes and the fall of tools.

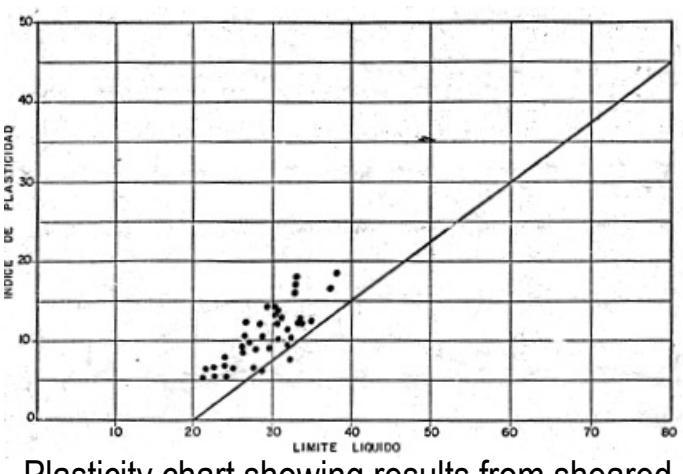
Plasticity chart showing results from sheared pelite

- PI = 5 to 20;  $\omega_L$  = 20 to 40; clay content (minor to 2 microns) = 40 %;  $\omega \le \omega_P$ ; fully saturated
- $\gamma_{\rm d}$  = 1.8 to 1.9 g/cm<sup>3</sup> and;  $\gamma_{\rm s}$  = 2.44 to 2.68 gr/cm<sup>3</sup>

Routine testing in the field laboratory of the Atterberg limits was then used so as to check that the plasticity indices fell in the known range.

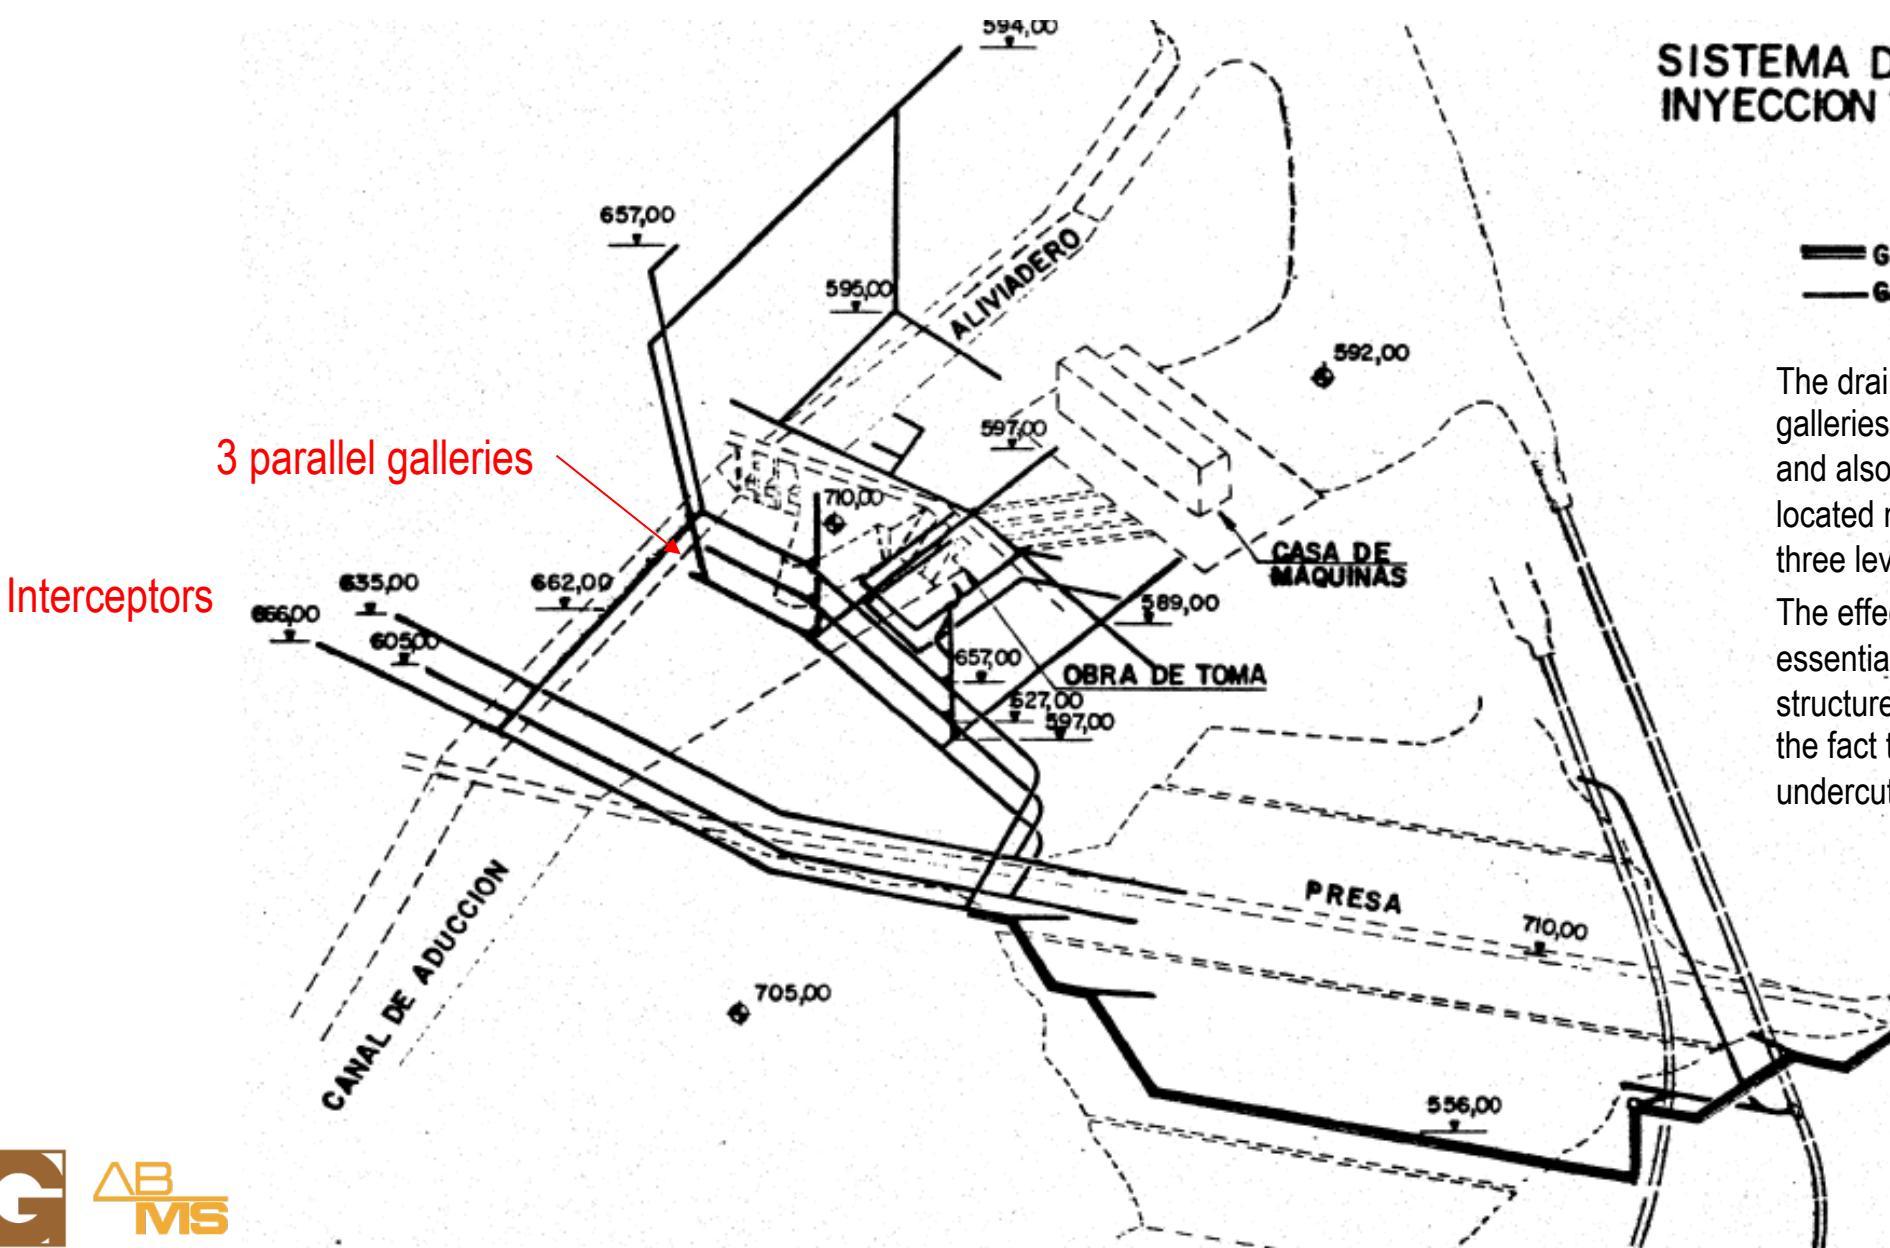
## DRAINAGE SYSTEM

The effective drainage of the left bank was essential for the stability of the slope and the structures due to the inclined bedding and the fact that excavations would partly undercut the slope.

The drainage system is accessed from galleries on both sides of the Power House and also through two shafts 115 m deep, located near the intake and connecting the three levels of galleries in that sector.

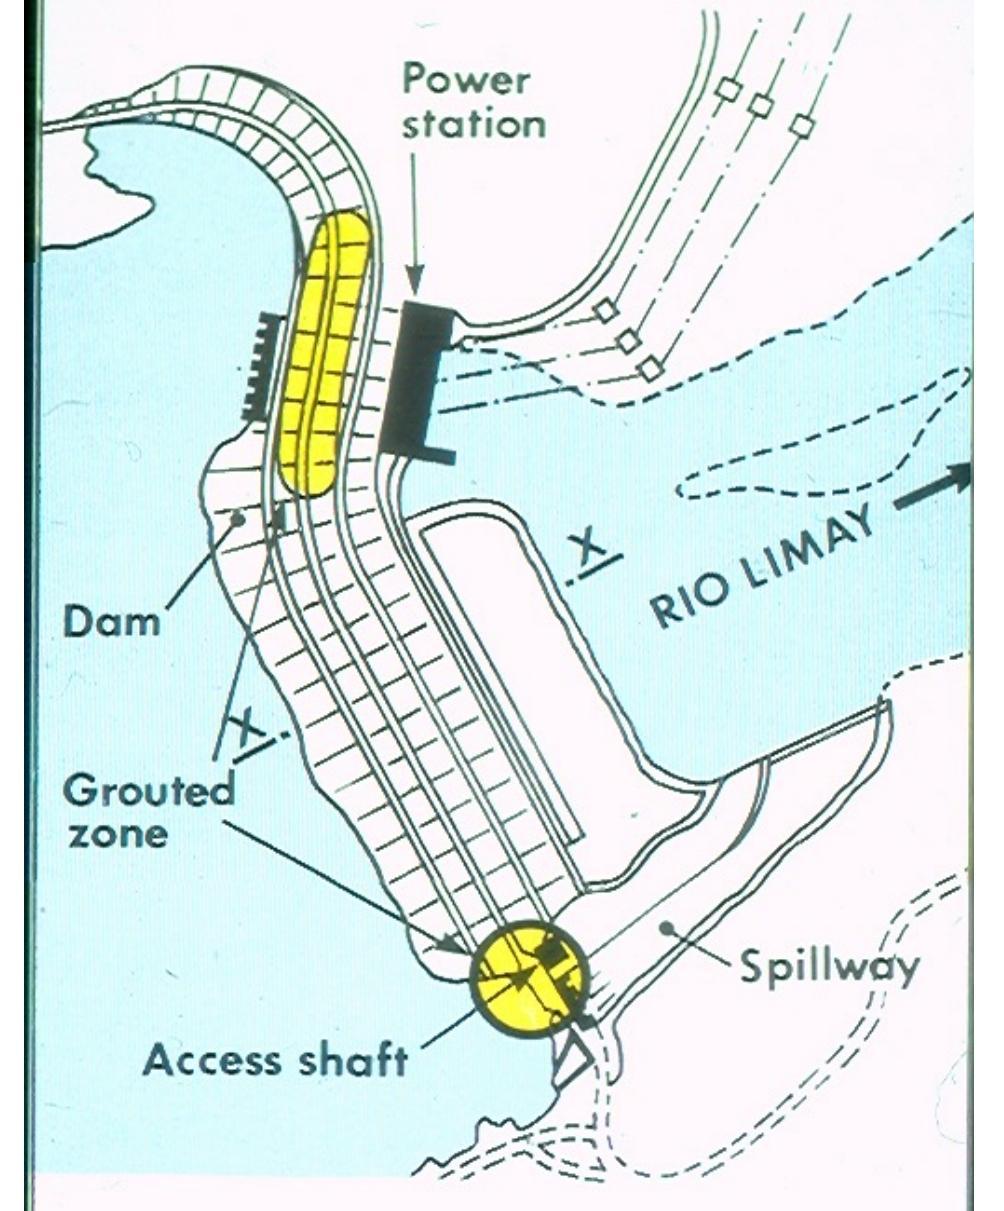
### **TREATMENT AREAS**

- The performance of the dam and its foundation did not cause any particular concern from 1972 to 1982.
- In November 1982 the attention was focused on the evolution of high piezometric levels recorded in the core contact with the right abutment. An extensive program of studies and investigations was initiated by Hidronor to determine the causes of this behavior.
- Chemical analyses carried out on water samples from different drains showed that the measured seepage water of about 100 I/min contained an average of 2 g/l of soluble solids.
- An investigation was performed to identify some of the existing fissures and joints and the amount of water seeping through them to know the percolation pattern through the dam foundation.
- Field surveys have shown the presence of valley stress relief related joints, particularly on the right cliff between the dam and spillway area.

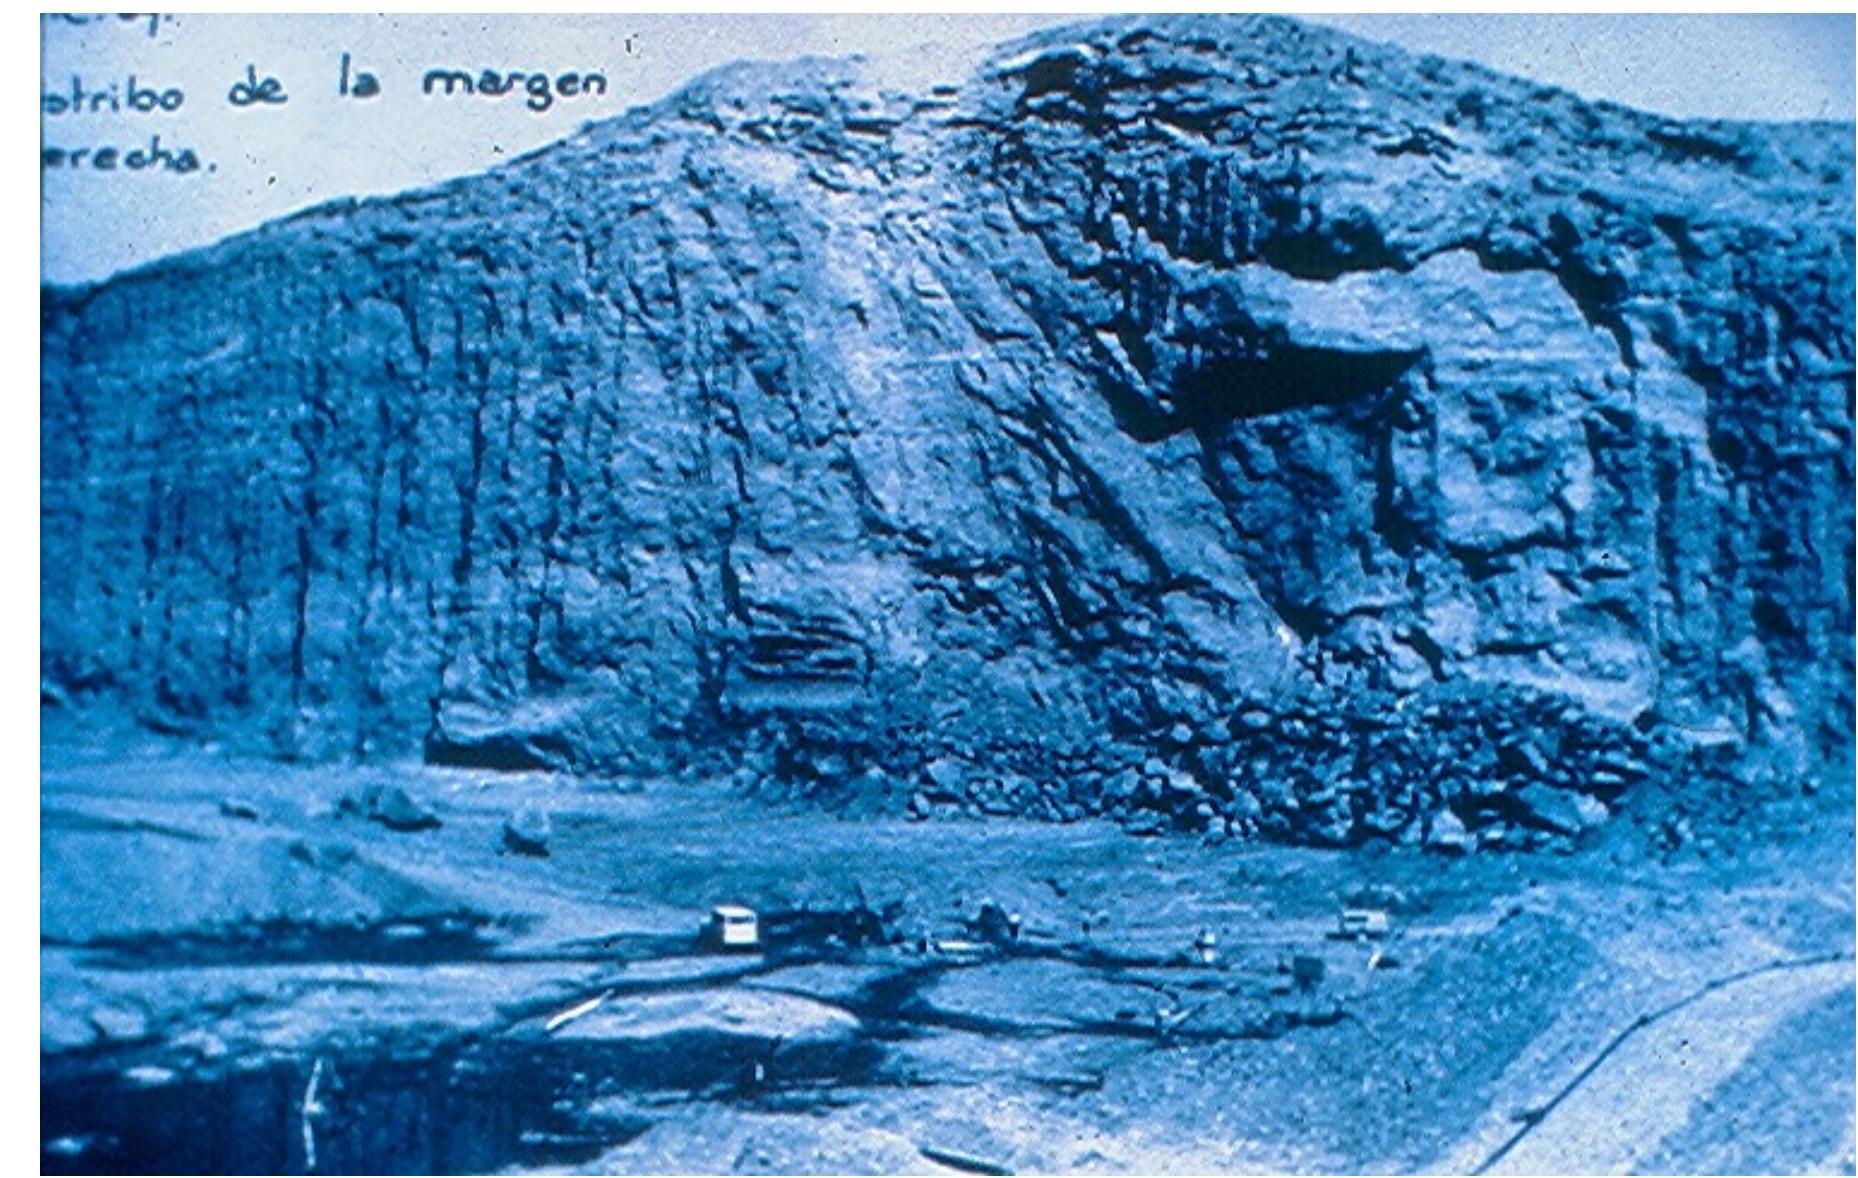
### **RIGHT ABUTMENT**

The first few holes drilled towards the contact face AB revealed worse conditions that had been anticipated. A number of rack joints near the contact were found to be open and full of water at hydraulic pressures near reservoir level. The core when contacted was found in some cases to be either in a near fluid state or with very low consistency. The samples were recovered using special procedures.
