Some Case Histories with Lessons to Learn in Dam Engineering

Luiz Guilherme de Mello¹

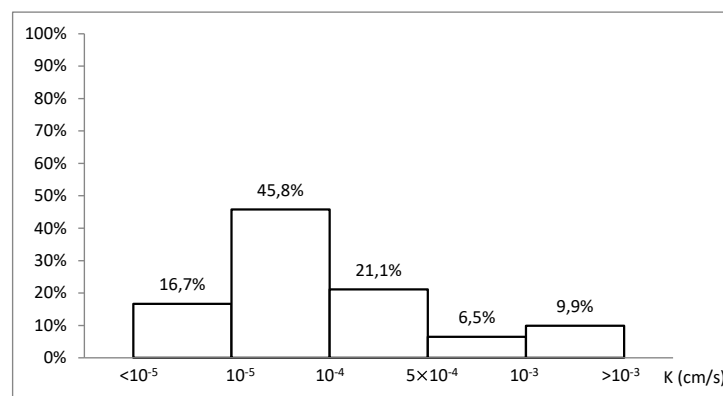
Figure 2.1 presents the distribution of the measured permeability values in the saprolitic soil; it can be seen that 38% of the values are higher than 10⁻⁴ cm/s, and 10% are higher than 10⁻³ cm/s, values which are not compatible with the existing experience in saprolitic soils. No sample from the SPT tests recovered every meter exhibited any feature that could justify the high permeability values encountered, such as sand or gravel.

Figure 2.1 - Distribution of Measured permeability values

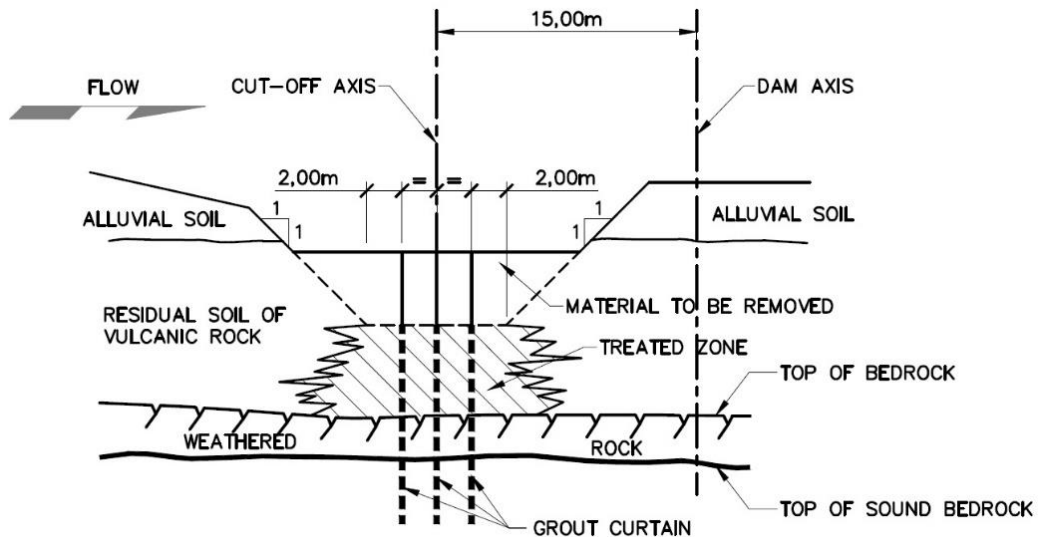
Figure 2.2 – Balbina Dam foundation treatment typical cross section

Figure 2.2 illustrates a typical cross section for the proposed hydraulic fracturing grouting foundation treatment. The goal of grouting was defined as creating, by grout pressure fracturing, a net of grout planes which would intercept each other and the canaliculi, filling them with grout over part of their length, in order to create a zone 5m to 6m wide with reduced and homogenised permeability. A maximum value of permeability of 10^{-4} cm/s was expected after treatment.

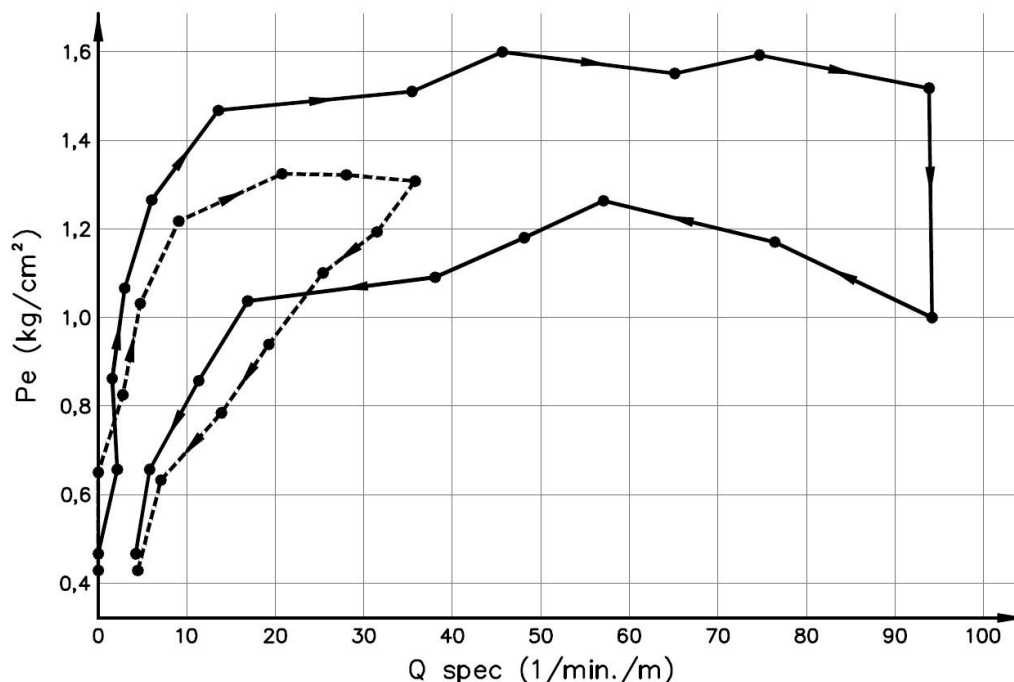
- Carefully performed water loss tests in drained and in undrained conditions. Figure 2.4 presents two of the referred tests, from which the pressure causing hydraulic fracturing and the minor principal total stress σ_3 , were interpreted. Following Bjerrum and Andersen (1972) discussions, the coefficient of earth pressure at rest K_0 was estimated, provided that σ_3 is assumed to be horizontal. This value was estimated to vary between $0.21 \leq K_0 \leq 0.36$.
- After grouting with different colored cement pigments added to each grouting phase, inspection trenches showed valid the assumption of the orientation of σ_3 .

Figure 2.4 – Groutability Test example – Hydraulic fracturing of the saprolitic soil

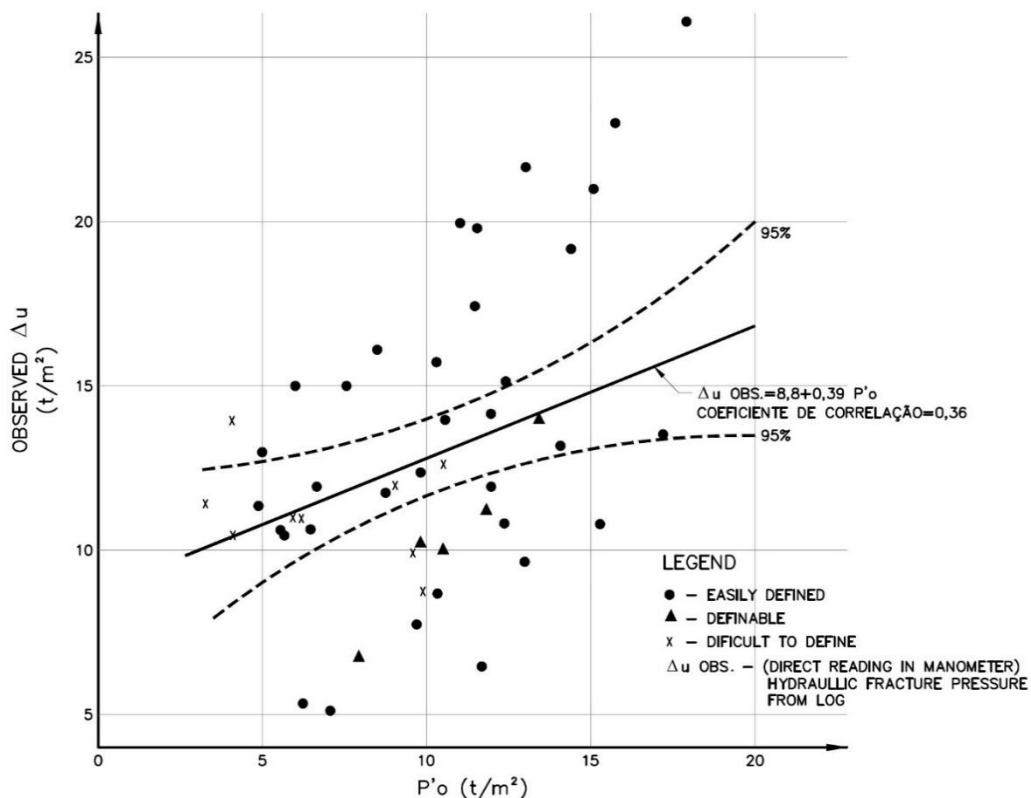
Figure 2.5 – Relationship between the increase of pressure to generate hydraulic fracturing and effective stresses in water loss tests

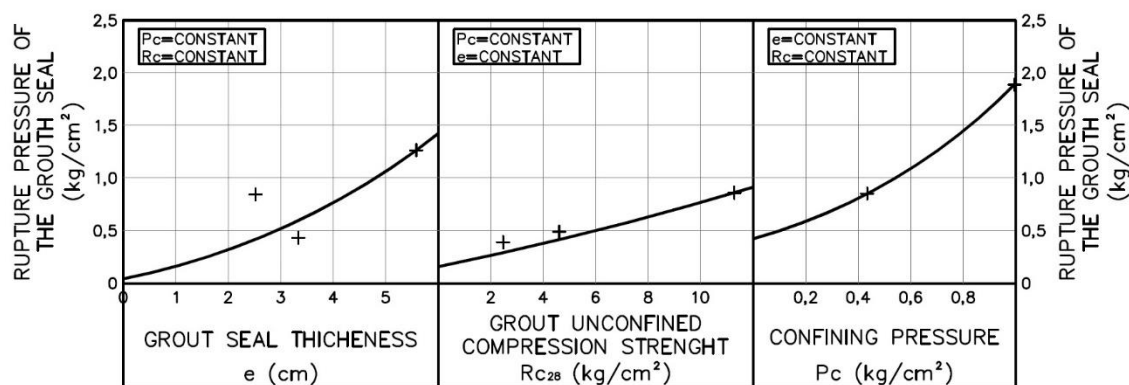
The physical characteristics of the grout necessary to fix and seal the PVC tube needed to be carefully evaluated so that it would not condition the pressure values required for its rupture when grouting of the foundation soil. Several grouts were prepared in PVC pipe molds, with variable thickness and grout resistance. Tests simulated rupture processes of the annular seal grout, as a function of its thickness, grout strength and confining pressure. The results of these tests showed that the increments of the seal grout rupture pressure as a function of the three variables tested were higher with the confinement pressure and with the seal thickness, for rupture pressure values within the same order of magnitude, as shown in Figure 2.6.

Figure 2.6 – Results of tests with grout seal models

Based on these results, a grout mixture for the annular seal was defined as:
cement: 285kg / soil: 290kg / water: 805l

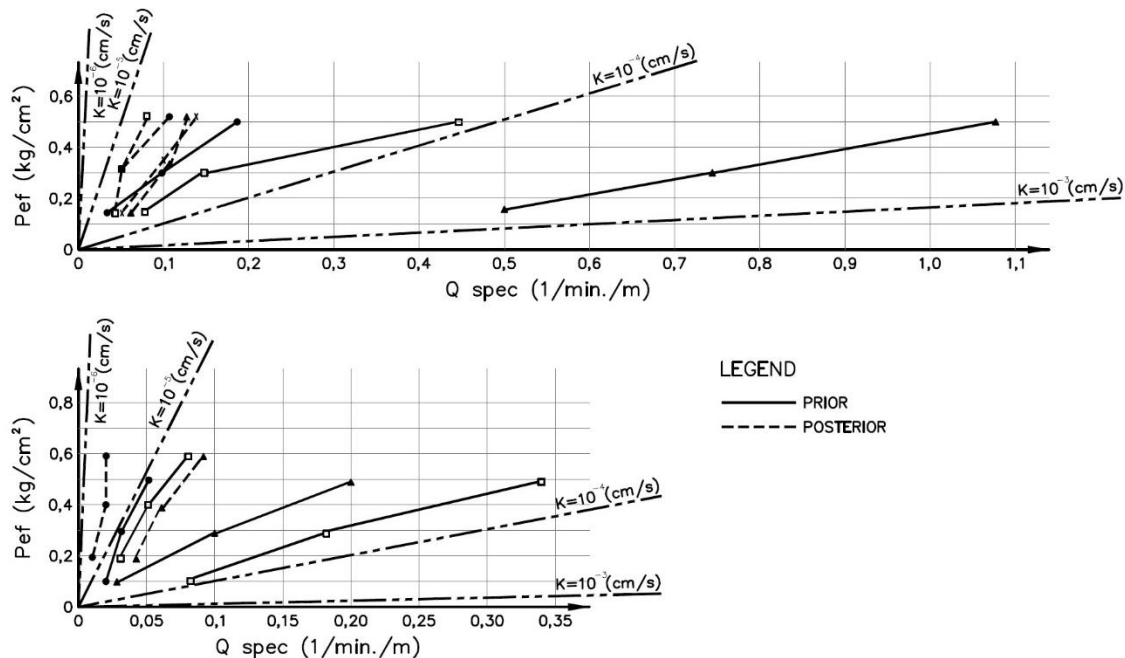
interpretation of the water loss tests following Babouchkine's (1965) formulation is presented. The control tests indicated that after grouting there was considerable reduction in permeability coefficients, especially with the elimination of coefficients above $5 \cdot 10^{-3} \text{ cm/s}$.

Figure 2.7 – Comparison of water loss tests prior and posterior to treatment

An analysis of this data demonstrated the success of the treatment applied considering the elimination of high permeability zones and the consequent foundation homogenization with respect to its permeability.

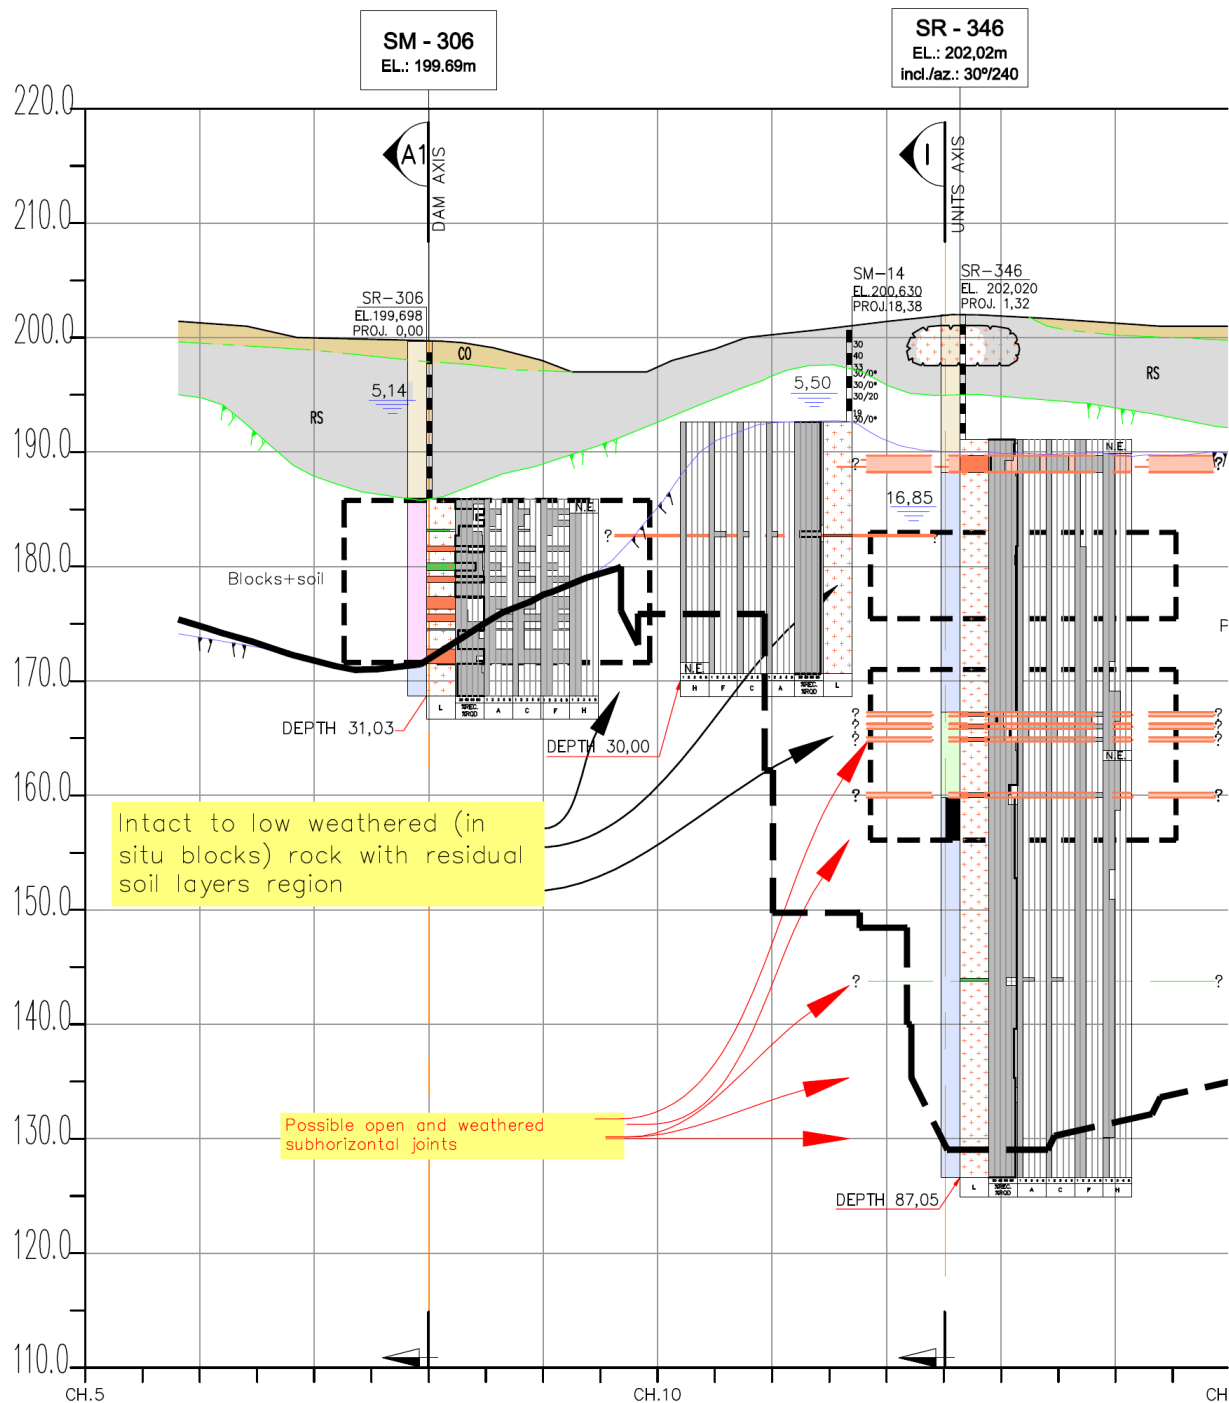
For detailed design, local difficulties prevented that detailed investigations were performed before beginning of the excavations in some regions, principally at the dam's right abutment, where the intake and the powerhouse structures are located. As soon as access was permitted, 38 additional rotatory borings were initially done, 4 with optical imaging, which allowed the visualization of the spatial position of the weathered zones. This allowed the separation of the horizontal from the inclined or vertical discontinuities, which is difficult and very debatable when the correct control of the discontinuities' strike is not known due to the mechanical fragmentation of the rock cores during drilling and core recovery. A high frequency of weathered sub-horizontal discontinuities was observed but the difficulty of correlating its continuity inhibited its extrapolation in the design cross sections used for design decisions and calculations, as shown in Figure 3.4.

Figure 3.4 – Teles Pires Intake structure foundation geological cross section after initial additional investigations for detailed design

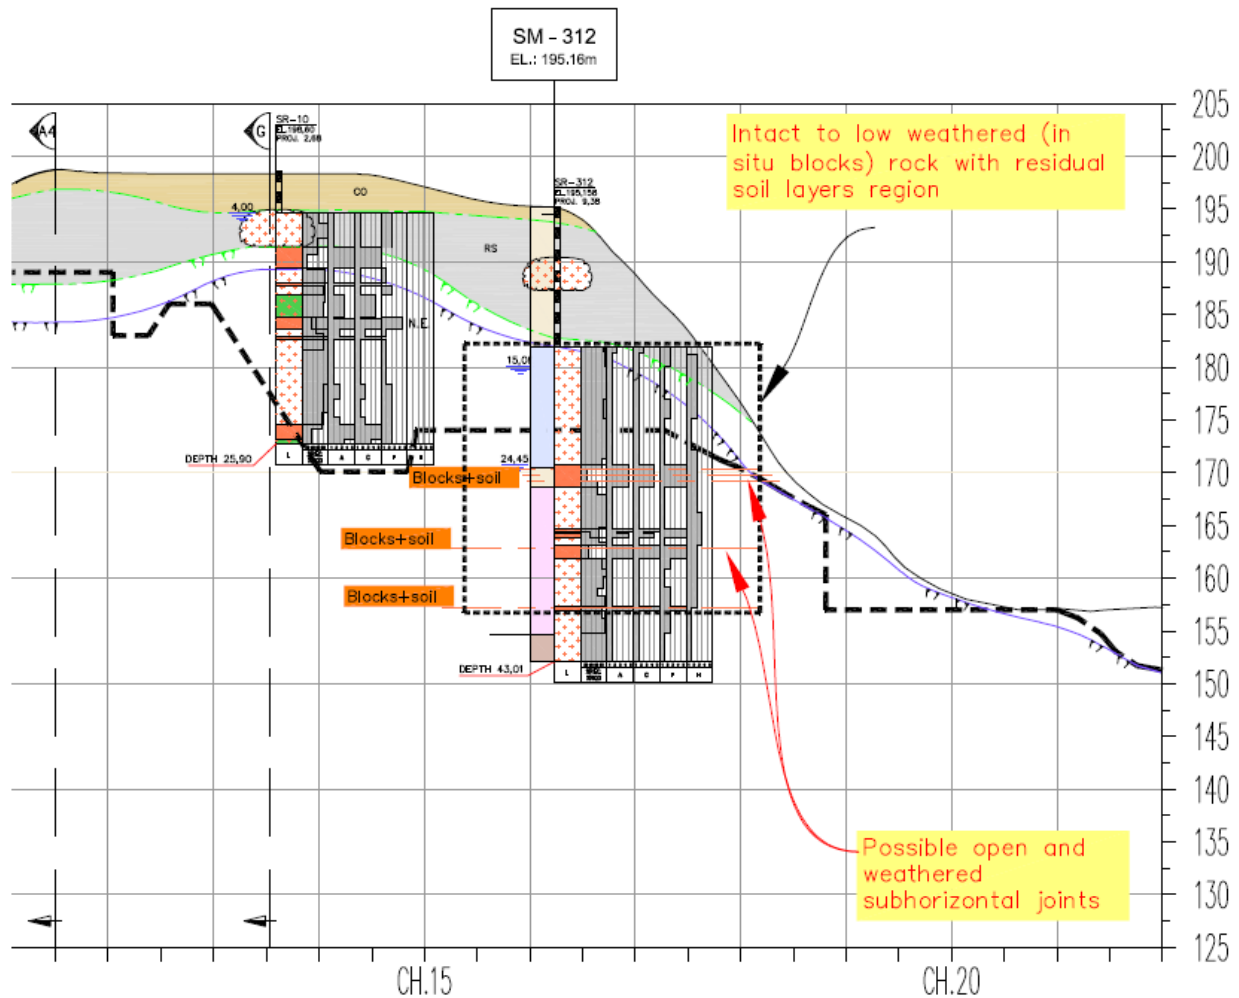
The gradual increase in data acquisition clearly showed that the necessary revision of the geological model previously conceived had a major impact in the project's structures' stability. The incidence of weathered sub-horizontal discontinuities (Figure 3.5) combined with the joints pattern had direct practical implications in the excavations' design, leading to the need to lower the foundation of the water intake structure.

Figure 3.5 - Teles Pires Intake structure foundation geological cross section after further investigations, showing denser pattern of weathered subhorizontal joints

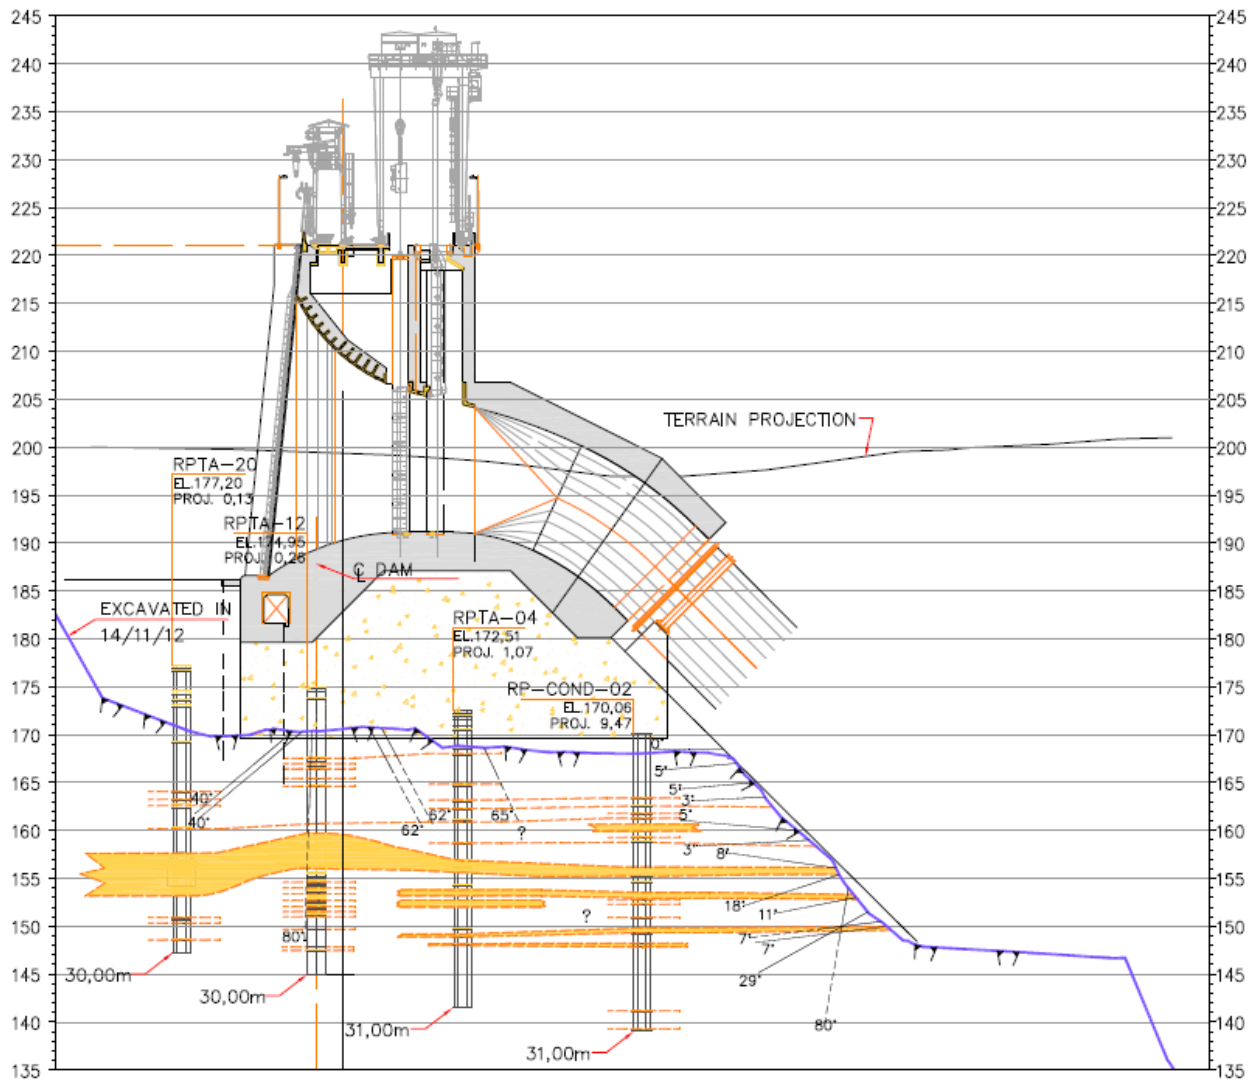
Figure 3.6 – Updated discontinuity pattern at water intake structure foundation – Cross section after rotopercussive dense array investigations

A comprehensive investigation program based on a dense array of rotoperussive borings, described by qualified geologists, was performed to better and quickly map the substrata underneath this structure, leading to the proposition of a much more complex discontinuities pattern than initially predicted (Figures 3.6 and 3.7). It clearly indicated the presence of thick discontinuities with soil filling concentrated between elevations 155m and 170m.

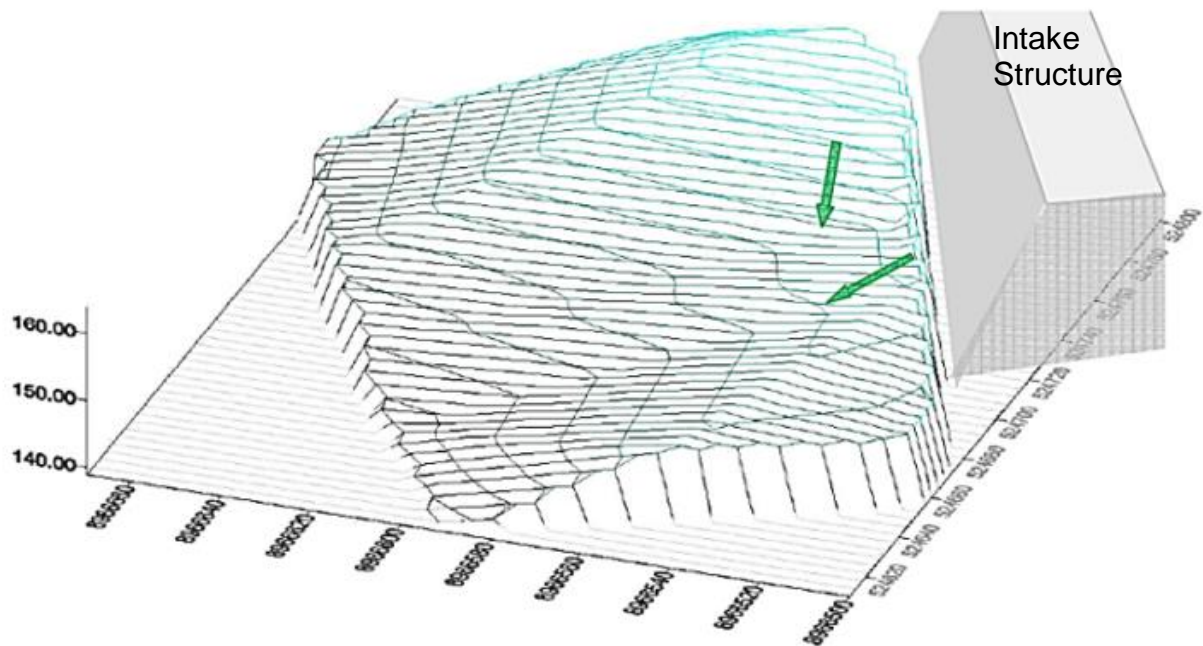
Figure 3.8 – Master joint 3 D surface model

Later, during excavations, geological mapping confirmed that numerous of the sub-horizontal discontinuities presented decametric extension with weathered soils filling frequently laminated and pre-sheared, with presence of estriae and slickensides. This characterized a sub-horizontal shear zone with indication of displacements accompanied by its subparallel secondary joints.

This shear zone, identified as master joint, has its trace clearly visible on all walls of the excavation (Photo 3.1), dipping downstream with local components towards the river as shown in Figure 3.8.

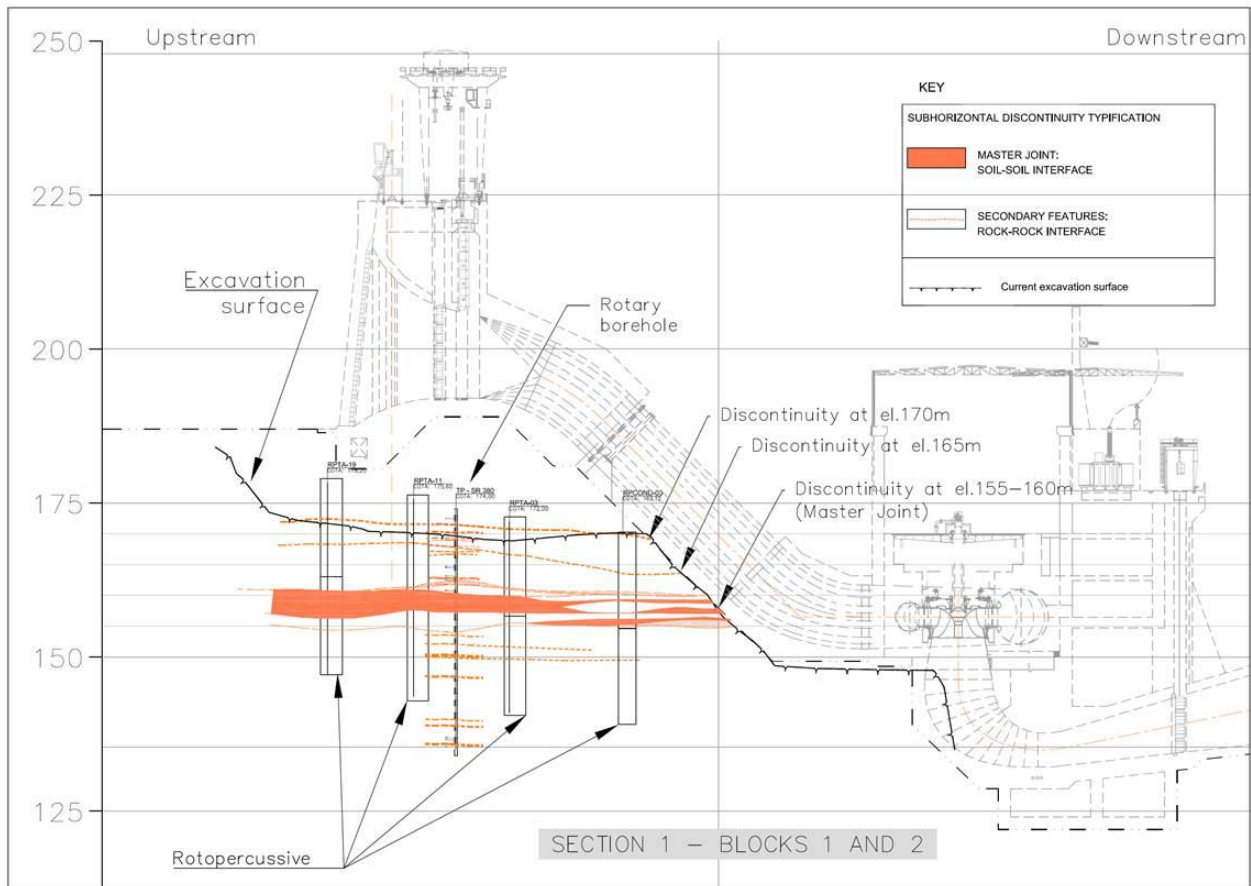
Figure 3.9 - Water intake structure cross section with discontinuity pattern in tune with proposed updated geological model

Based on this revised geological model the stability of the intake structure with relation to its sliding became intrinsically conditioned by the master joint, requiring special attention. Photo 3.4 presents the discontinuity pattern mapped at the water intake structure foundation's as seen in the penstocks excavation face, and Figure 3.9 displays a cross section for the water intake structure, presenting the identified discontinuity pattern as used in the geomechanical model proposed.

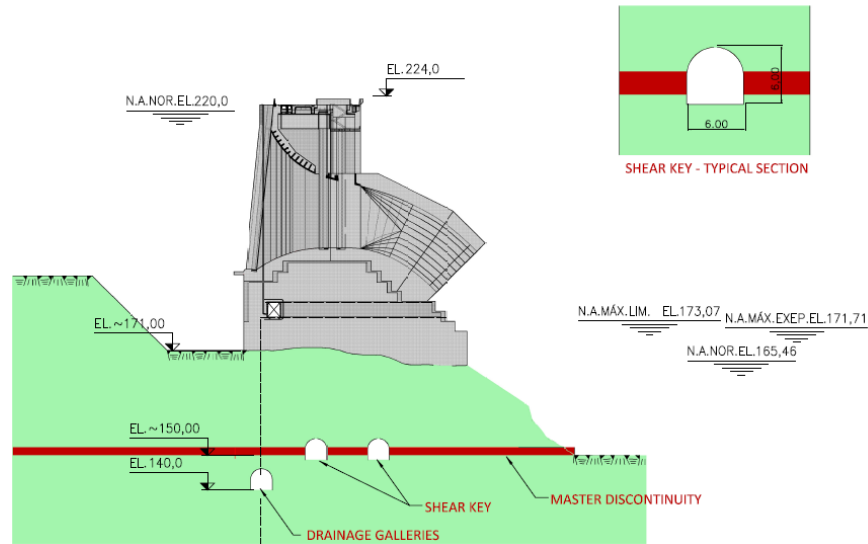
Figure 3.14 – Modeled Shear key geometry

Again, this value of shear strength could not be anticipated to prevail in the master joint or any other persistent discontinuity with slickensides, leading to the decision to design underground galleries filled with concrete to contribute as shear keys, increasing the safety factors to sliding to the required value. Having in consideration the distinct stress-strain behaviour of the concrete in the shear keys with relation to the soil filling of the discontinuities, it was decided that the shear keys should sustain all the horizontal stresses applied at the elevations where discontinuities prevailed, with no load being

transmitted through the rock massif. Two longitudinal shear keys linked by five transversal shear keys were designed. The geometry of these galleries was not rigidly fixed in design, the specifications being that the galleries should follow the master joint (Figure 3.14), excavating an additional 2.5m of the rock massif above its crown and 1m below its invert.

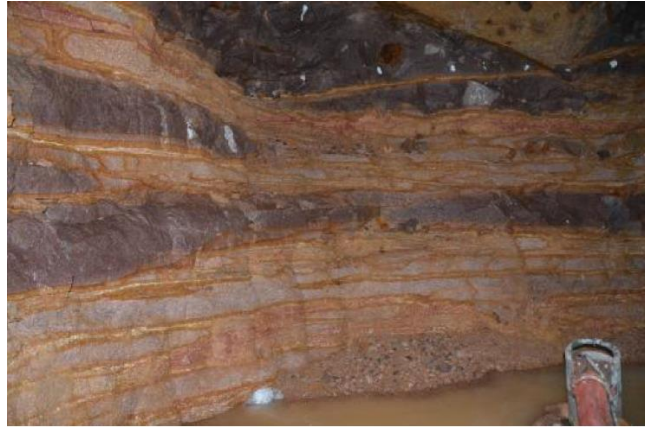
Photo 3.6 – Detail of the weathering pattern in the Master Joint

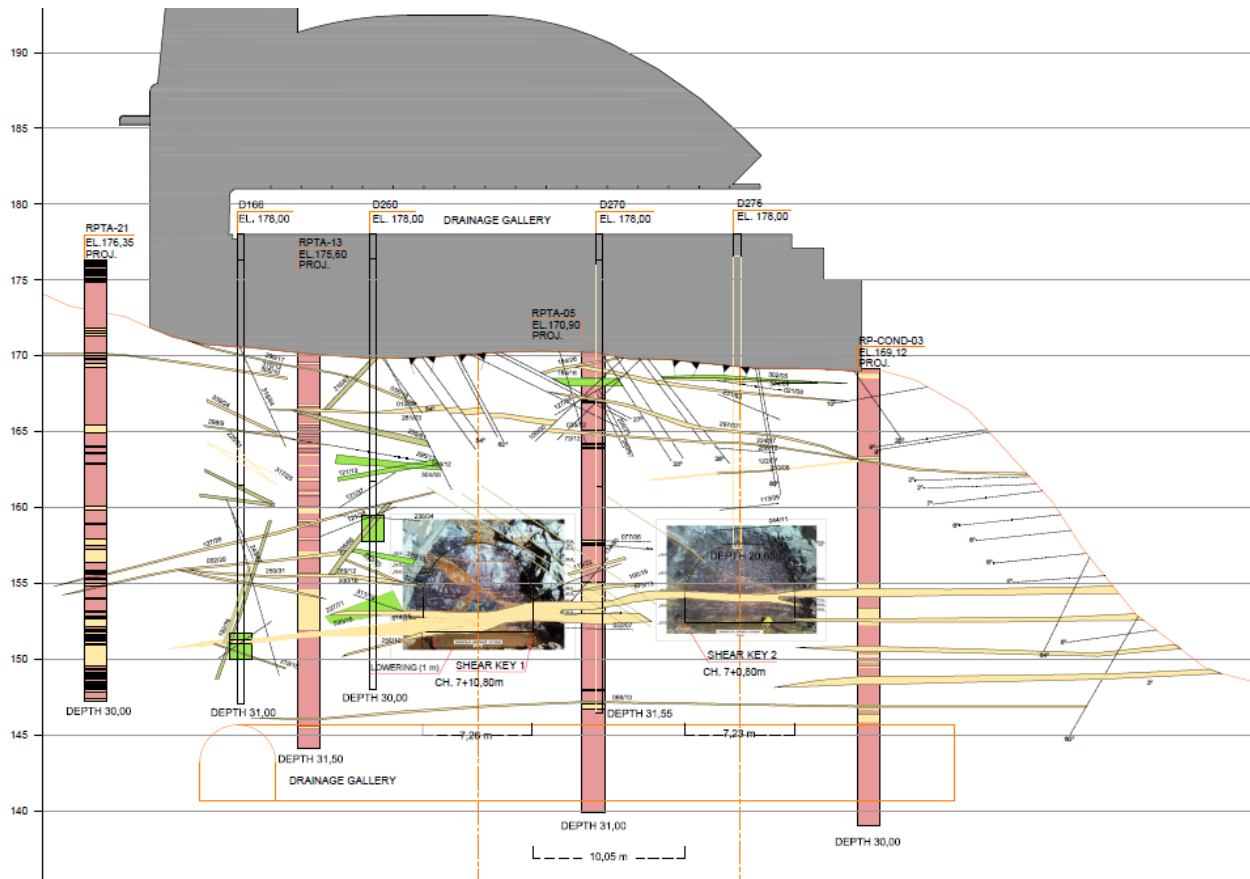
Figure 3.19 – Water intake structure foundation cross section with master joint and secondary parallel joints

Secondary parallel joints above the master joint were also identified and mapped during excavation (Figure 3.19); their influence in the stability of the intake structure had to be discussed and evaluated together with that of the master joint itself, taking in consideration their spatial random variation.

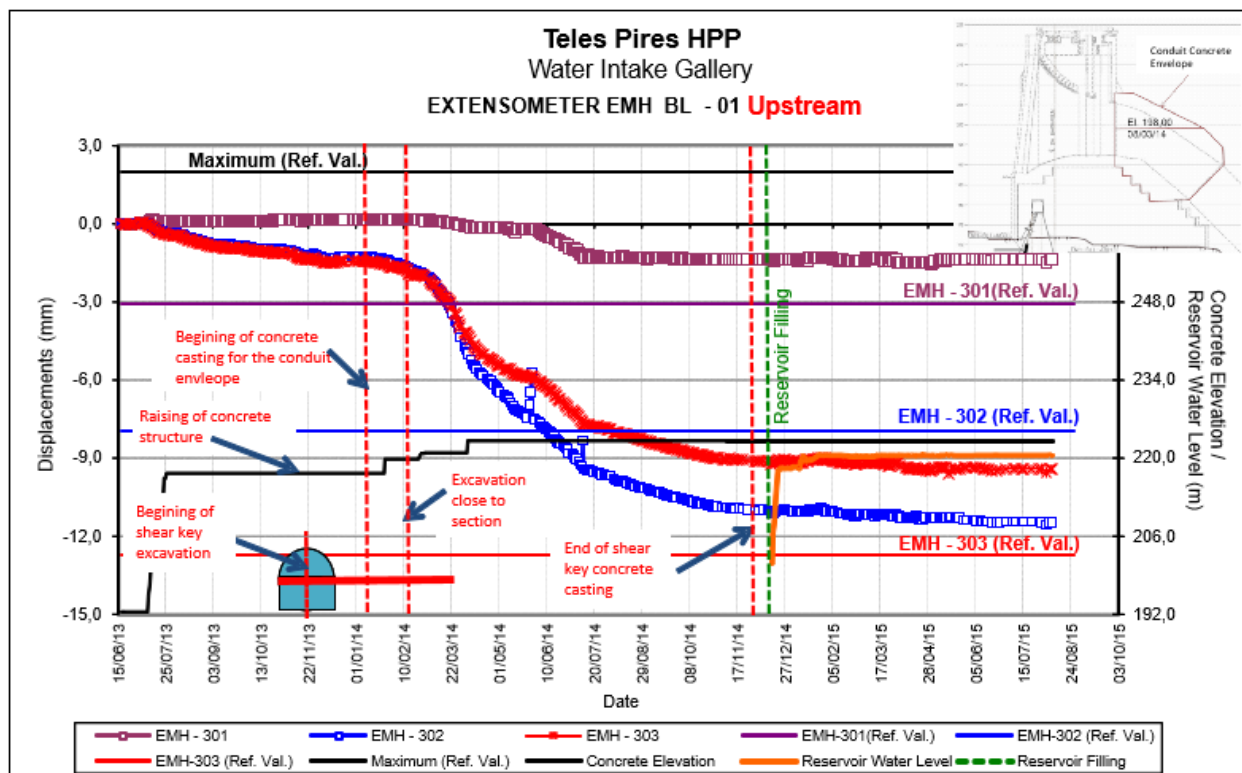
Figure 3.21 – Typical data for extensometer installed in the water intake structure's foundation underneath one of its concrete blocks

The extensometer measurement results presented in Figure 3.21 is representative of the behaviour shown in all such instruments.

Readings show that deformations of approximately 10mm happened when the galleries were being excavated in the region of influence of the instrument, especially as tunnel excavation suffered important overbreak in following the master joint within the design criteria, leading this excavation to being only 4m to 5m from the foundation of the intake structure. Additionally, the load imposed by the concrete around the penstocks before filling the shear keys with concrete is considered to have influenced the behaviour monitored. Soon after concrete filling of each gallery/shear key deformations stopped completely, and were not affected or mobilized by reservoir filling at all.

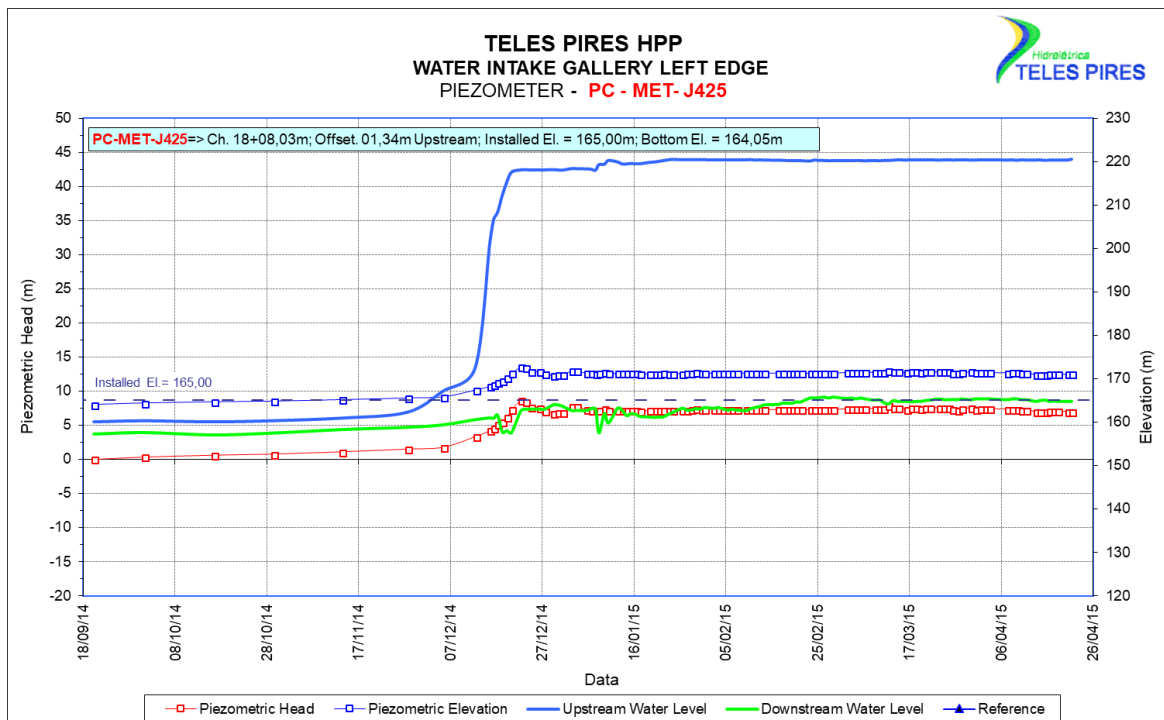
Figure 3.23 – Piezometer and reservoir level data

The measured piezometric values (Figure 3.23) lead to conclude that the diagram of water thrust suggested by the BoC for the structure's foundation was surpassed in some of the intake blocks, while all readings were lower than the piezometric levels associated to the hypothesis of a non-efficient PEAD upstream impervious blanket in the foundation.

Having in consideration that no incremental deformations were measured by the extensometers when the water thrust diagram started to be imposed by reservoir filling, the fact that some readings were higher than those postulated by the BoC did not raise any further concerns.

The piezometers also allow the verification of the efficiency of the grouting curtain. The measured values allow to interpret that this efficiency is on average associated to a reduction of 60% of the measured upstream water pressure.

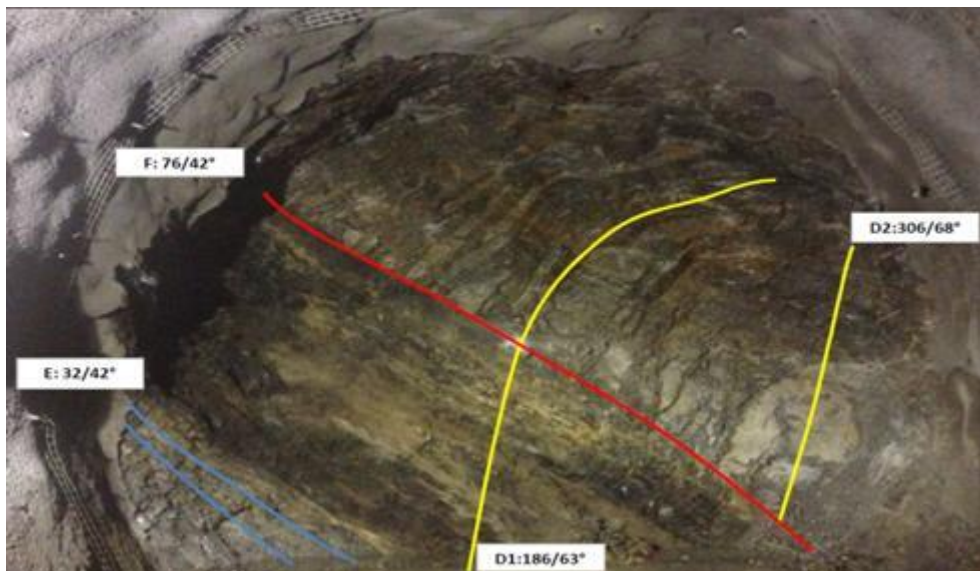
During excavation of the tunnel, various lithological types were crossed: gray and/or banded limestones, bituminous limestones, breccia and andesitic dykes. At some chainages shearing developed along the bedding planes was observed, which at these locations presented a clayey, silty or crushed rock filling. These particular features were named "stratigraphic fault"; Photos 4.1 and 4.2 illustrate these features in the excavation front.

Photo 4.2 - View of the “stratigraphic faults” in the gray limestones at the excavation front

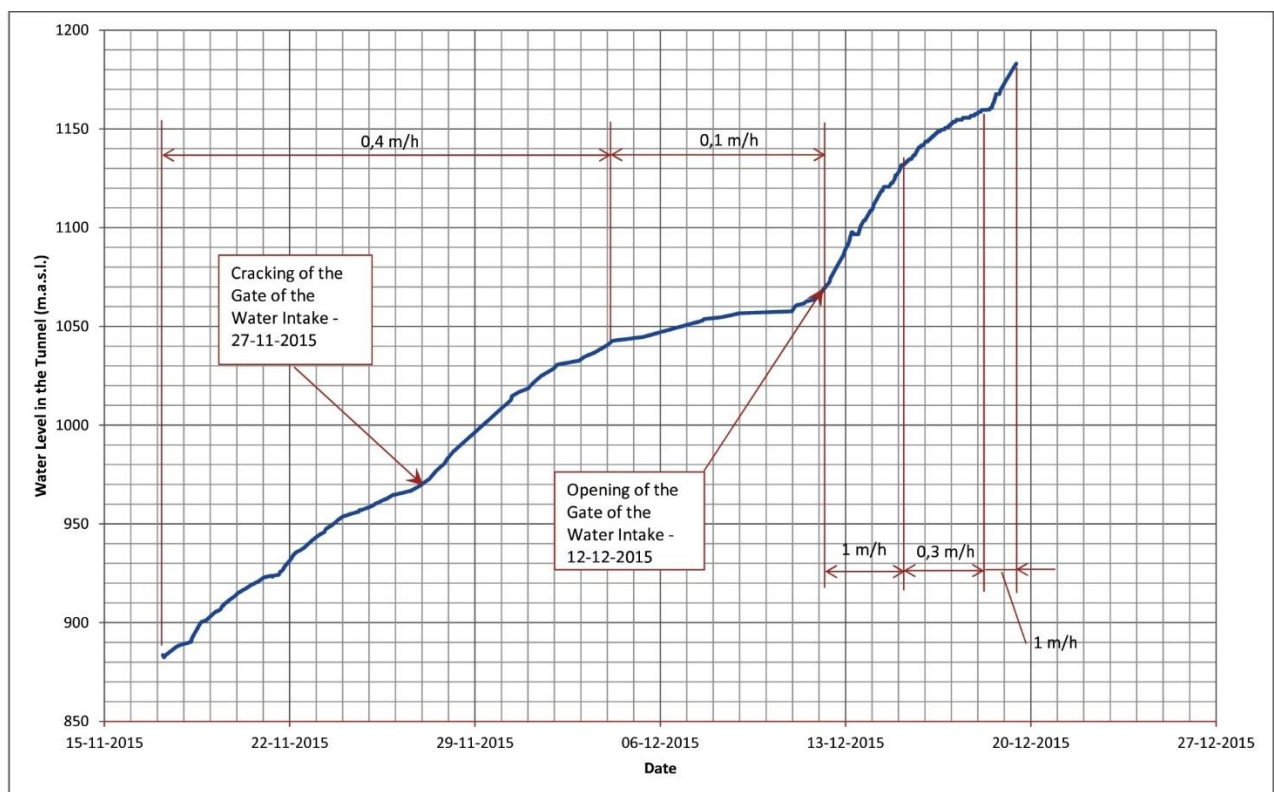
Figure 4.3 – Tunnel filling

Filling of the tunnel started on November 17th, 2015, using only the inflow in the tunnel provided by the natural water table. Figure 4.3 shows that from the beginning the water level inside the headrace tunnel rose at a rate of approximately 0.4m/h with the infiltration flow alone, well below the maximum recommended rate of 2m/h (Benson, 1988).

Filling continued at approximately 0.4m/h for the next seven days, when the water level inside the tunnel was observed to be stabilizing at approximately at elev. 1,050m.a.s.l. As the water level inside the tunnel rose, at this moment the exfiltration flow from the tunnel exceeded the infiltration rate.

With this procedure, the filling rate of the tunnel was increased to 1m/h for the next three days and dropped again to 0.3m/h, reaching elevation 1,160m.a.s.l. around noon on December 18th. As the last stretch of the tunnel would be less affected by the filling flow (the floor is less inclined), it was decided to raise the reservoir level again to finish filling the tunnel. This was done on December 19th in the morning. The filling rate during this last day was 1m/h.

As the filling rate fell to 0.1m/h, it was decided to lower the reservoir level so that one of the gates at the water intake could be opened with a low head. In this way the inflow and water velocities could be controlled, avoiding damage to the concrete floor of the tunnel. Lowering of the water level in the reservoir to the elevation 1,182.2m.a.s.l. (just 0.7m above the gate sill) began on December 9th, and the reservoir level was kept at this elevation, corresponding to an inflow of 4.0m³/s.

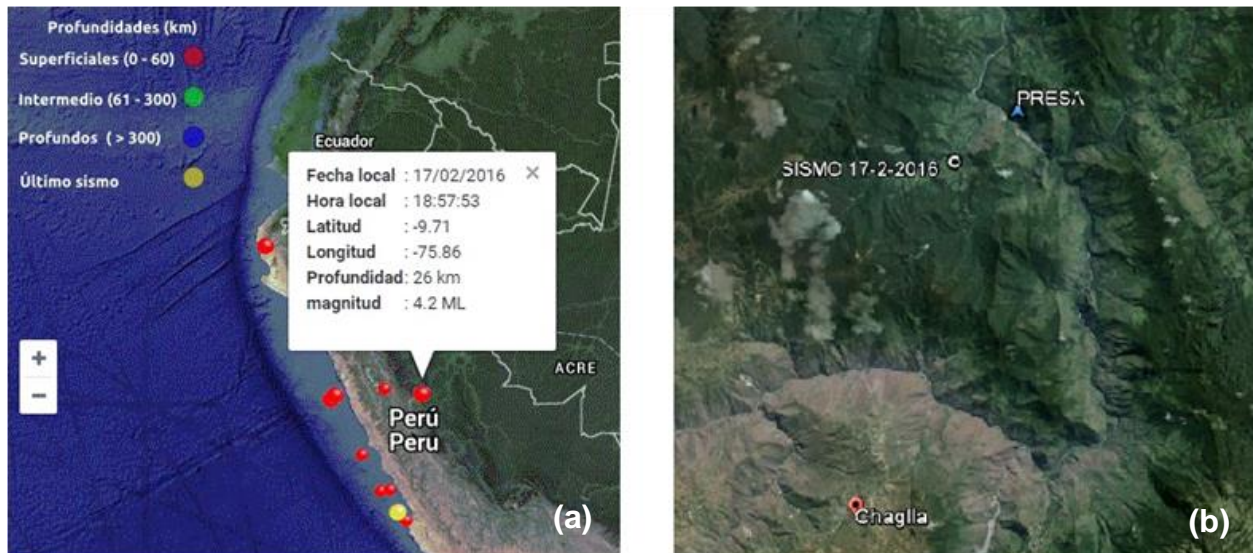
On February 17th, 2016, at 6:57 PM an earthquake of magnitude 4.2 on Richter scale struck at a distance of approximately 3km from the Chaglla Hydroelectric Power Plant Dam and 13km from the powerhouse.

Figure 4.4 - Earthquake location: (a) Location (determined by the IGP) of the 4.2 ML earthquake that occurred on February 17th, 2016; (b) Close-up showing the location of the Chaglla Dam (PRESA), of the village of the same name and of the earthquake (SISMO).

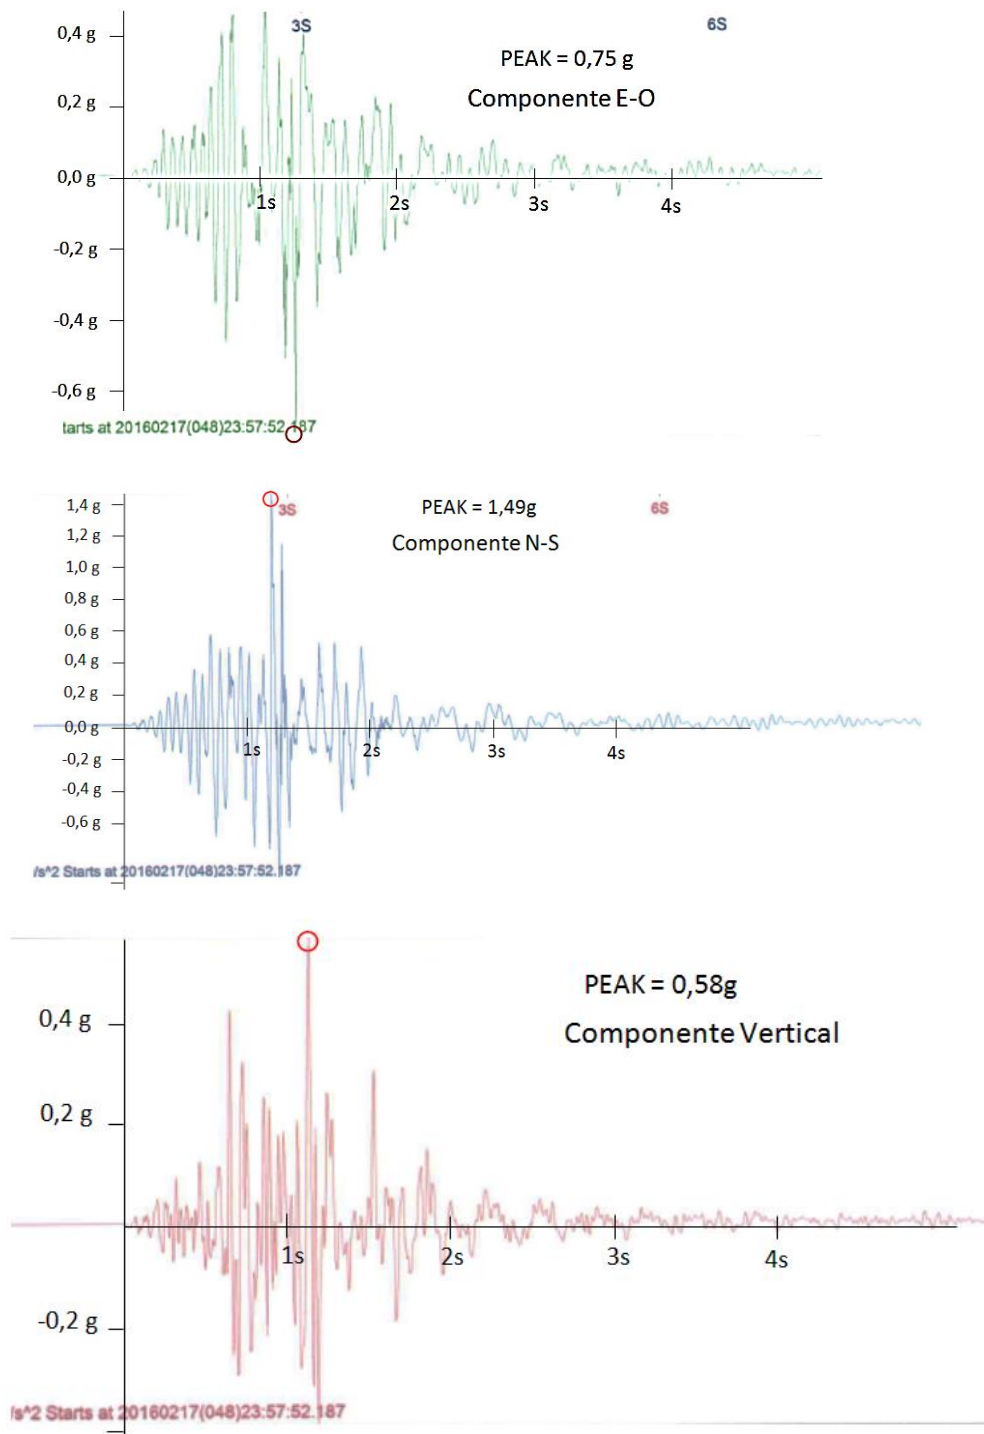
Figure 4.5 shows the recordings of the three earthquake acceleration components over time at the dam. The estimated distances from the epicenter of the earthquake to the dam and power house (other recordings) are 3km and 13km, respectively.

Figure 4.5 - Crest of the dam: Recording of the three acceleration components

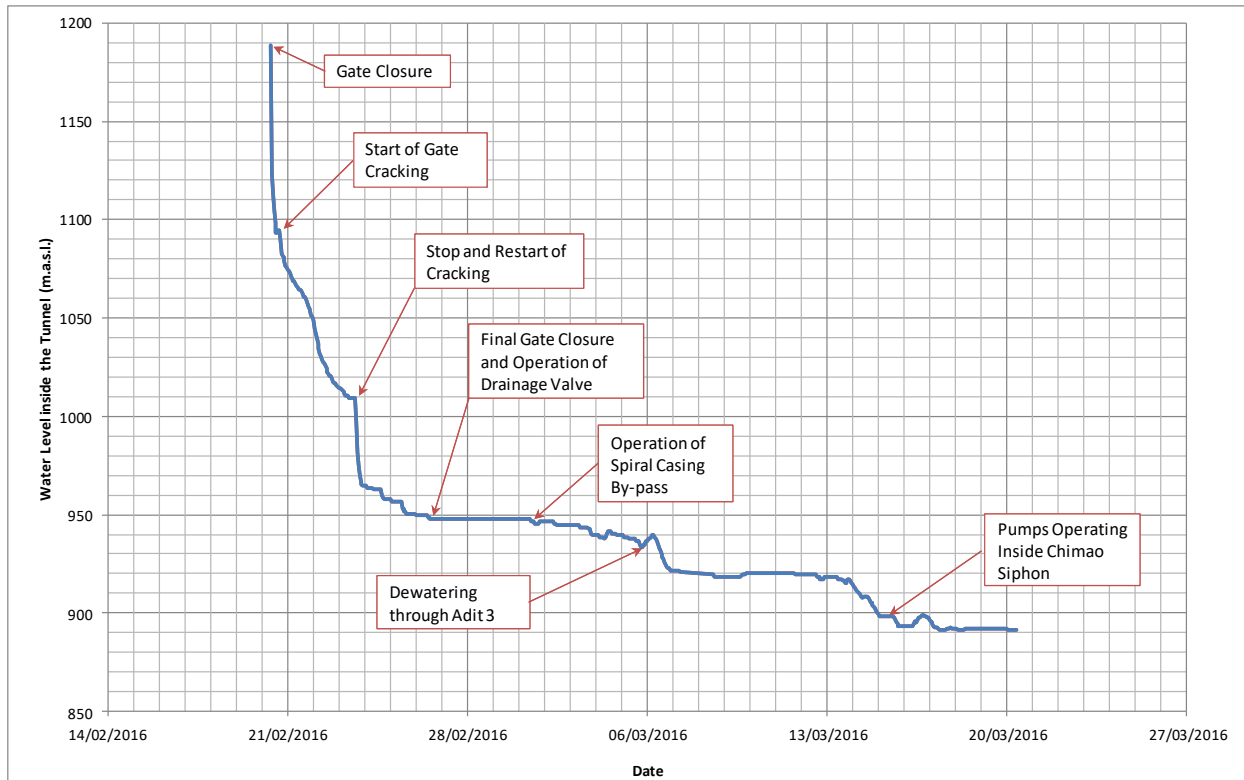
Due to the water leakage in the tunnel, and the lack of infiltration from the rock mass in the upstream section of the tunnel, the initial dewatering rate was very high - 65 meters in the first hour. To reduce the dewatering rate, one of the gates at the water intake was cracked and the dewatering rate dropped to 11m in the second hour, and 8m in the third.

Figure 4.6 - Dewatering curve of the headrace tunnel and main events

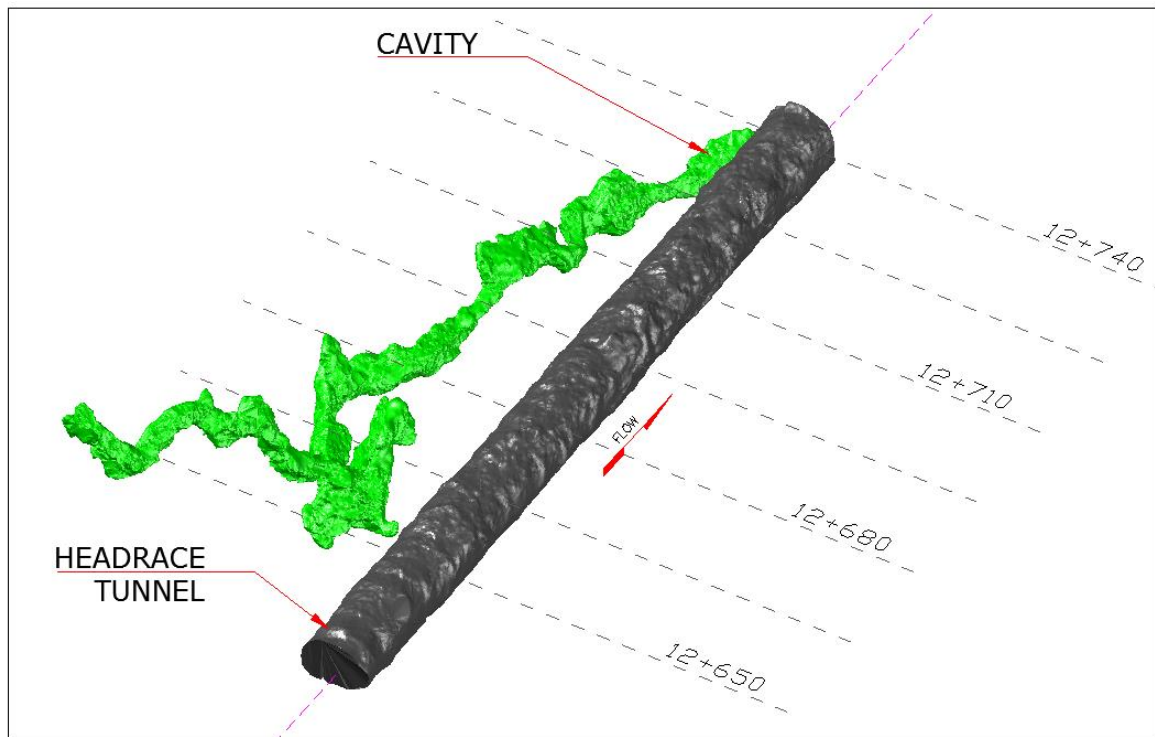
Figure 4.7 – Isometric side view of the El Hoyo de la Beba cavity

Analysis of Figure 4.7 indicates that the cavity extends along a “stratigraphic fault”, that is, a fault developed along the orientation of the limestone bedding, slightly diagonal to the axis of the headrace tunnel between chainages 12+740, where it enters the tunnel, and approximately 12+680. From this point on, because of joints and / or sinistral faults, the cavity joined a karst conduit, approximately 110m upstream of chainage 12+740.
