Some Case Histories with Lessons to Learn in Dam Engineering

Luiz Guilherme de Mello¹

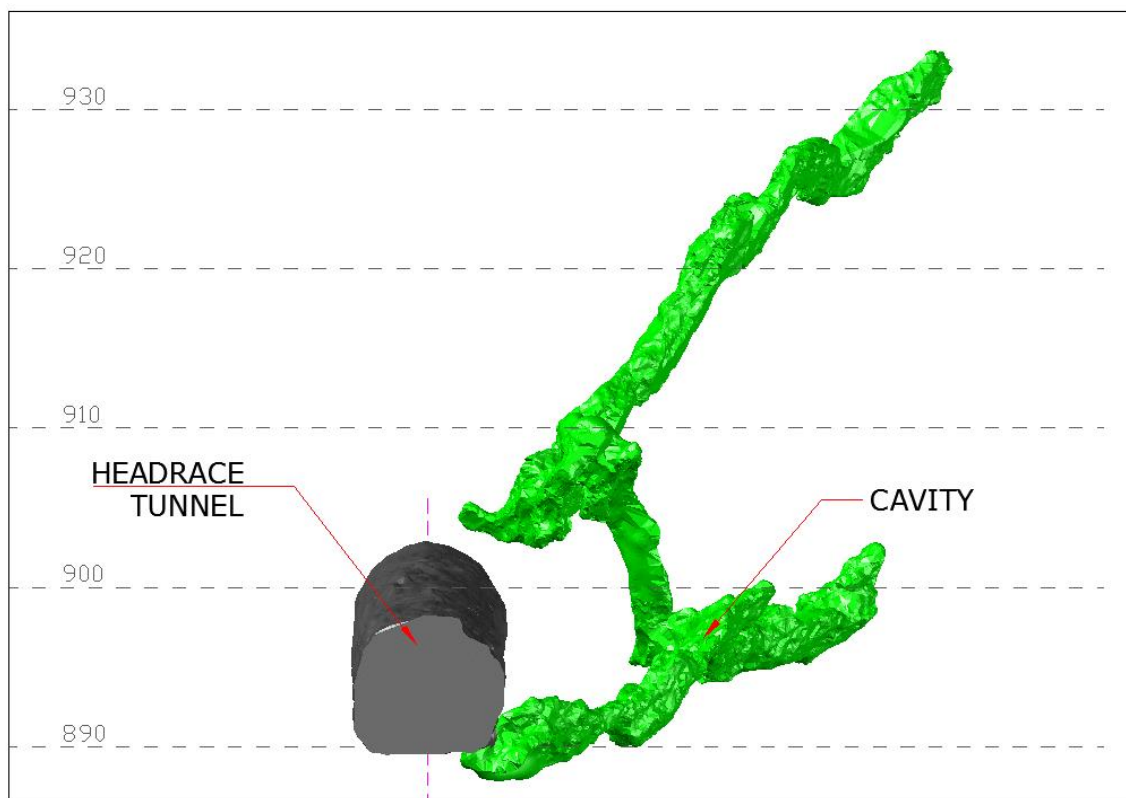
Figure 4.8 - Isometric view towards upstream of the El Hoyo de la Beba cavity

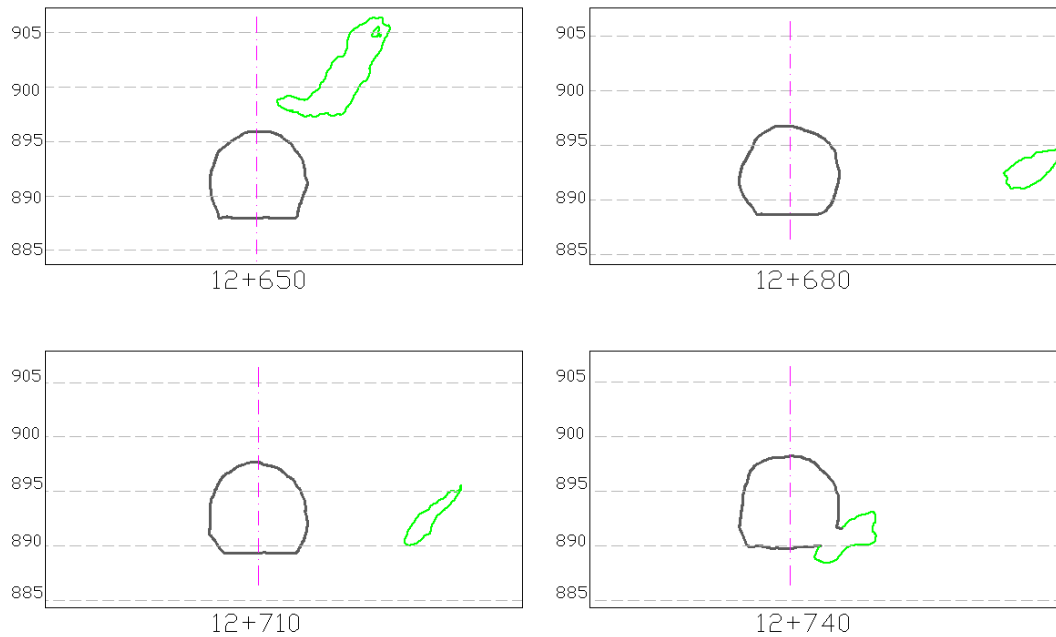
Figure 4.9 - Cross-sections of the headrace tunnel showing the position of the El Hoyo de la Beba cavity
