### 17° Congresso Nacional de Geotecnia

10° Congresso Luso-Brasileiro de Geotecnia 11° Encontro de Jovens Geotécnicos

### **VII VICTOR DE MELLO LECTURE**

### LESSON LEARNED FROM DAM CONSTRUCTION IN PATAGONIA ARGENTINA

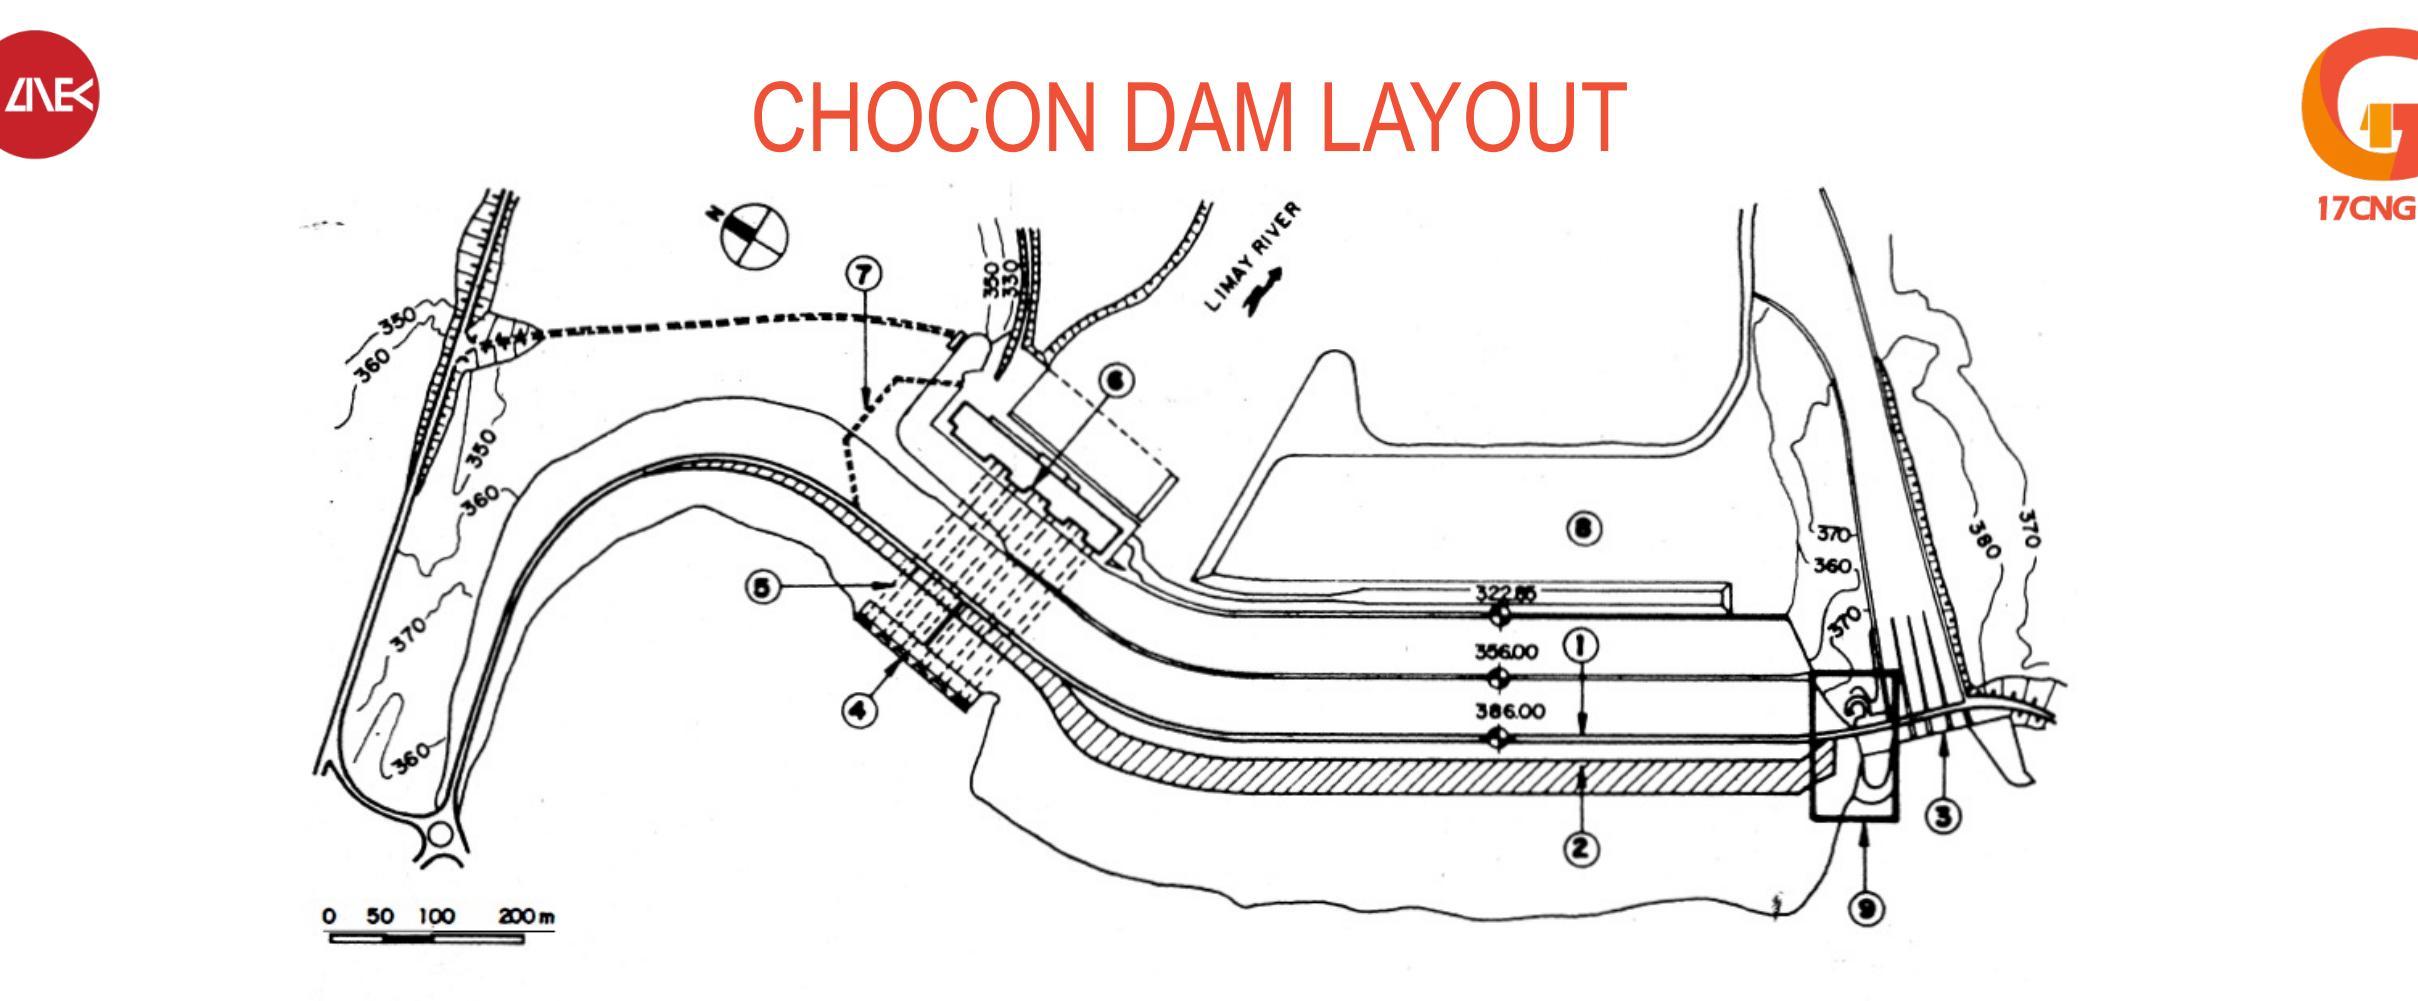
The earth dam is one of the largest in Argentina, 92 m maximum height, 13 millions of m3 and 2.245 m crest length. The lay out was based on the topography. The spillway is located on the right bank, about 100 m from the right abutment.

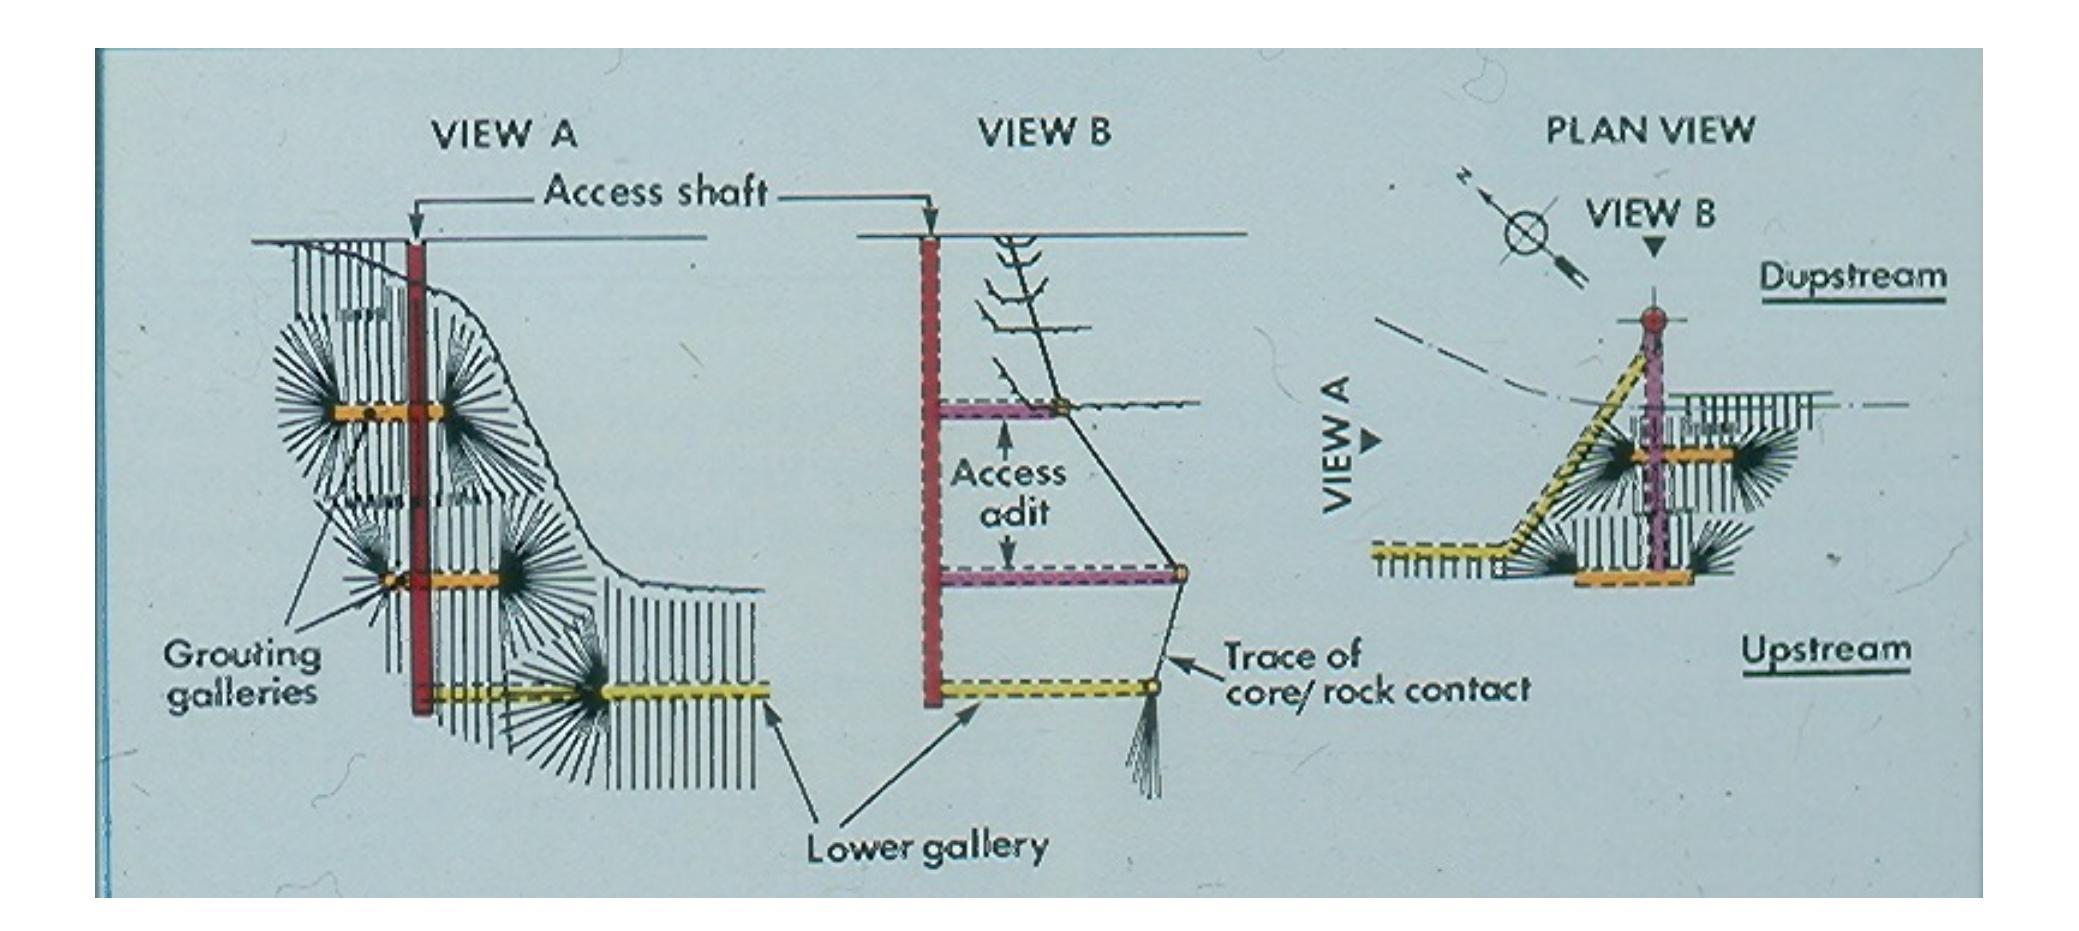
## **RIGHT ABUTMENT – ACCESS SHAFTS**

- A shaft in the rock, 107 m deep and three galleries at elevations 346, 308 and 282 m were then constructed to permit remedial grouting and drainage treatment of the rock abutment in the zone adjacent to the rock-core contact.
- The core is founded at the right bank in a cut off trench. A horizontal section of the abutment core-rock contact at El. 357 m
- The core against the rock, face AB, and downstream, face BC, bears directly against the rock, without any protective filter.

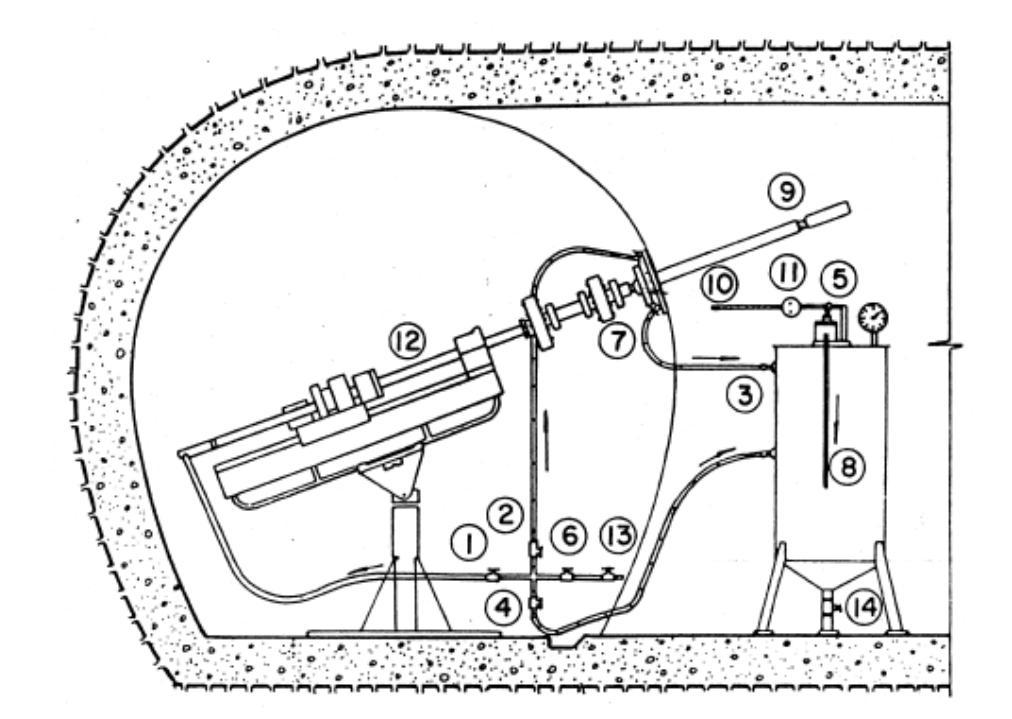
# **RIGHT ABUTMENT CONDITIONS**

- Rock near the contact was highly fractured due to stress relief and to blasting effects.
- At El 369 m there was zero effective stress at the rock-contact above El 357 m. These data confirm that a crack existed within the core close to the steep abutment, caused by differential settlement and arching between the core and the rock face. Exploratory holes showed the existence of open joints up to 2 cm wide.
- The fissures, subvertical and parallel to the river valley, are attributed to stress relief in the recent geological past due to valley erosion and possibly widened by blasting during construction.
- GIN method: stable mixes (water-cement 0.67/1.0 ratio by weight). Total volume injected was more than 100 m<sup>3</sup>.
