LESSONS FROM THE LIVES OF TWO DAMS

The Fourth Victor de Mello Lecture

James K. Mitchell

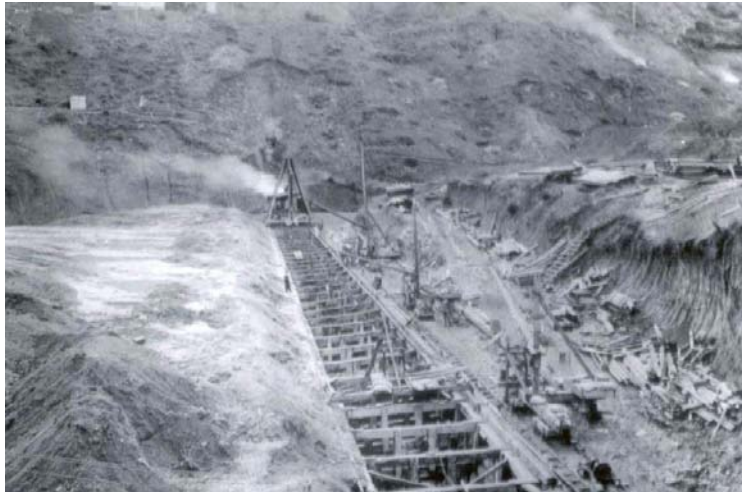
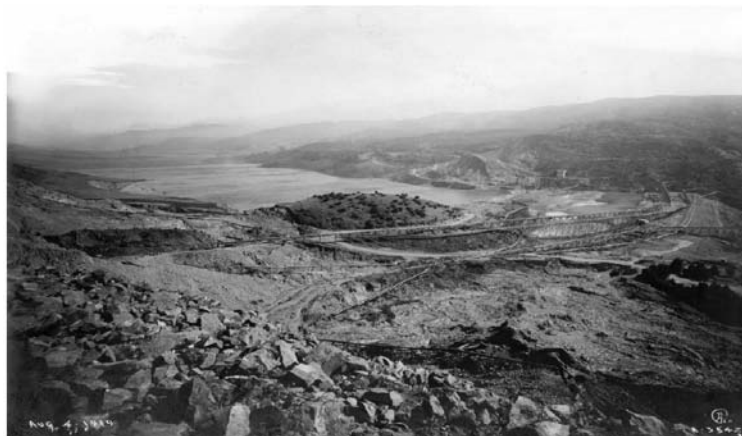
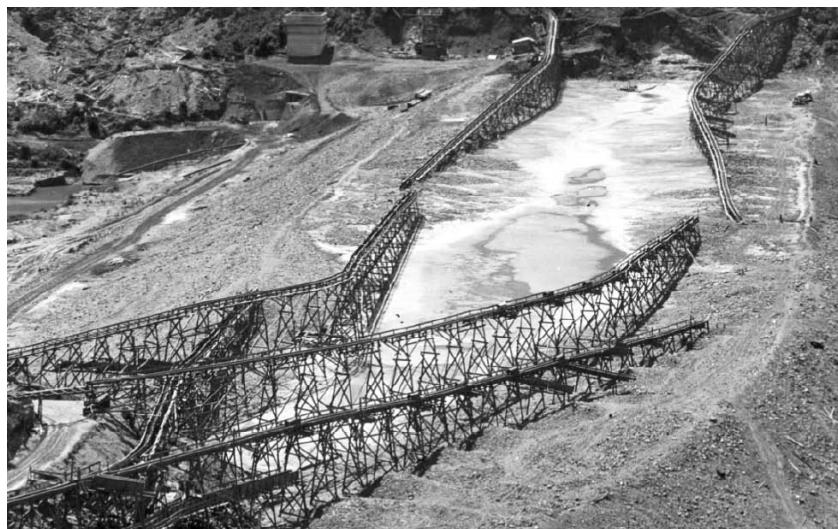
(a) Core trench to bedrock with shoring in 1917

(b) Hydraulic fill construction site in 1919

(c) Hydraulic fill transportation and deposition in 1920

Fig. 1. Stages in the construction of San Pablo Dam. (East Bay Municipal District construction photos Reproduced and reported by TNM Terra Engineers, Inc., Ninyo and Moore, 2007)

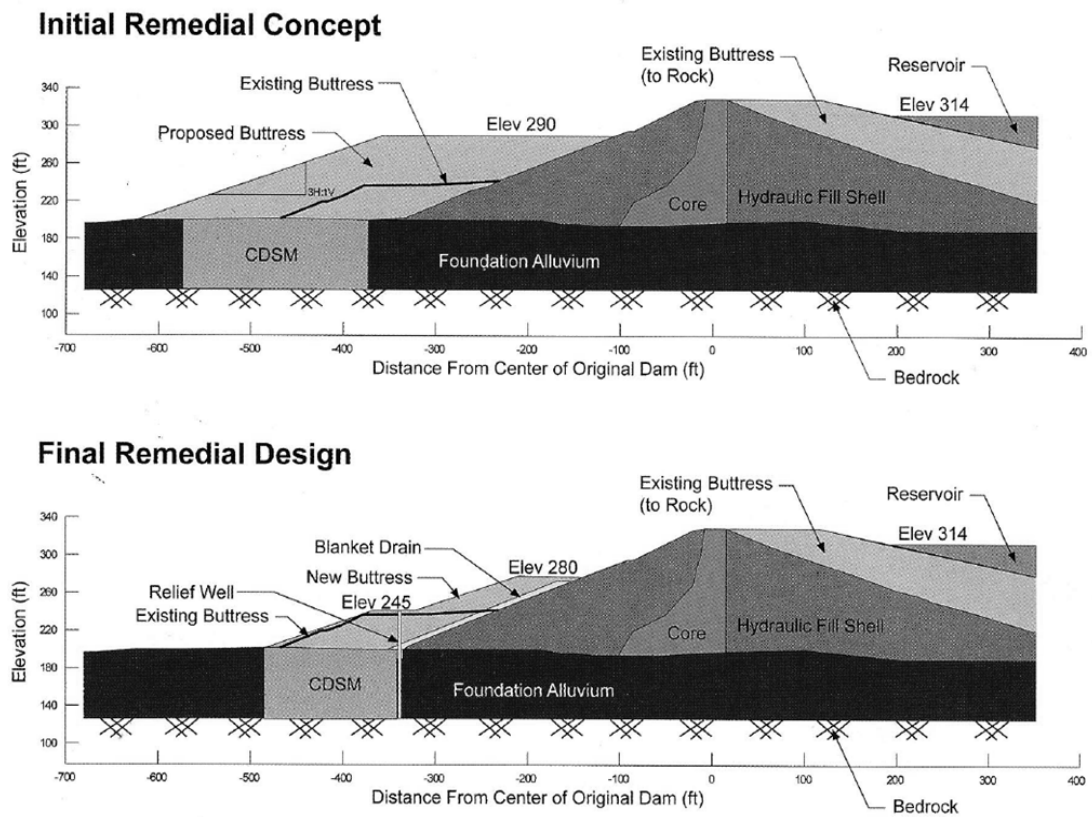
460 Fig. 3. Remedial designs for mitigation of seismic risk to San Pablo Dam. (from Yiadom and
 461 Roussel, 2012).

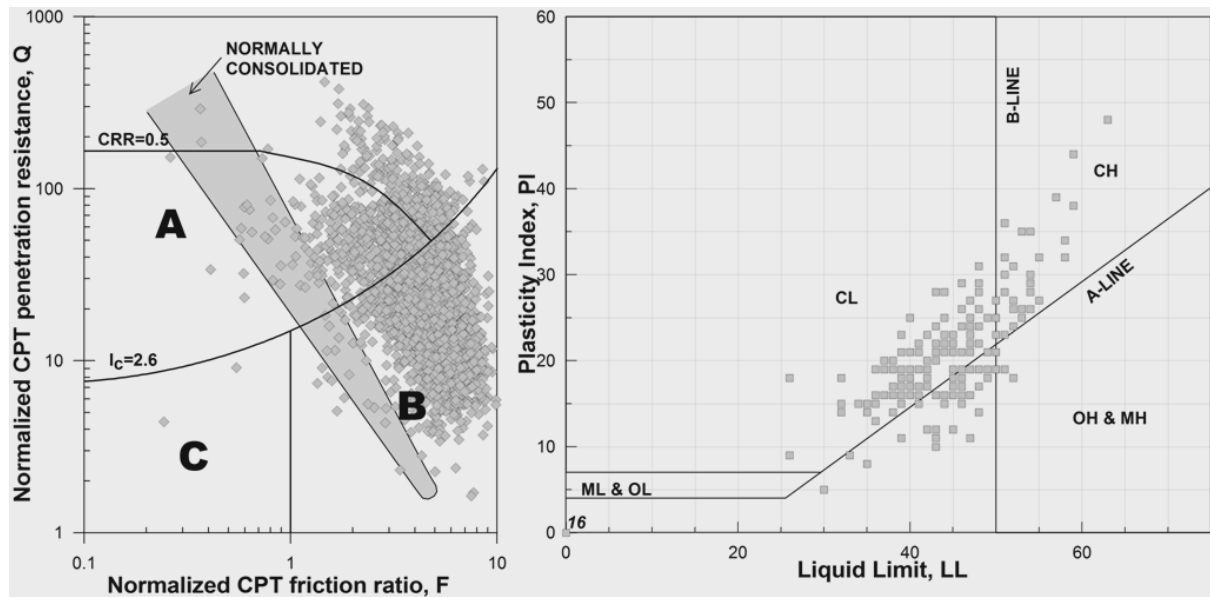
Fig. 4. CPT and Classification data for the San Pablo Dam hydraulic fill shell material. Zone A: Cyclic liquefaction possible; Zone B: Cyclic liquefaction unlikely; Zone C: Flow/cyclic liquefaction possible. (from Moriwaki, et al, 2008).

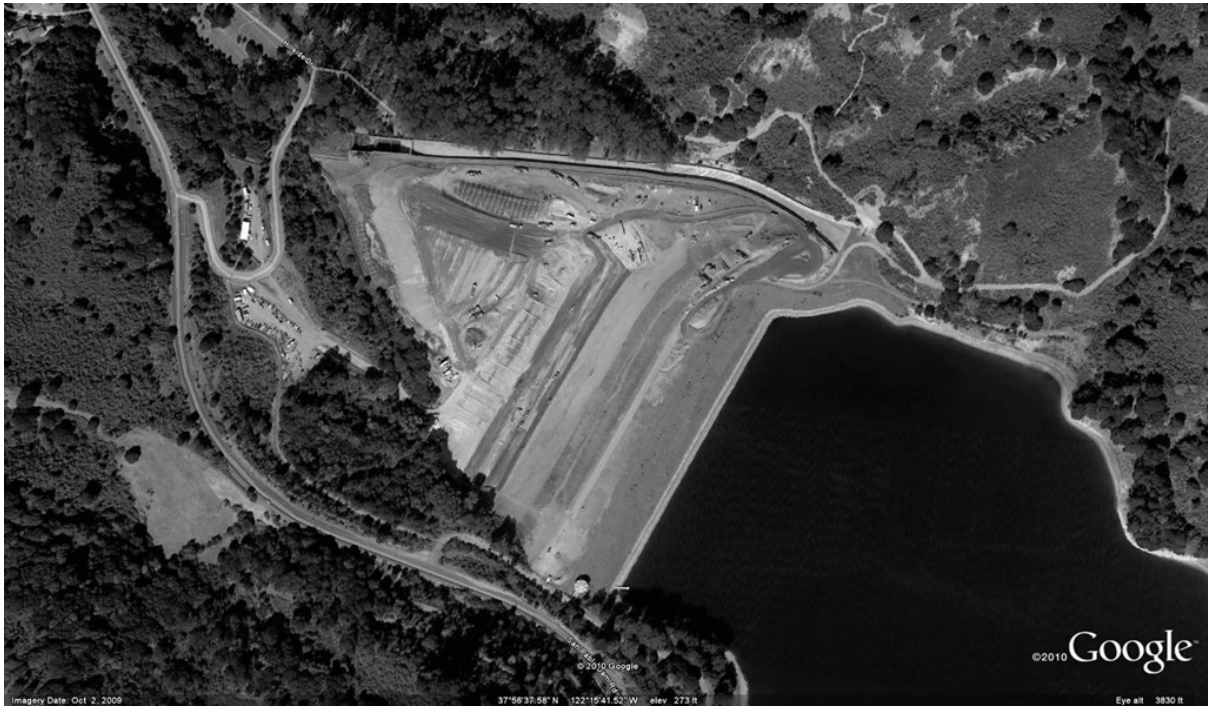
Fig. 5. San Pablo Dam in 2010 after seismic remediation using cement deep soil mix in the downstream foundation and a downstream stability berm. (Google Earth, Imagery Date 10/2/2009).

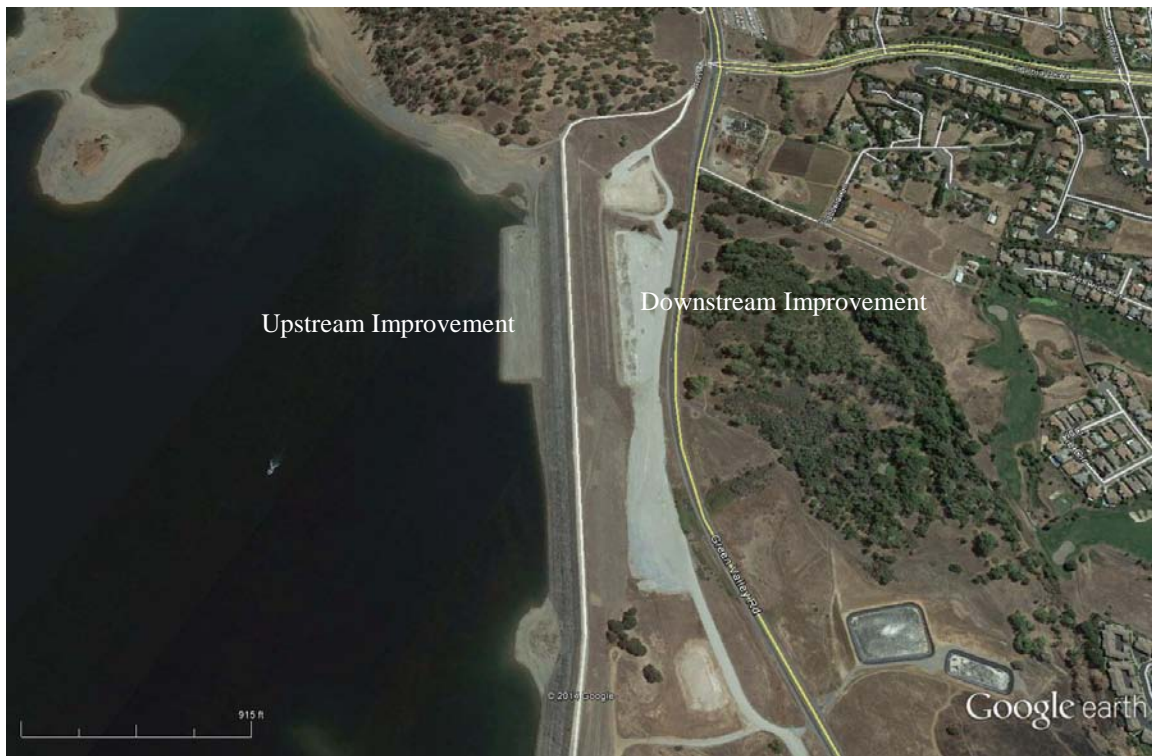
Fig. 7. Aerial view of Mormon Island Auxiliary Dam as it appeared in August 2013. Critical section over potentially liquefiable foundation material extends about 300 m from the left abutment. (Google Earth, Imagery Date 8/13/2013)

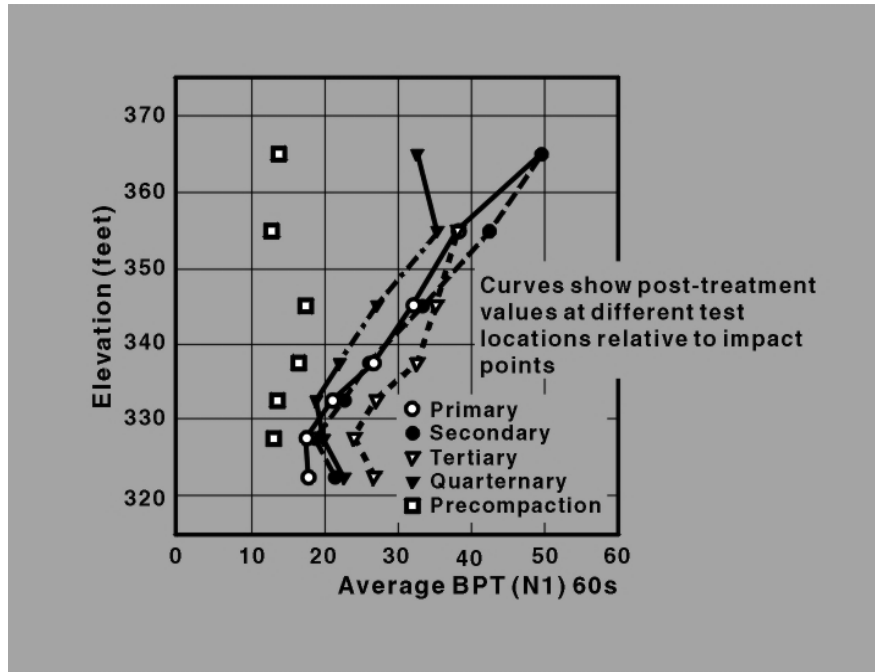
Fig. 11. Pre- and post-deep dynamic compaction Becker Penetration Test equivalent $(N_1)_{60}$ values beneath the upstream slope of Mormon Island Auxiliary Dam.

The effectiveness of the DDC can be seen in Fig. 11, which shows values of Becker Penetration Test (BPT) resistance, converted to equivalent SPT values of $(N_1)_{60}$, as a function of elevation. The BPT measures the number of blows to drive a 168 mm (6.6 in) outside diameter double-walled casing a distance of 0.3 m using a double-acting diesel pile driving hammer. This test is useful in soils containing gravel and cobbles, where difficulties are often encountered when using the SPT. The decrease in penetration resistance with depth in Fig. 11 is characteristic of the DDC method for soil improvement, with an effective treatment depth of about 10 m (35 ft) being about the maximum attainable when heavy weights are used in soils of no to low plasticity. As shown in Fig. 11, the DDC was unable to densify the soil within the treatment zone over the full depth to the underlying bedrock.

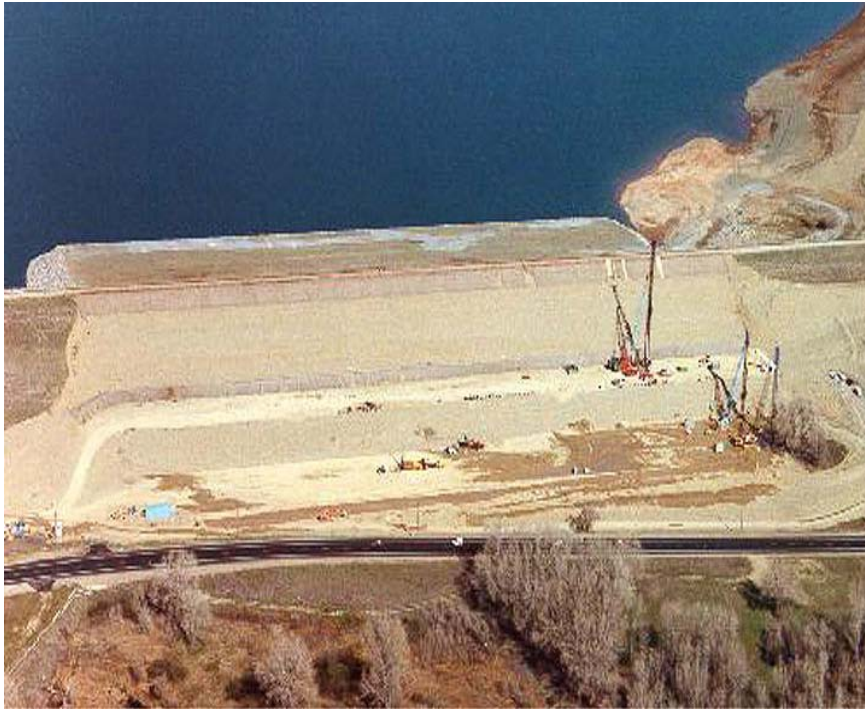
Fig. 13. Installation of stone columns and gravel mini-column drains beneath the downstream embankment of Mormon Island Auxiliary Dam in 1994. Note the excavation and steepened slope needed for development of a working platform and for optimization of the improvement zone location for its effectiveness as a key block.

It is imperative to keep in mind, however, that whenever a project involves excavation into the downstream slope; e.g., during the stone column and drain installation, Fig. 13, or into the foundation, as was necessary for the key block construction at MIAD, Fig.16, there may be increased seepage as well as a temporary decrease in factor of safety against stability failure while the excavation is open that must be evaluated and assessed in terms of increased failure risk.
